# THE RESTORATION WORK IN NAARDEN

Jeroen van der Werf

Keywords: Naarden, New Dutch Waterline, seventeenth century fortifications, heritage management, restoration.

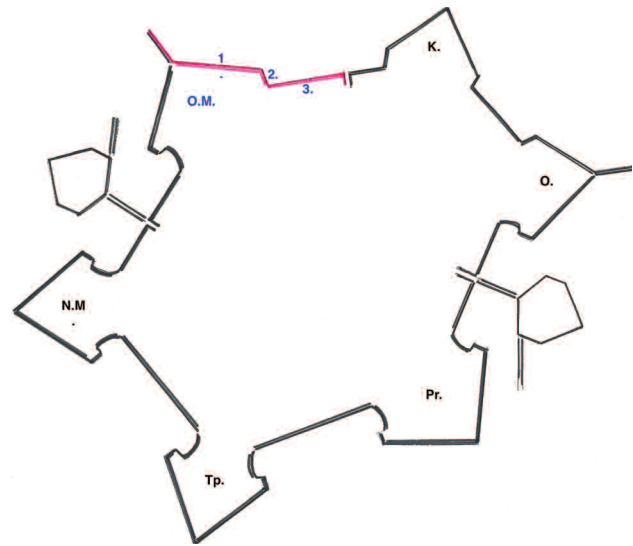
Figure 8 Schematic map of the fortifications showing the area (in pink) where the work of 2018-2019 took place: Bastion Oud Molen (marked with O.M. in blue) and the adjacent curtain wall. The numbers 1, 2 and 3 mark the three representative locations where the work was started. After this was finished another 120m<sup>2</sup> of wall was restored around position 1. The other bastions of the town are: K: Katten, O: Oranje, Pr: Promers, Tp: Turfpoort, N.M: Nieuw Molen.

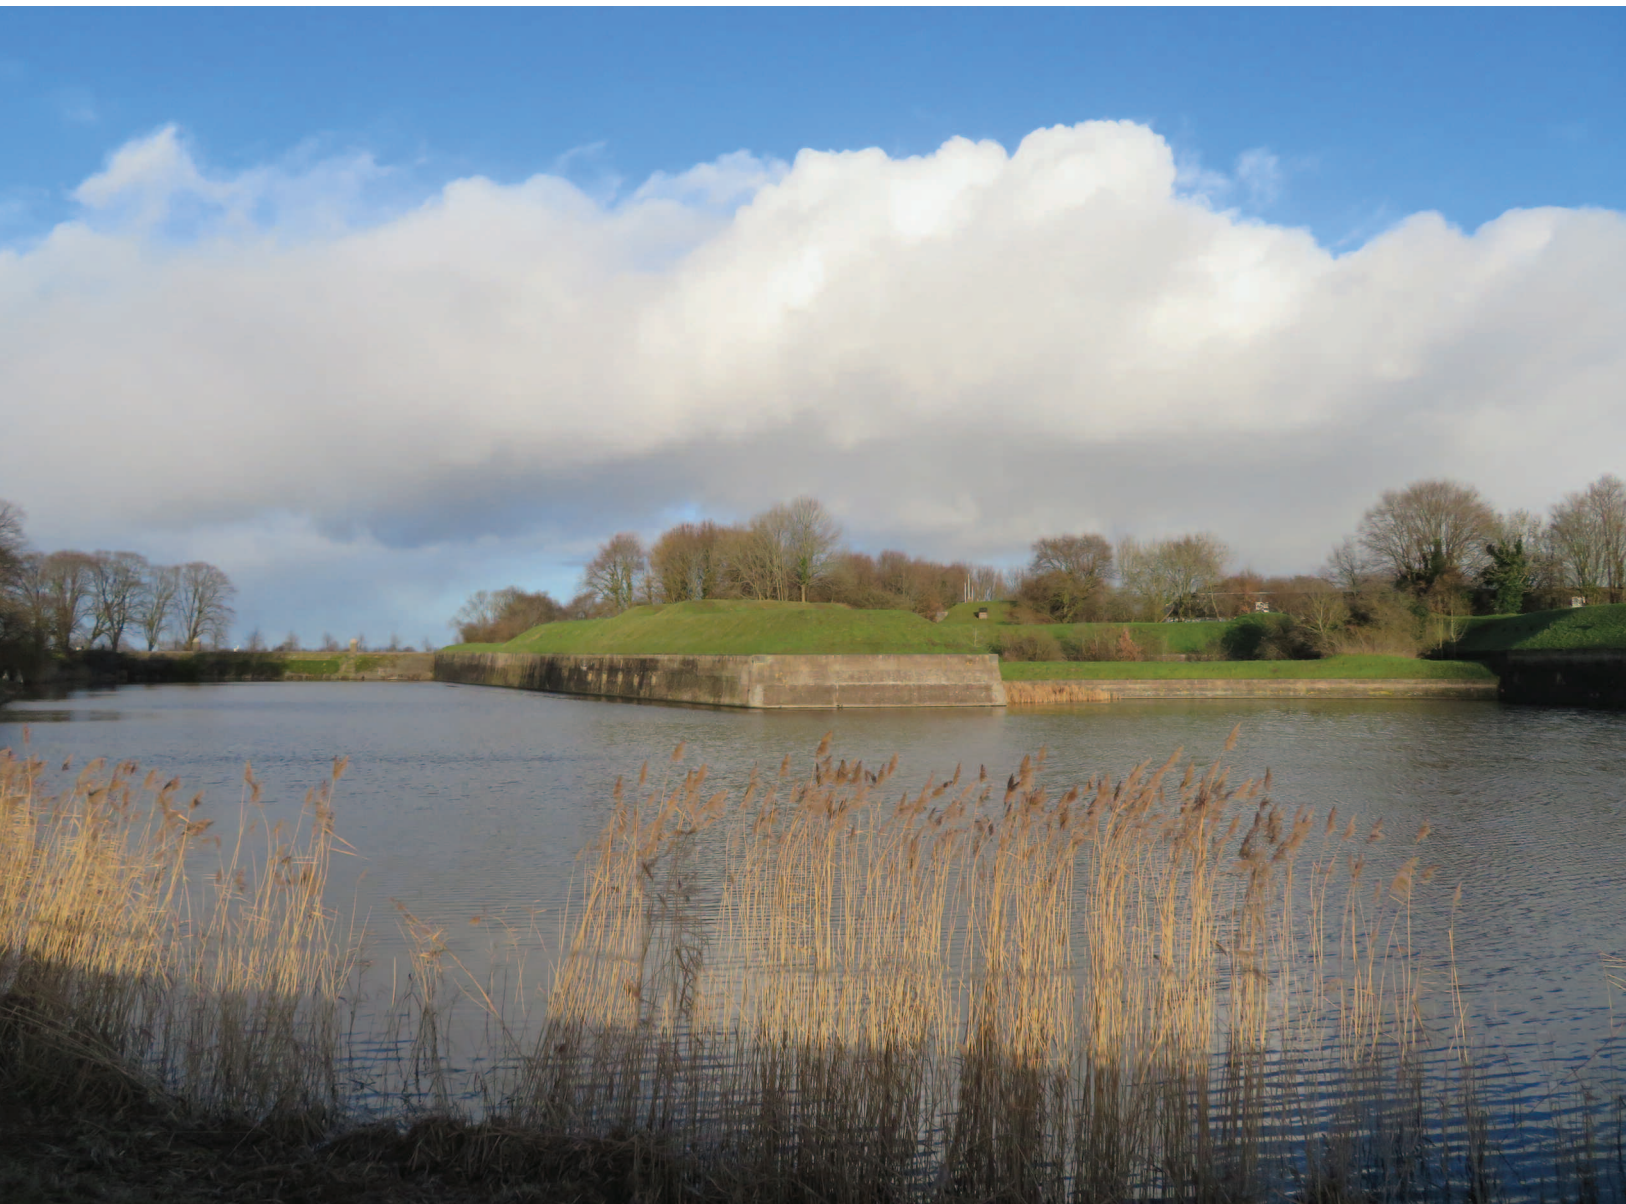
*Figure 9 View of bastion Oud Molen when entering the city. (All uncredited images by the author)*

The restoration work started in May 2018 with a part of the fortifications where no restoration work had taken place since the 1950s: bastion Oud Molen. The first step was to determine the exact condition of this part of the walls and amount of work needed. An overall inventory of it had already been made in order to make the work description but this inspection would be much more detailed. The walls were inspected up-close. All types of damages on the surface were categorized (e.g. loose bricks, missing joints, broken bricks etc.) and the type and quantity of work

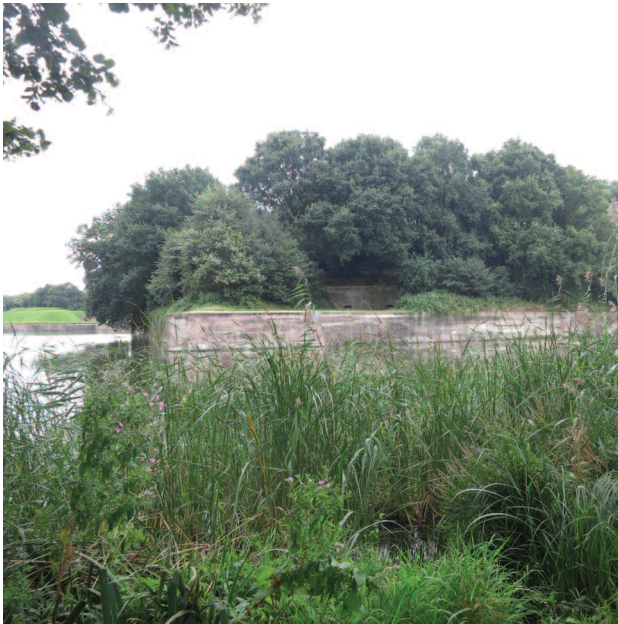
*Figure 10 The vegetation on Bastion Katten during the summer. It doesn't take much imagination to see the amount of work this brings about.*

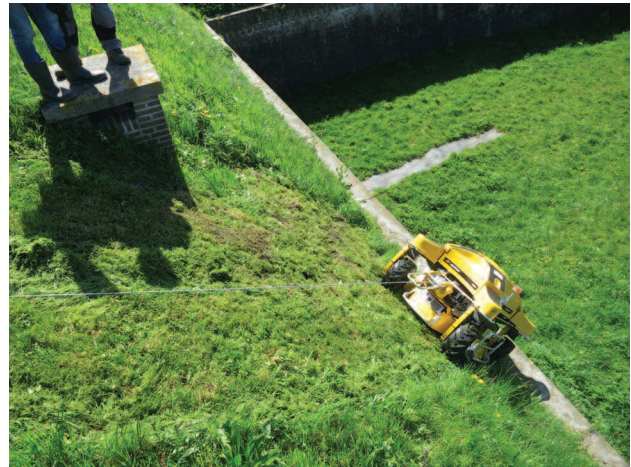
*Figure 11 The mowing machine designed for mowing steep slopes in action*

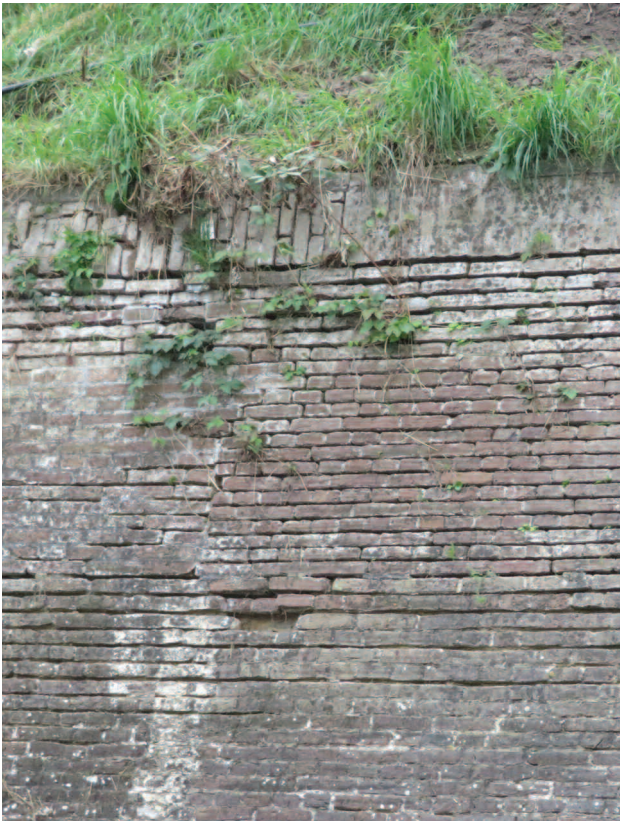
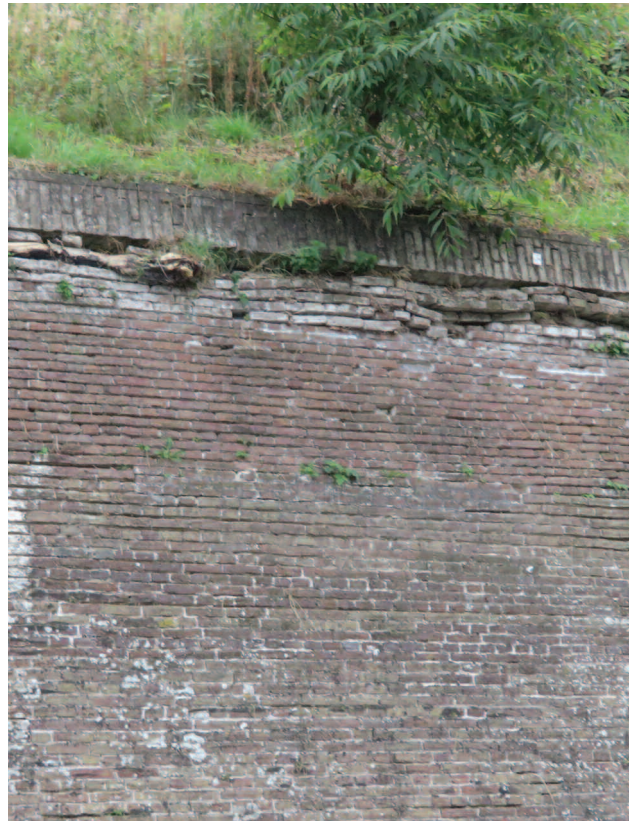
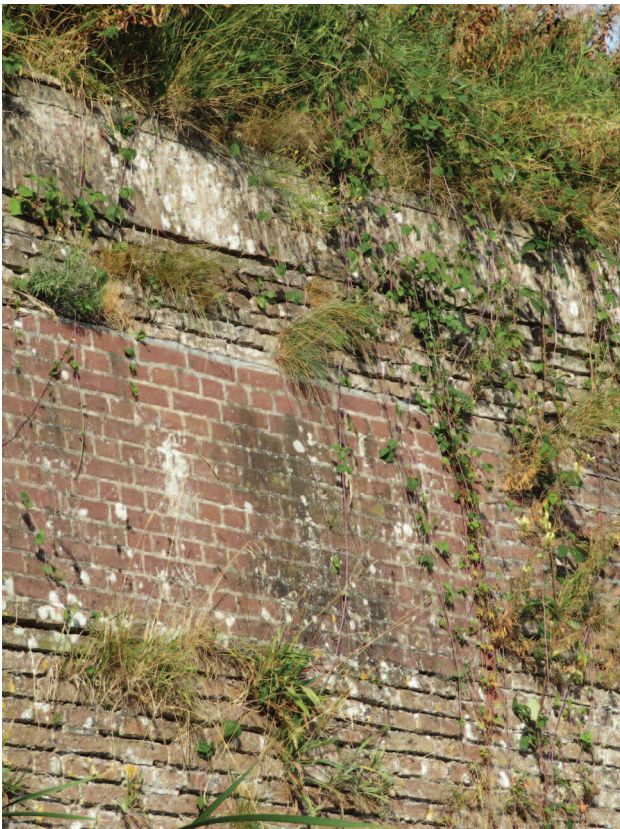
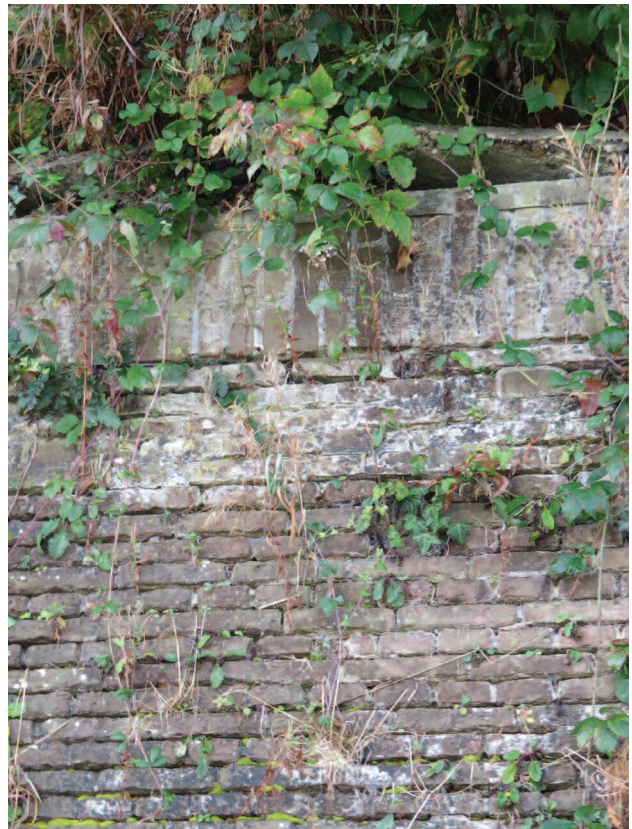
*Figures 12, 13, 14, 15 Four pictures of the walls of bastion Oud Molen just before the work started. There is a lot of visual damage: missing joints, broken bricks, loose bricks and much vegetation growing in and on the walls.*

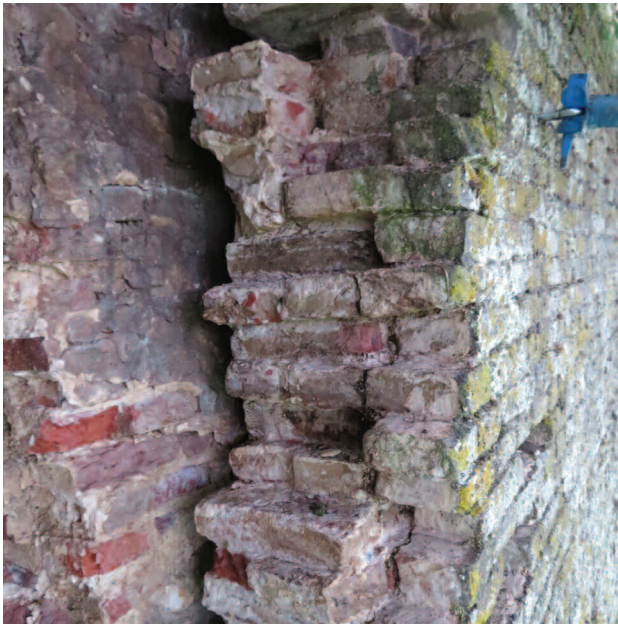
Figure 16 The cavity found in the bastion front. It is about 6 to 8 centimetres wide 3 metres high and over 10 metres long.

3. The walls showed large cavities, caused by repairs from the past: damaged parts of the wall were taken out and replaced, without giving the new masonry any connection to the existing brickwork (Figure 18a). They were just filled in. Cavities were left behind them or came to be after a process of erosion. These repairs date from the nineteenth century.

The existing construction on the other hand is stable and causes no further damage. By preserving it the construction will behave in a more predictable way and will be much easier to monitor. It will create the least amount of risk in the future. So, after a careful inspection on location it was decided to leave these cavities as they were.

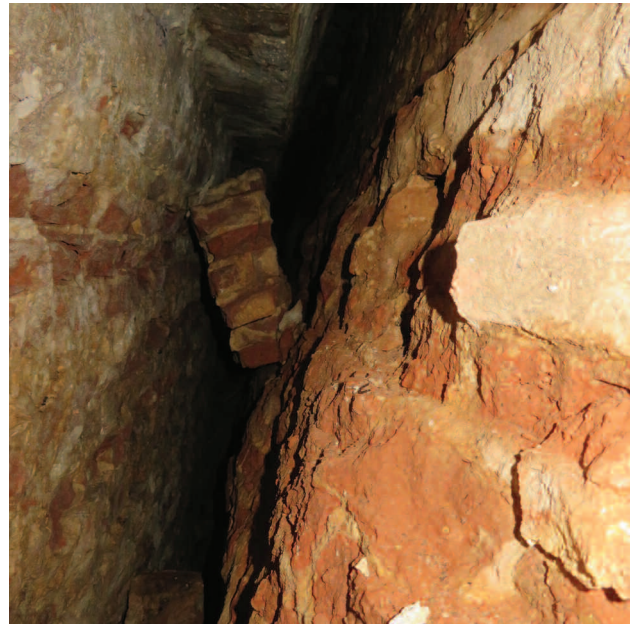
Figure 17 The same goes for this cavity (located in the flank of the bastion) but this one is about 30 to 40 centimetres wide.

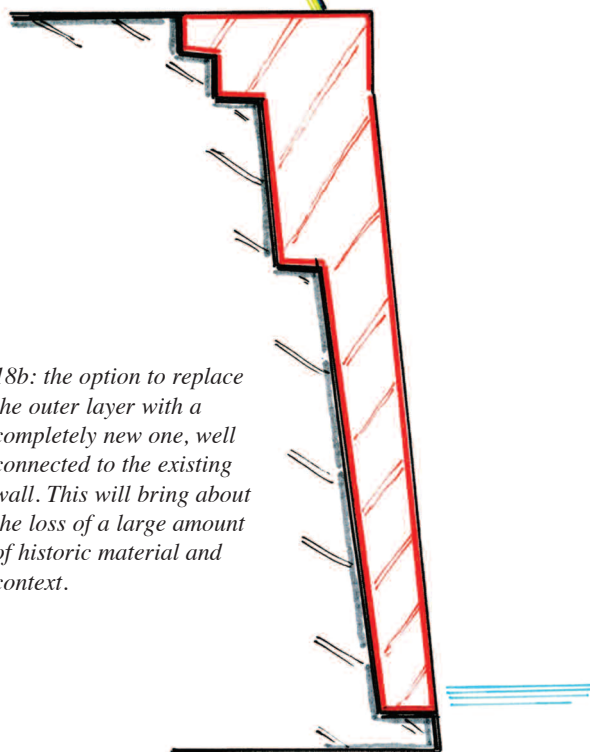
18b: the option to replace the outer layer with a completely new one, well connected to the existing wall. This will bring about the loss of a large amount of historic material and context.

would be much too expensive it would also mean the destruction of a historical layer of the fortification walls. An unthinkable solution from a historic point of view. Other solutions were the use of stainless-steel anchors to connect the two layers, or to fill the cavities with a mortar, poured in from above (Figures 18b-d).

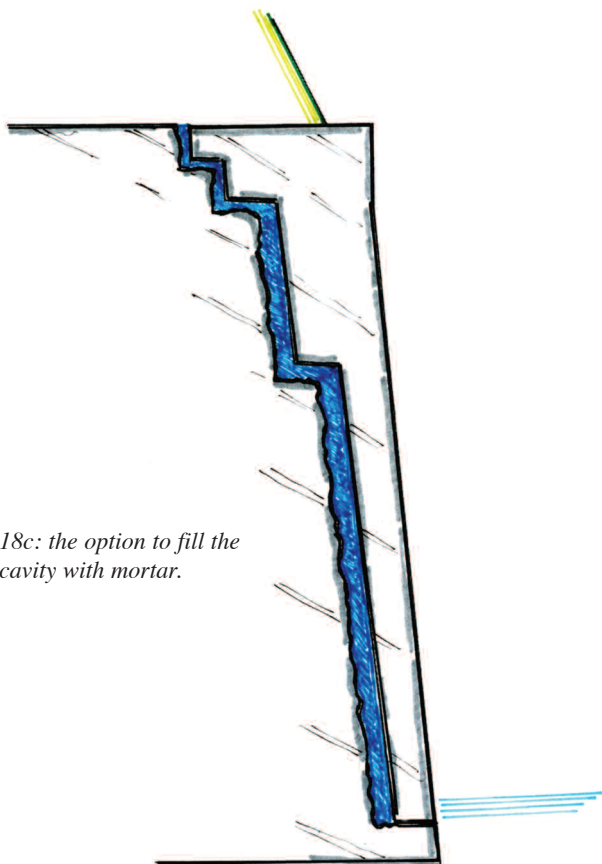
18c: the option to fill the cavity with mortar.

These last two solutions would result in a construction with unpredictable behaviour: Connected, the two layers lose their ability to move independently. This might lead to tension in the masonry, causing new and unpredictable damage in the future.

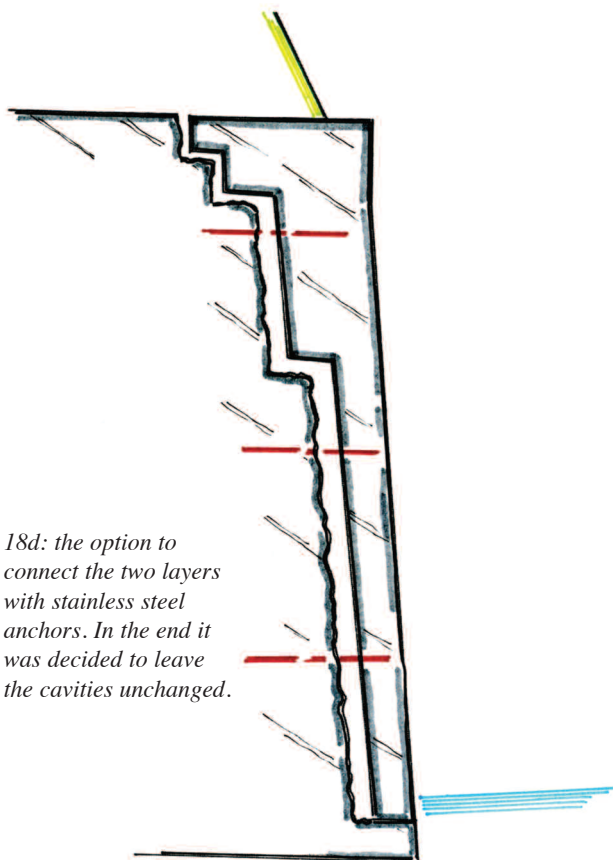
18d: the option to connect the two layers with stainless steel anchors. In the end it was decided to leave the cavities unchanged.

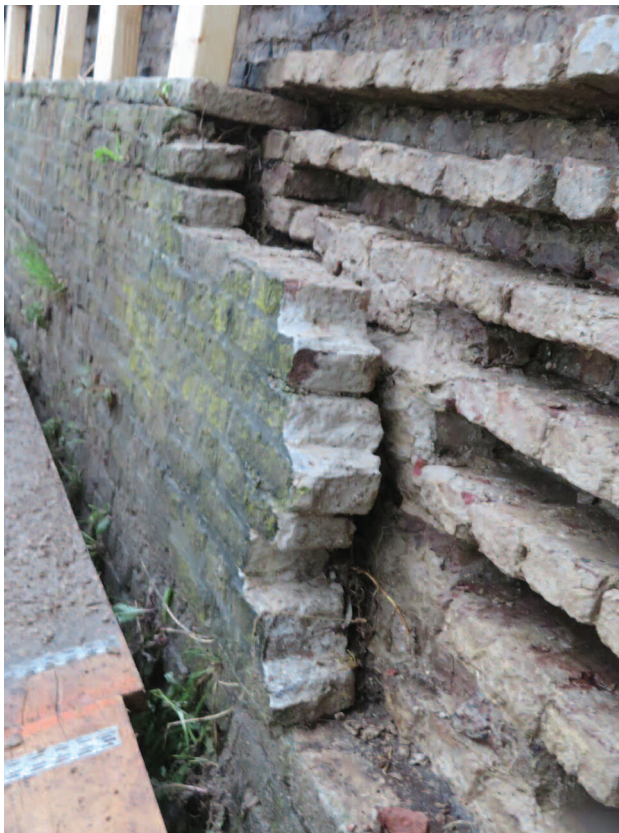
2. Large portions of the wall showed lateral cracks, causing big slabs of masonry to come loose. This is caused by the process of water infiltration and freezing described above when combined with cement joints. When this

*Figure 19 A slab of bricks broken loose from the masonry behind it, caused by the use of cement-based mortar and dense bricks.*

Where slabs of brickwork come loose or have lost their coherence with the surrounding masonry, they will be taken out and replaced by new masonry. Stable parts will be preserved. When they are surrounded by solid, well maintained masonry they won't deteriorate any further and can last for years to come.

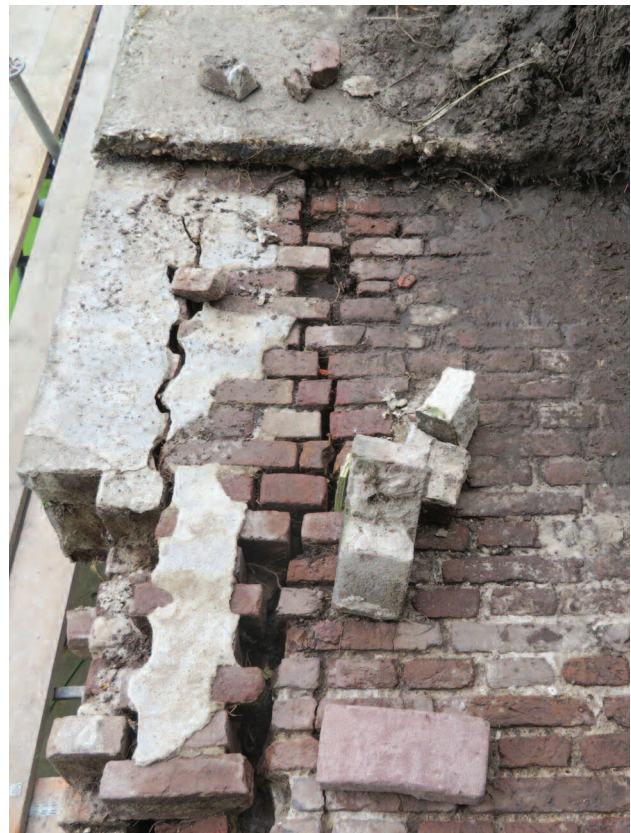
*Figure 20 The top covering of the wall is cracked. Cracks up to 2 centimetres wide will be repaired with mortar. Wider cracks will be filled out with new bricks. After that it will be smeared with a layer of dense mortar, replacing the existing, eroded one.*

This is the most urgent problem to be solved. For this, the upper part of the wall and the top covering need to be repaired. After that, the top covering will be smeared with a centimetre-thick layer of dense mortar to make it more waterproof over a breath of 60 centimetres. It will prevent new water infiltration in the future.

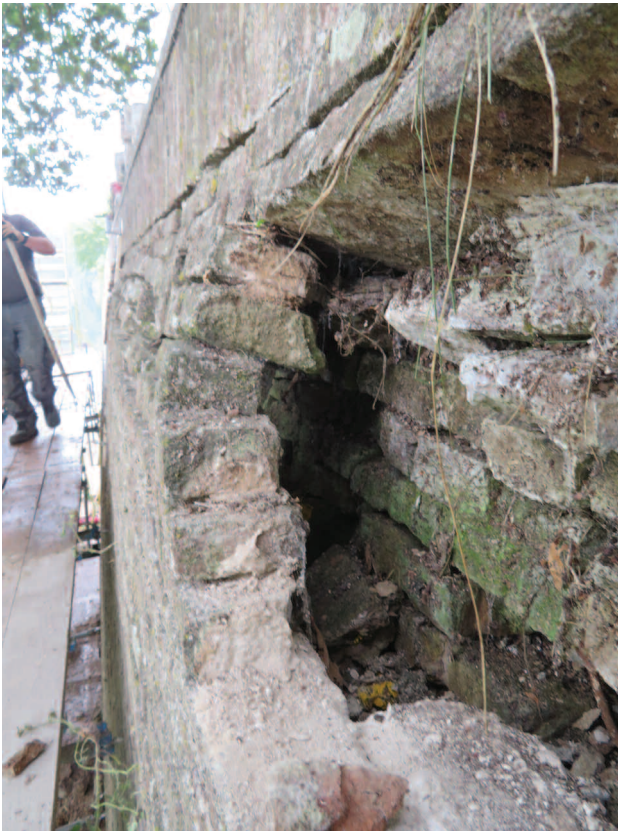
process continues long enough the lateral cracks become wider and let in earth and plants, causing them to widen further and eventually cause large parts of masonry to break out of the wall.

*Figure 21 Another slab broken loose. Over time the cavity behind it was filled with earth and vegetation, causing it to break out further*

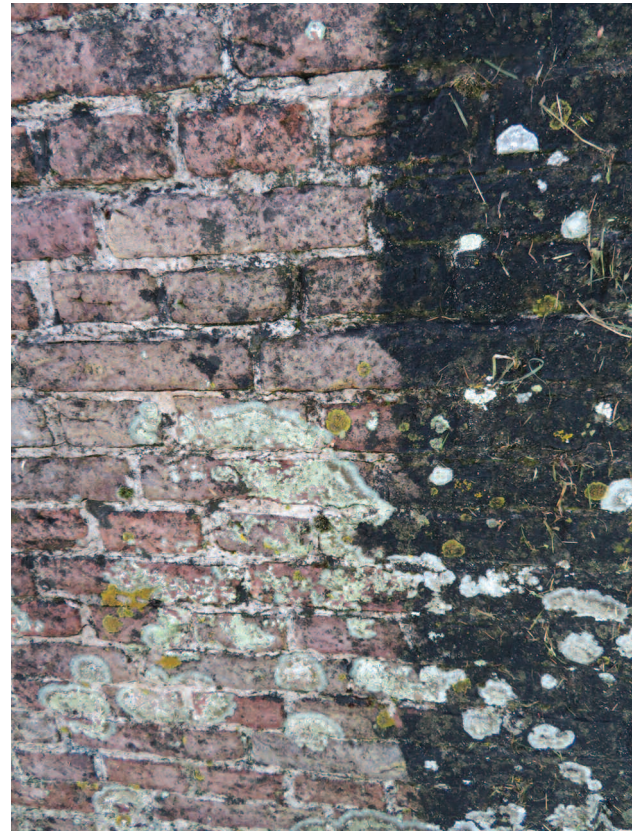
*Figure 22 Before the work starts the masonry will be cleaned carefully. The black pollution disappears but the lichen is kept intact, saving much of the appearance of the wall.*

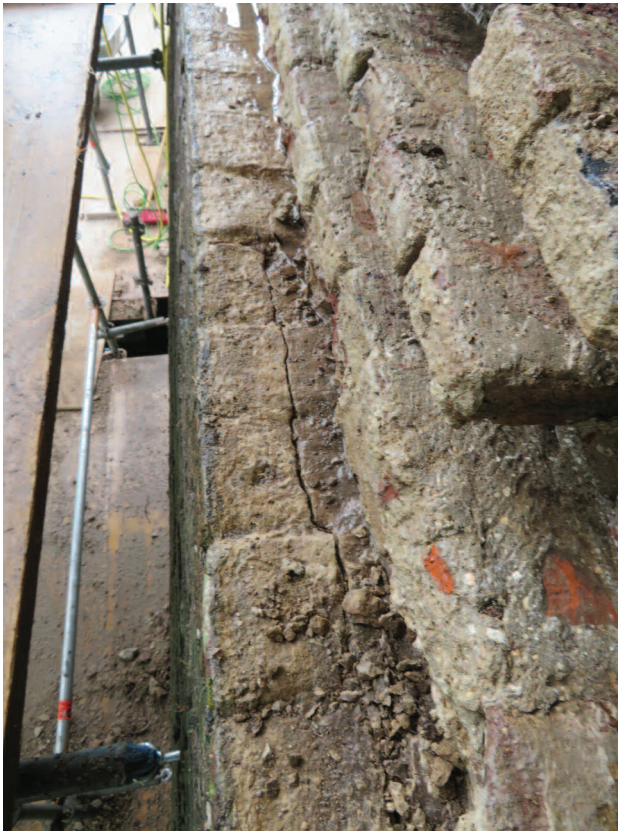
Figure 23 A lateral crack. Over time this part of the masonry can break out further, if maintenance is neglected. This part of the wall can be preserved if the surrounding masonry is kept in a good condition through regular maintenance.

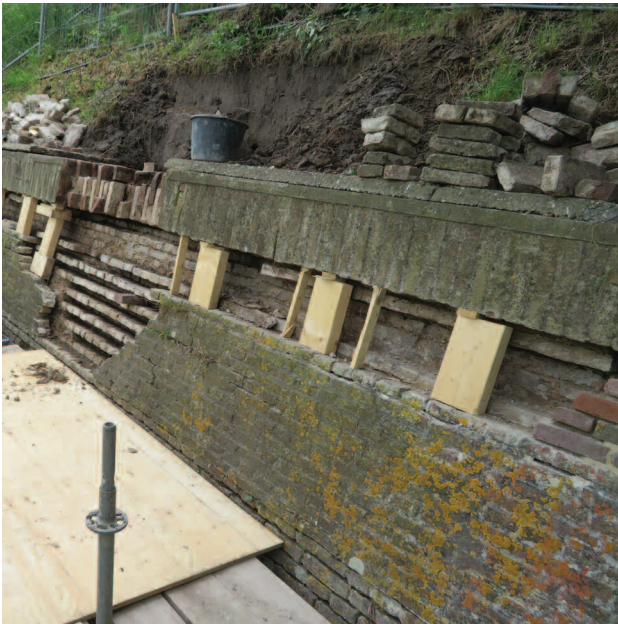
Figure 25 The wall during the restoration work

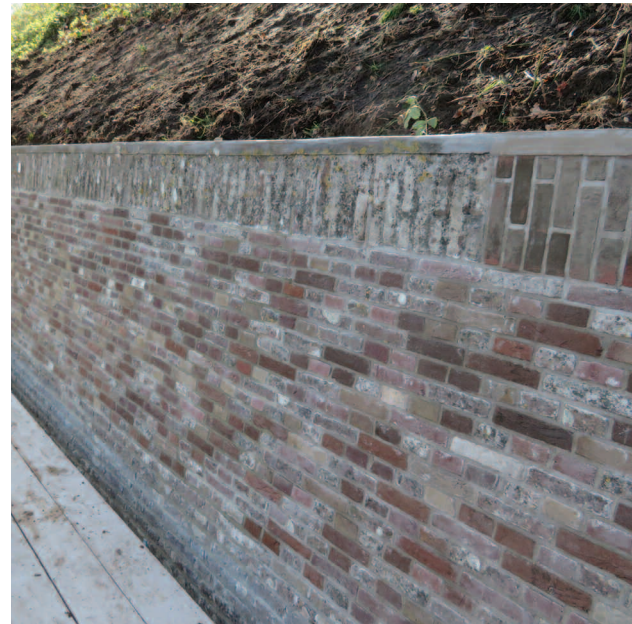
Figure 27 The wall after the restoration work

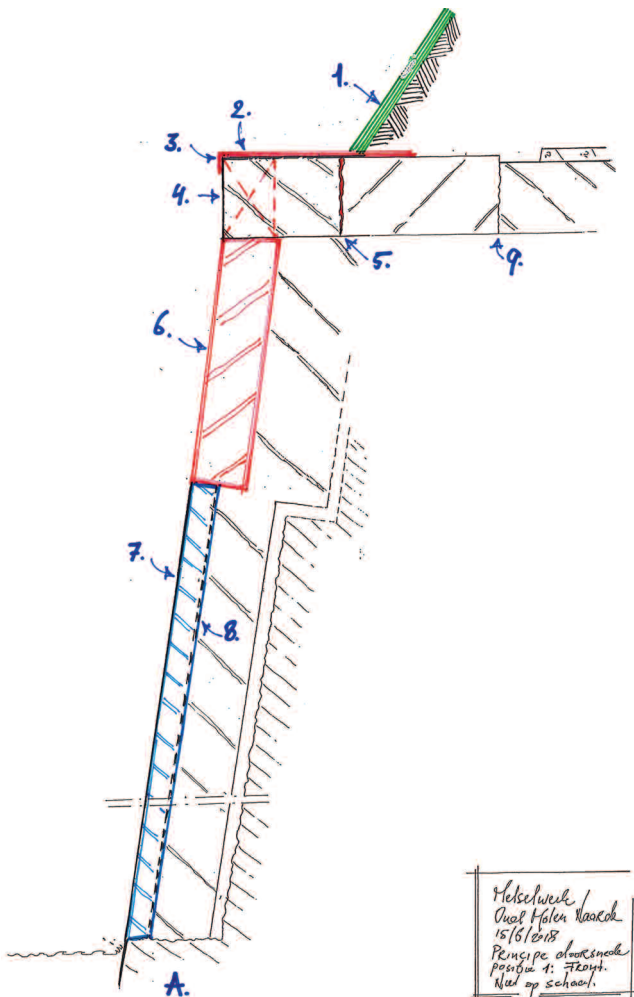
- 1: The earthwork restored
- 2: The concrete slabs have been removed
- 3: The top covering of the wall has been smeared with a new layer of dense mortar
- 4: The outer edge of the top covering is restored. Some parts have been replaced
- 5: The cracks have been repaired. Small ones poured-in with mortar, wide cracks filled out with new masonry
- 6: The top 1-1.5 metre of the wall has been replaced over the depth of 1-1.5 stone. As many existing bricks as possible have been reused (about 40% average)
- 7: The joints of the masonry in the lower part of the wall have been replaced (varying from 50 to 90% depending on the condition of the existing work)
- 8: Lateral cracks still exist but are consolidated in healthy restored masonry

As described above: no work has been done on the cavities.

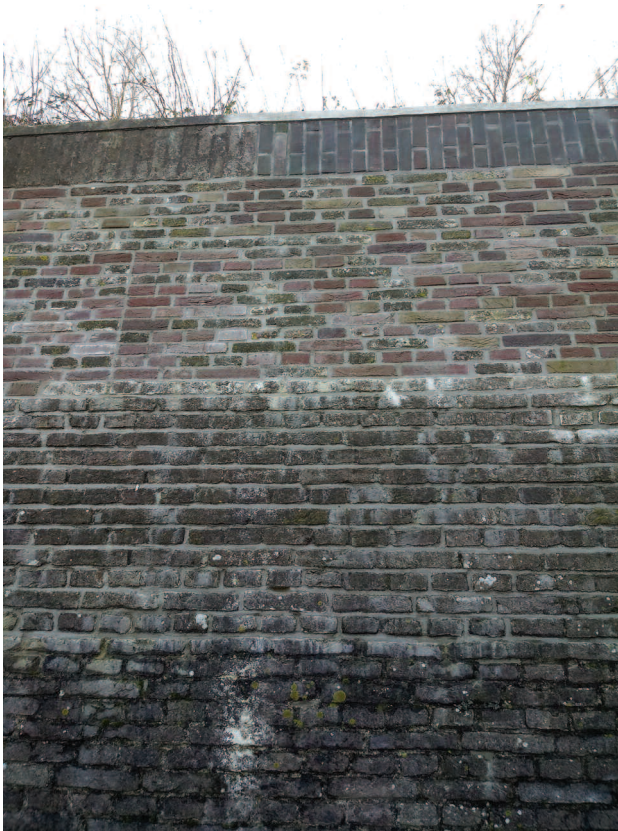
During the restoration work another interesting phenomenon was noted. After the first work had been done, a thin white efflorescence was visible around some

of the new joints: residues of lime. There turned out to be an almost constant transmission of water through the masonry. This is logical given the fact that the walls are covered in a huge mass of earth, but it was more than expected. The consequence is that the inside of the wall is almost permanently wet, even during a dry summer. The way the water moves through the brickwork is unpredictable, it will find its way through small cavities in the masonry and through the pores of the bricks and joints. It causes small streams of water to come out at one spot and leaving other parts of the surface completely dry. Because of the humidity of the brickwork the lime in the new mortar doesn't get the opportunity to react properly with oxygen, causing it to dissolve in the transmitted water and being brought to the surface of the wall, where it will cause the white efflorescence after the evaporation of the water. So, it was important to find a mortar with less lime, better suitable for a wet environment. Several alternatives were possible:

Figure 28 White efflorescence on the bricks. This caused a revaluation of the mortars used.

A part of the wall has been restored with each of these alternatives. Over the next two years these parts can be monitored to see which mortar gives the best results. In the meantime, the planned restoration work of 2020 and 2021 will focus on the facades of the nineteenth century military buildings. They don't have the problem of water transmission and efflorescence as the walls do. Here a straightforward lime-based mortar will do.

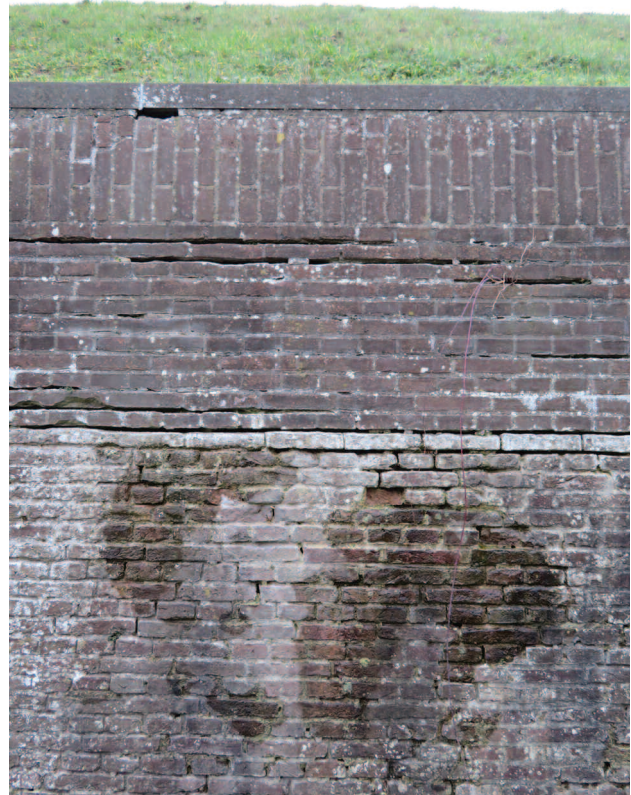
Figure 29 Example of water transport in other parts of the wall. There is continuous water transport in the masonry. It is unpredictable where the water will come out. Causing a small stream of water in one place and leaving other parts of the wall completely dry.

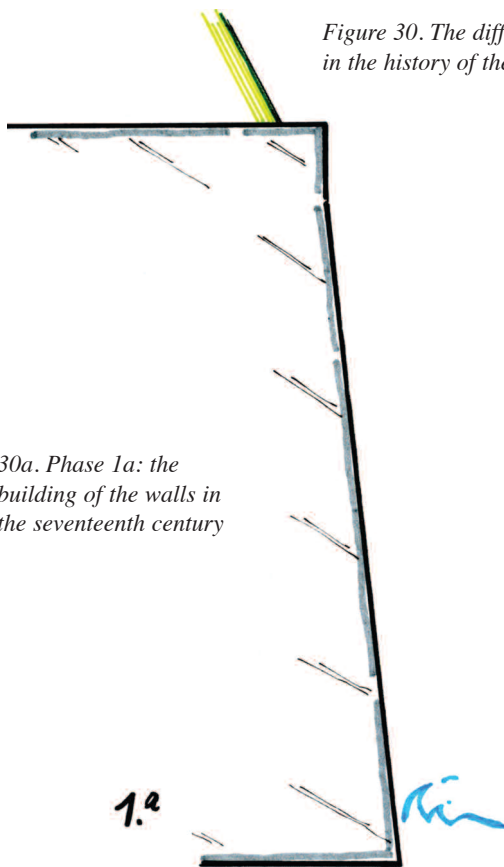
30a. Phase 1a: the building of the walls in the seventeenth century

The seventeenth century, the building of the walls: soft

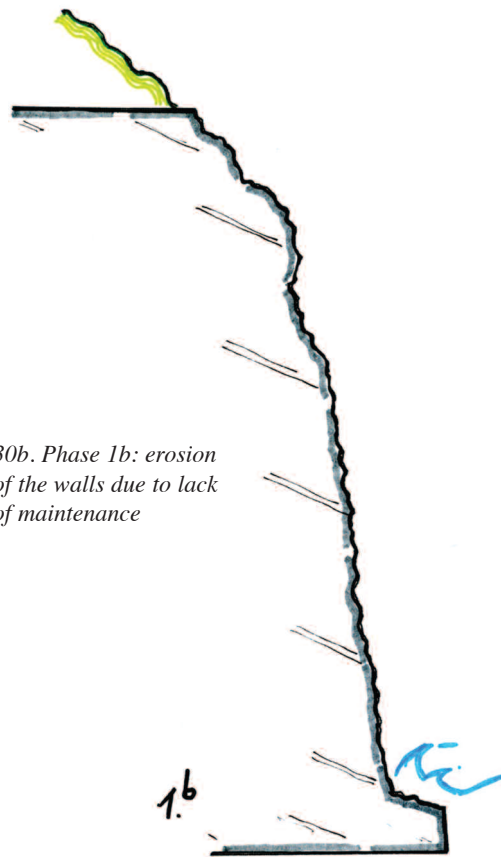
30b. Phase 1b: erosion of the walls due to lack of maintenance

Due to lack of maintenance during the eighteenth century, this part of the walls, exposed to the sea was

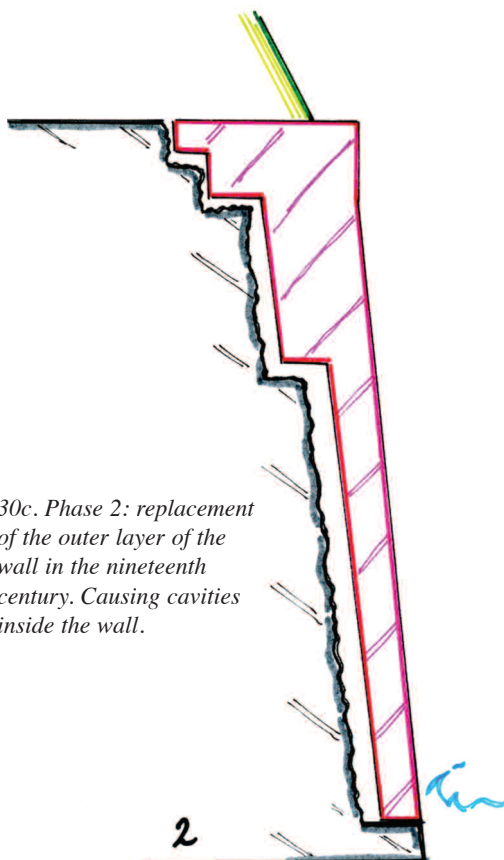
30c. Phase 2: replacement of the outer layer of the wall in the nineteenth century. Causing cavities inside the wall.

severely damaged. It was repaired during the second half of the nineteenth century by replacing the outer layer of the walls with a new wall of hard, purple bricks. This new wall was placed against the existing wall without any connection. This construction resulted in the cavities mentioned above.

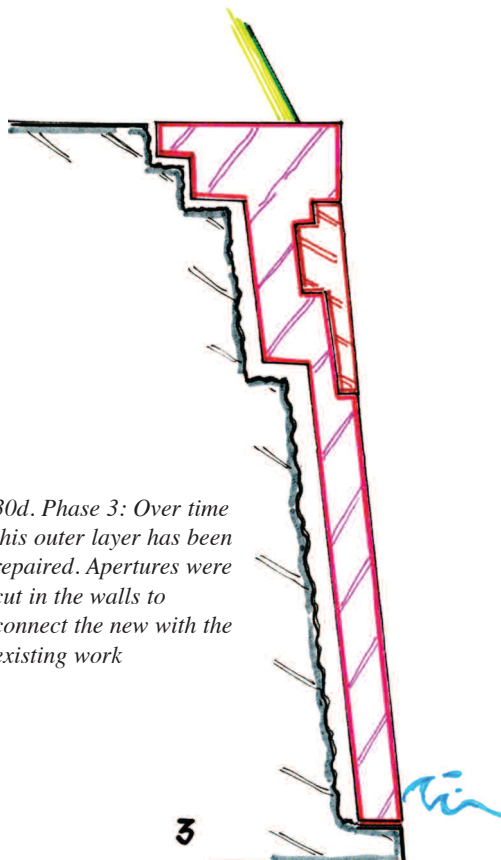
30d. Phase 3: Over time this outer layer has been repaired. Apertures were cut in the walls to connect the new with the existing work

These new walls were restored over time. Parts were replaced and in order to connect the new and the old, apertures were cut in the existing work.

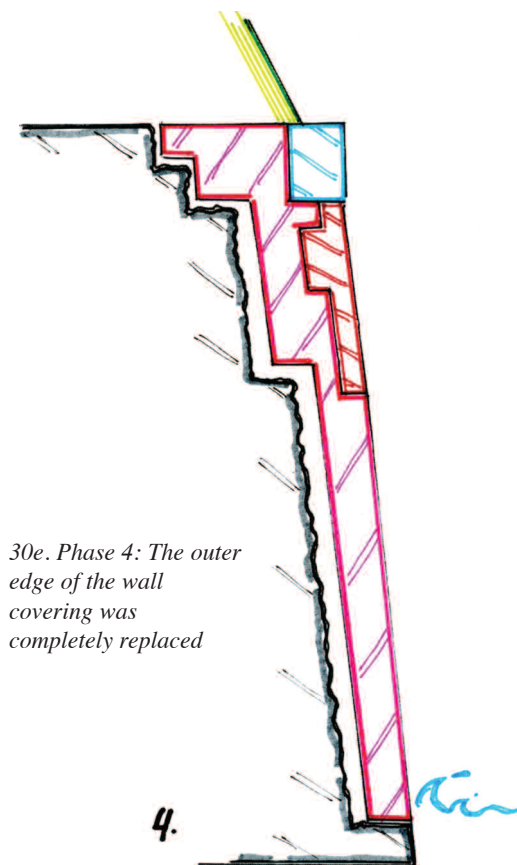
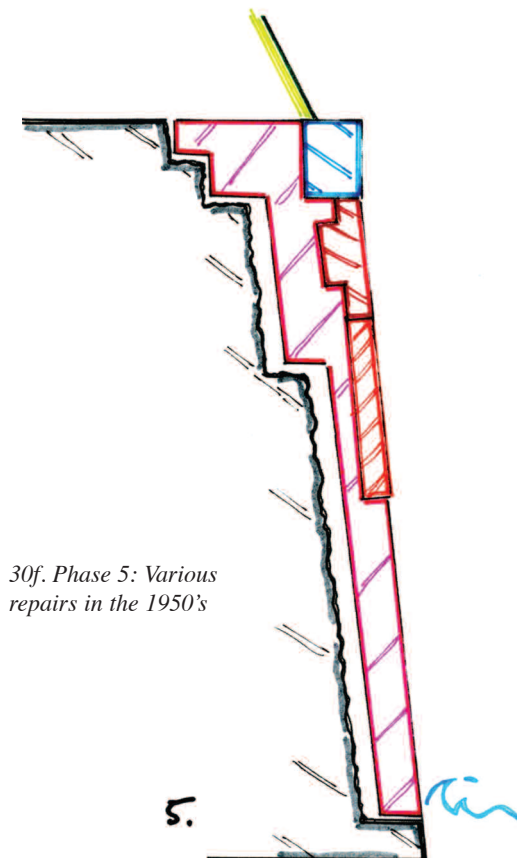
30e. Phase 4: The outer edge of the wall covering was completely replaced

The outer edge of the wallcovering was completely replaced. Judging from the type of bricks used there, this was done in the early twentieth century.

Missing parts of the walls were filled-in with new masonry. Here dense bricks and hard cement-based joints were used. Parts of these reparations break out of the walls today, because they are not compatible with the existing work. Judging from the materials used, this was done in the 1950's.

30f. Phase 5: Various repairs in the 1950's

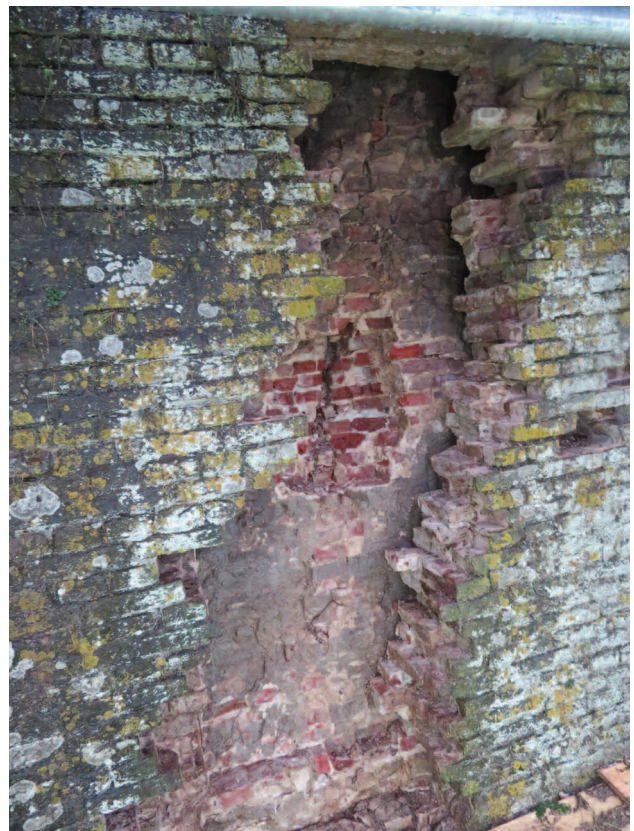
Figure 31 Here the outer layer of the wall is visible. It was placed in front of the existing wall in the nineteenth century. Behind this new layer there is a cavity. The seventeenth century brick work can be recognized by its clear orange colour. The new brick work has a purple colour.

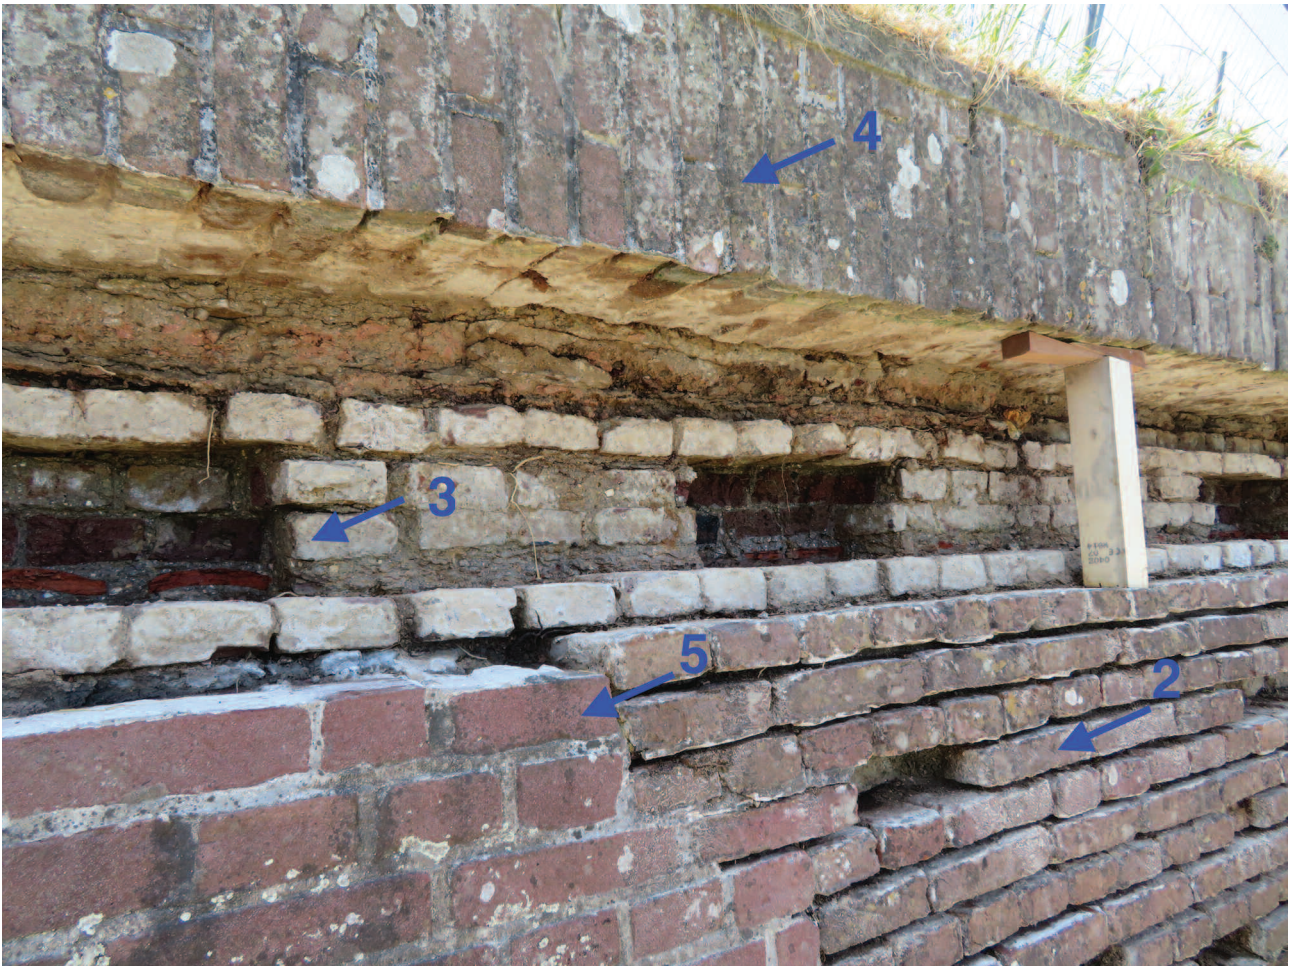
Figure 32 Part of the wall during the restoration. The phases 2 through 5 are all visible here. Number three points out one of the three apertures visible on this picture.

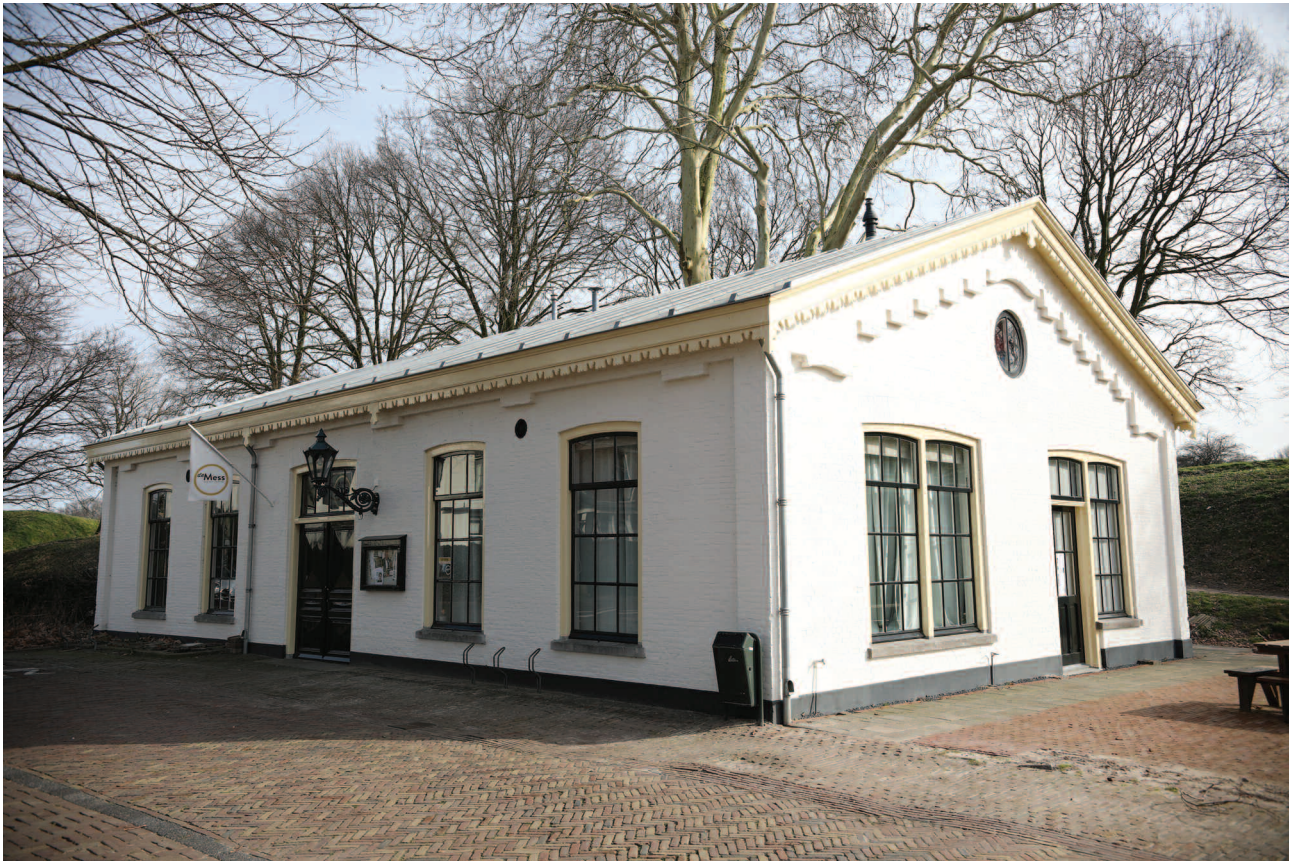
*Figure 34 The cantina after restoration. The facades were painted white in the 1980's. It was impossible to remove the paint, so the façade was left painted.*

The shell of the building and the loadbearing structure were restored by the Monuments Foundation. The rest of the work was done by the tenants and a large group of volunteers, under supervision of the foundation. The whole project was finished in September 2017, when the theatre opened its doors for the first time. The theatre turns out to be a great success and can count on an ever-growing group of volunteers for its operation.

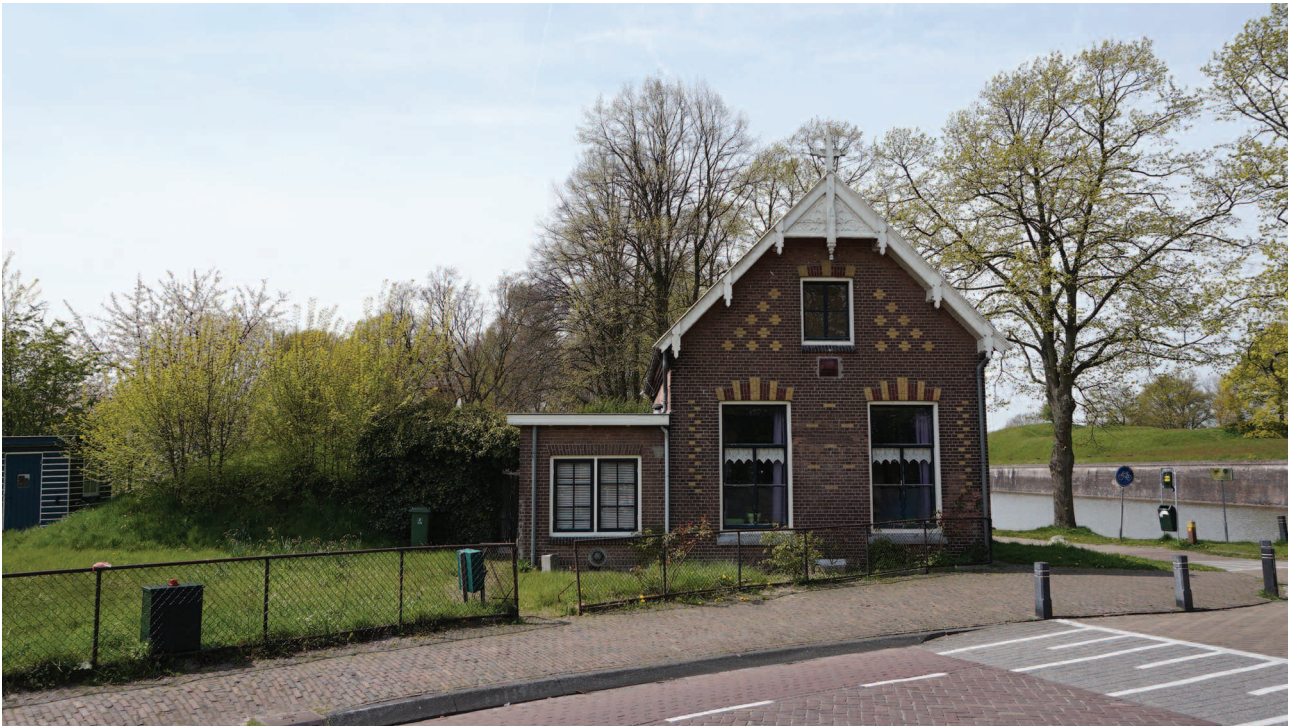
*Figure 35 The bridge-keeper's house before the restoration. The white roof frame separates the roof and the façade into two different entities.*

restored in 2017, shortly after the renovation of the garrison's cantina. On location research was done to find the original colours of the woodwork. For this, the existing paint, on doors, windows, roof frames etc., was scratched away layer by layer until the original colour was exposed. In the case of this building it turned out to be green for the windows and an ochre yellow for the rest of the woodwork. During the restoration this colour replaced all the white from the past. As a result, the dark red and yellow details of the masonry stand out more and the building becomes more of a coherent whole. It is much more present in its environment.
