# THE RESTORATION WORK IN NAARDEN

Jeroen van der Werf

Keywords: Naarden, New Dutch Waterline, seventeenth century fortifications, heritage management, restoration.

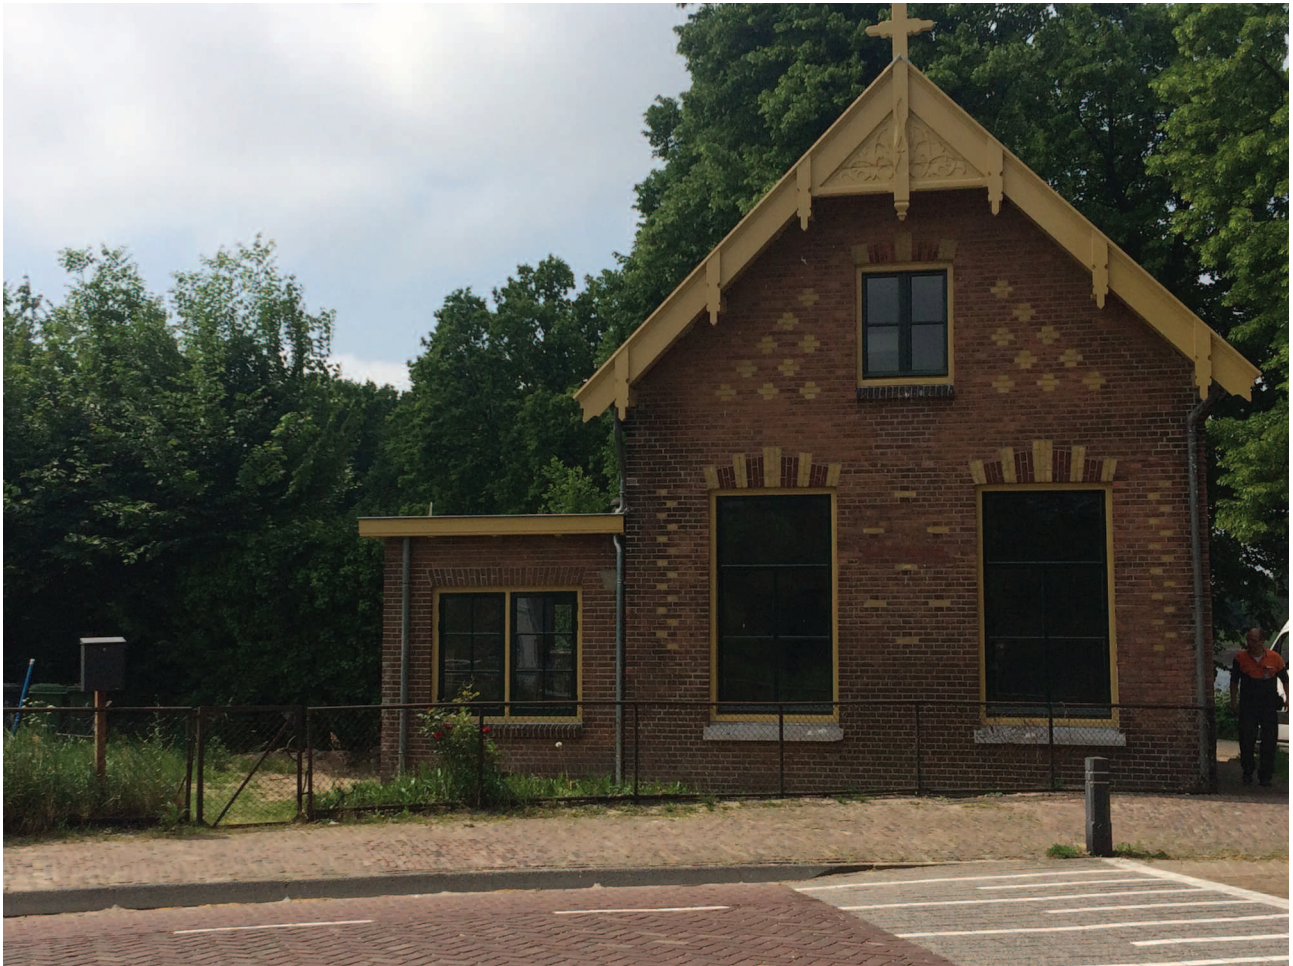
*Figure 36 The house after restoration. By using the original ochre colour roof frame and façade form a harmonious whole. The building looks more logical.*
