Proceedings of the 8th International Congress on Construction History  
Stefan Holzer, Silke Langenberg, Clemens Knobling, Orkun Kasap (Eds.)

## Between practice and rule: codification, testing and use of plain concrete in Dutch military architecture (1870's–1910's)

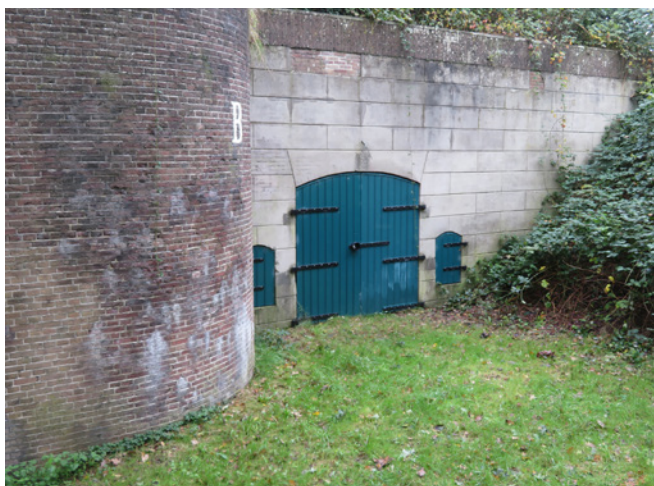
Figure 3. Naarden (NL), the building made of lime-based concrete dating from 1878 (Authors).

The aforementioned type of concrete was used for two buildings in Naarden, both dating back to 1878. In one case, it was used to cover and strengthen an existing brick building, while in the other, the whole building was made of concrete. (Fig. 3) Notably, in both cases the concrete has an open structure and is relatively soft. Evidently, the tamping did not prevent the formation of many cavities, which can be attributed to the relatively large size of brick fragments incorporated in the mixture. (Fig. 9)

As for the current state of the concrete buildings in Naarden, the concrete building from 1878 is in a good condition, thanks to an intervention carried out in the 1990's. At that time, the facade faced significant deterioration, characterized by the detachment of plaster due to infiltrating water and frost. The relatively soft concrete underneath showed signs of cracking and crumbling. In response, the outer 10 to 12 cm of the facade were removed and replaced by a brick cladding, protecting the rest of the concrete from further deterioration. Although the historic concrete is no longer visible, this measure has ensured its preservation.

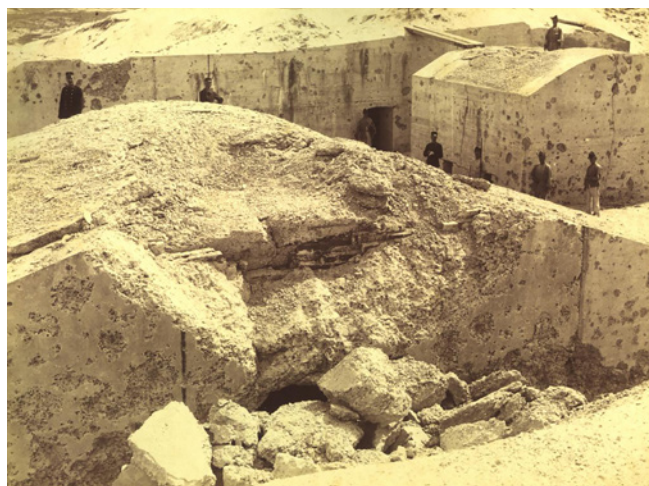
Figure 4. Schoorl (NL), photo of the firing tests from 1892 (Artillery Museum Oldebroek 0476-95).

Another important step in the spread and use of concrete was then marked by the large scale firing tests carried out, in various stages, between June 1891 and October 1892 near the small town of Schoorl, in the northwest part of the Netherlands. (Fig. 1) During this period, five different targets were constructed to test the suitability of concrete for both new buildings and the reinforcement of existing structures (National Archive 1892). (Figures 4–5) The specifications for the construction of these targets prescribed the use of a cement-based concrete for the walls that were exposed to direct cannon fire, to be realized with Belgian Bluestone as aggregate in the composition of one part cement, one part sand and three parts stone. Moreover, the stone particles had to be of a size between 0,5 and 3,0 cm. For the making of the concrete and its application in the mold, a similar process had to be followed as described in the previous paragraph for the lime-based concrete, although with some interesting differences. Instead of adding the stone particles to the mortar as was the case with the lime-based concrete, now it was the mortar that had to be added to the stone. For the application in the mold, the wooden pestles were replaced by iron ones with a prescribed weight of 20 kilos. Ultimately, the layers of

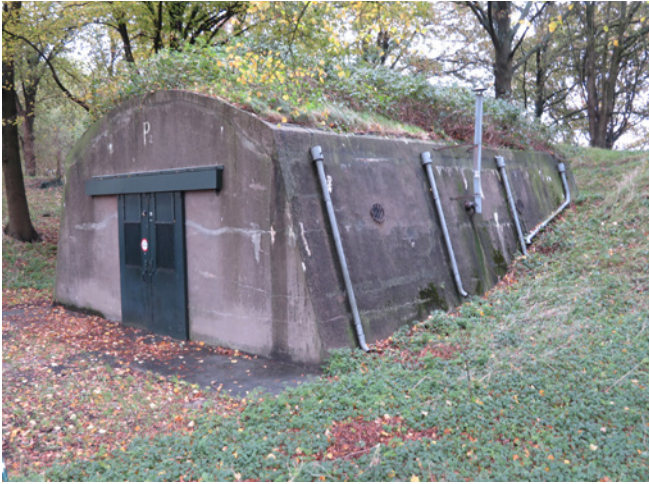
Figure 6. Naarden (NL), concrete shelter on the covered way dating from 1895. The drainpipes were added in a later restoration (Authors).

Since this new standard was not included in the 1893's edition of the Terms and Conditions, which still showed the same texts as in 1872 and 1879, building specifications related to works realized in Naarden have represented a relevant source of information about the evolution of concrete after the tests in Schoorl. In particular, reference is made to the specifications concerning the construction of the twelve bombproof concrete shelters in Naarden between 1895 and 1906, built according to two main typologies. While the first two buildings dating from 1895 have oblique walls and curved roofs, (Fig. 6) the ten younger ones—built in 1902, 1904, 1905 and 1906—are rectangular, lower and with a flat roof. (Fig. 7)

The two concrete shelters from 1895 also display a distinctive vertical cracking pattern. One of them shows one vertical crack in the middle of the longitudinal facade, while the other shows two cracks evenly distributed over the length of the facade. (Fig. 12) Given their volume, this cracking pattern could be indicative of multiple casting rounds during the construction, creating both horizontal and vertical seams between casting rounds. Later movement in the underground or thermal expansion caused them to crack at these weaker points. At present, these cracks are thin and stable, and are carefully monitored for any progression.

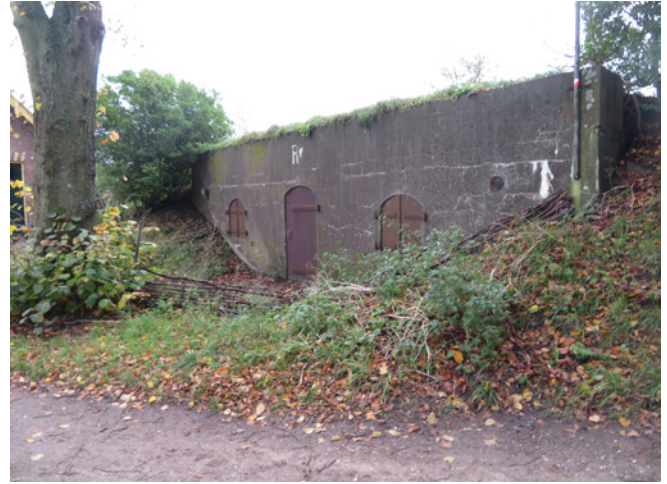
Figure 7. Naarden (NL), concrete shelter on the covered way dating from 1906. The shelters from 1902, 1904 and 1905 belong to the same architectural typology (Authors).

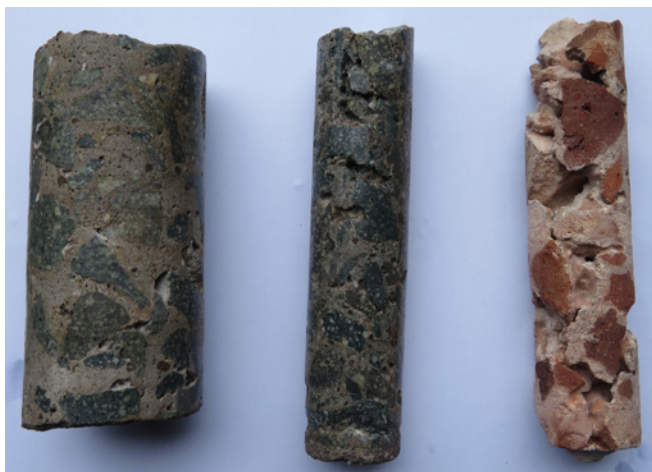
Figure 9. Three samples of the plain concrete in Naarden (NL): concrete from 1878 (right); concrete from 1895 (center); concrete from 1906 (left) (Authors).

By 1906, plain concrete had reached a new stage. Samples of cement-based concrete taken in Naarden show a very hard and dense material, completely different from the concrete with brick aggregates dating from 1878. (Fig. 9) Significantly, the 1906 edition of the Terms and Conditions (Minister van Oorlog 1906, 122, 123, 127, 135–139, 152–156) shows no differences from the specifications from 1905 and 1906 (National Archive 1905, 1906). This highlights the crucial role played by practical experimentations on the field—like the ones carried out in Naarden between 1895 and 1906—in the evolution and refinement of the standard.

The overview of the studied concrete recipes that is presented in table 1, shows an interplay between ingredients, hardness, and mass. In 1895, the roofs of the shelters in Naarden were made of concrete with a higher amount of cement than the walls. This adjustment aimed to achieve greater hardness, given the higher exposure of the roof to gunfire. Because cement was an expensive product, efforts were made to reduce its usage. The increment in the amount of sand from 1902 onward led to a higher sand/cement ratio, resulting in a harder concrete. Parallel to this, enhancements in the size ratio of the aggregate were made, contributing to higher density. The recipes for Oldebroek in 1909 show that an increase of mass could mean a decrease of cement. Concrete samples taken in Naarden further illustrate these principles (Fig. 9):

- The sample of 1878 concrete (right) shows lime-based mortar with bricks, featuring soft mortar and aggregates. The relatively large pieces of brick cause numerous cavities. The mix ratio is 10 parts mortar to 18 parts aggregate.
- The sample of 1895 concrete (middle) shows cement-based mortar with porphyry. The sample is taken from the wall of the shelter and has a mix ratio of one part cement, two parts sand and five parts aggregate. There are many, small pieces of stone visible. Despite its hardness and density, the concrete still shows several small cavities.
- The sample of 1906 concrete (left) shows cement-based mortar with porphyry in a mix ratio of one part cement, 1,25 parts sand and three parts aggregate. The higher content of mortar and the better size ratio of the aggregate has led to effective filling of cavities, resulting in a dense and hard concrete.

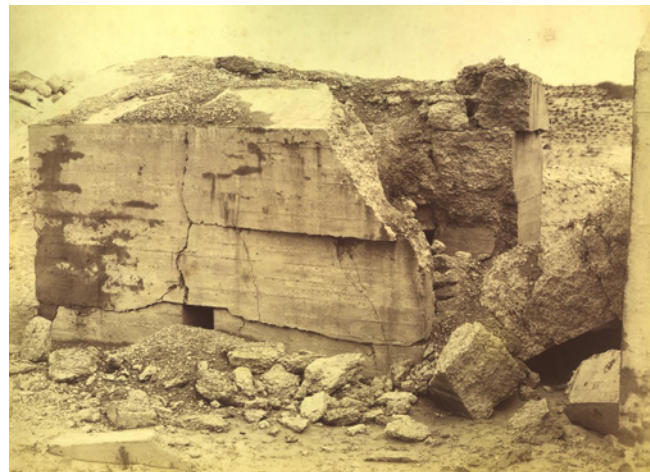
Figure 10. Photo of the firing tests in Schoorl from 1892, showing the horizontal crack caused by the pouring of the concrete in different layers (Artillery Museum Oldebroek 0481–48).

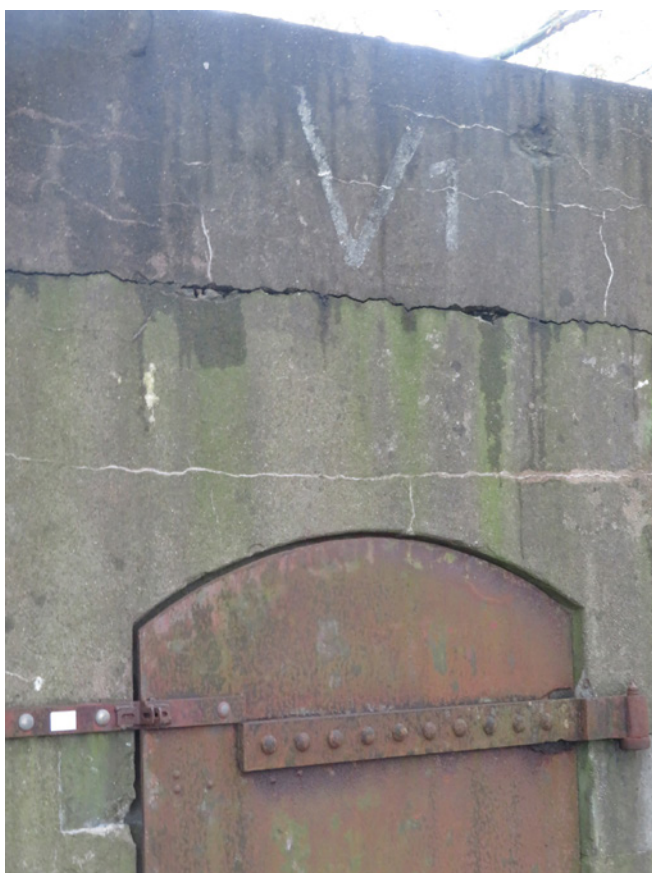
Figure 11. The horizontal cracking pattern on one of the shelters. The wide crack needs to be restored in the near future to prevent further damage (Authors).

explained, the concrete of the shelters was tamped layer by layer into a mold. Today, long horizontal cracks appear at the interface of some of these layers, where the cohesion of the material is weaker. The risk that the construction could crack at these points already showed in the firing tests in Schoorl. (Fig. 10) While most cracks are thin and pose minimal deterioration risk, some wider cracks necessitate restoration in the coming years. (Fig. 11)

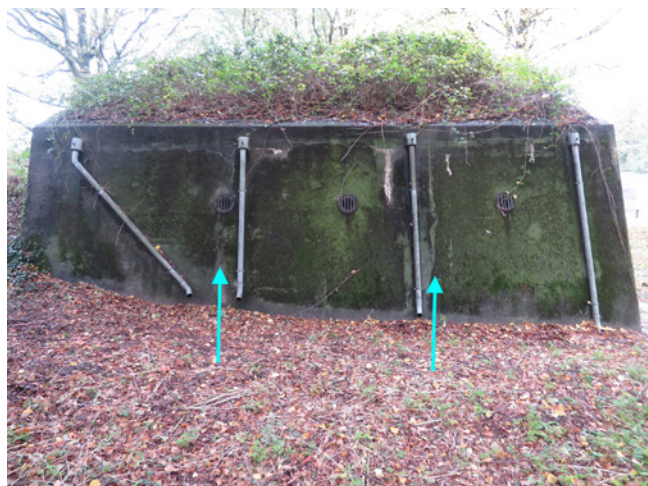
Figure 12. The cracking pattern in the longitudinal facade of the shelters from 1895. This one, shows two cracks, indicated by the arrows. The other shelter shows one crack in the middle of the façade (Autors).
