EUROPEAN PROJECT ON FORTIFIED LANDSCAPE FACING NEW THREATS

# RESILIENT FORTRESS

SUOMENLINNA SUMMER SCHOOL REPORT

ERASMUS+ project

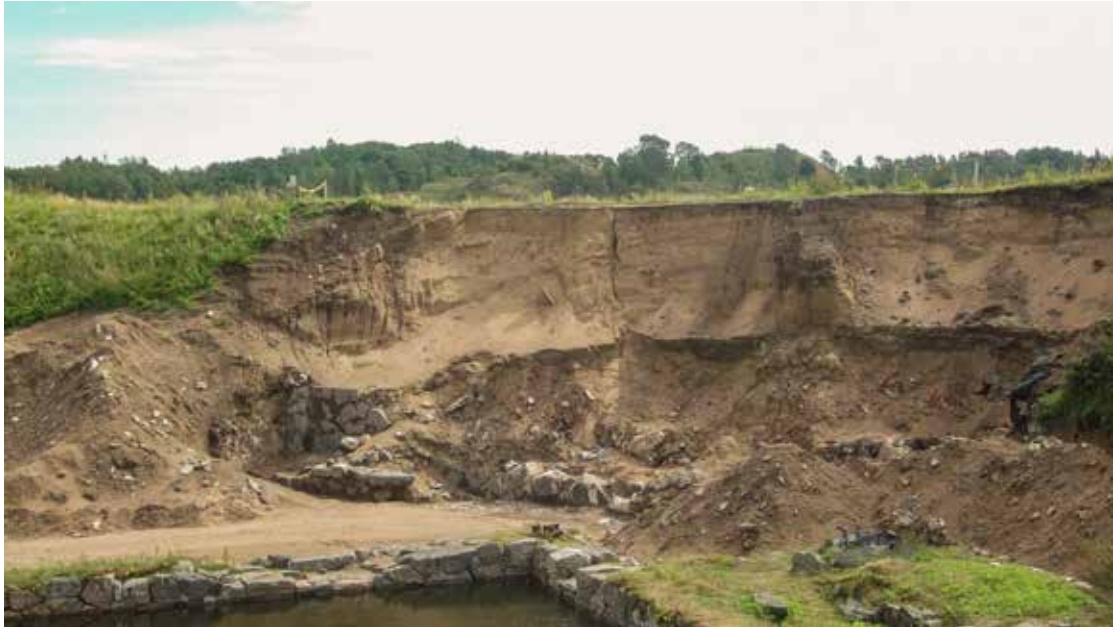
1.1) During the night of 30th April in 2016 some 50 m<sup>2</sup> of retaining wall with tons of sandy rampart collapsed without warning. A probable cause is that the combination of heavy rains and a big number of mole tunnels enabled the earthwork to be saturated with water. It seems that in wintertime, the ice pressure broke the wall, and in spring when frozen land melted, the earth pressure pushed the three-meter high and two-meter-thick 19th century wall several meters from its original position.

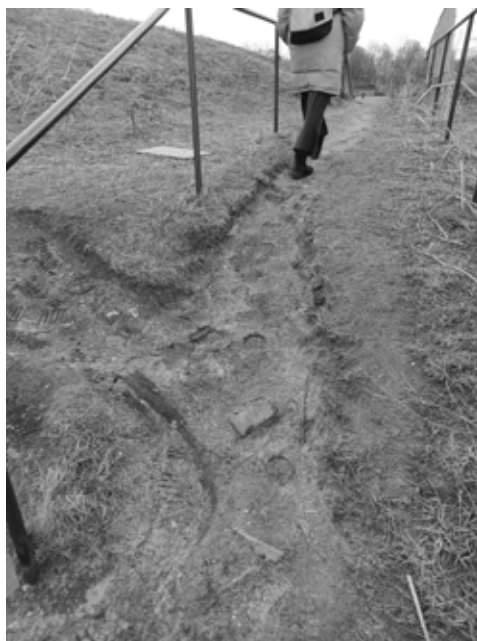
1.2) Fences erected for security reasons lead all walkers to the same path. A wet unfrozen soil is most vulnerable in wintertime. During dry summers the vegetation is also very sensitive.

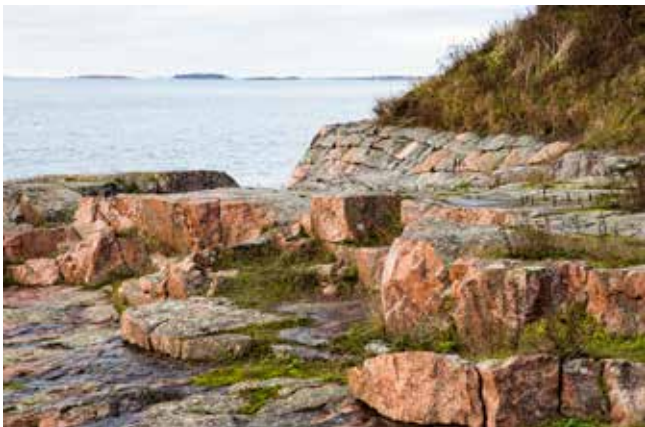
1.6) Suomenlinna bedrock and 20th-century quarry.

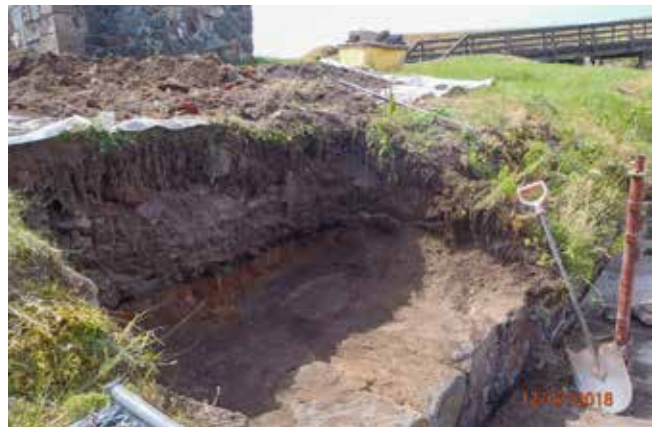
1.7) Bastion Lantingshausen test pit.

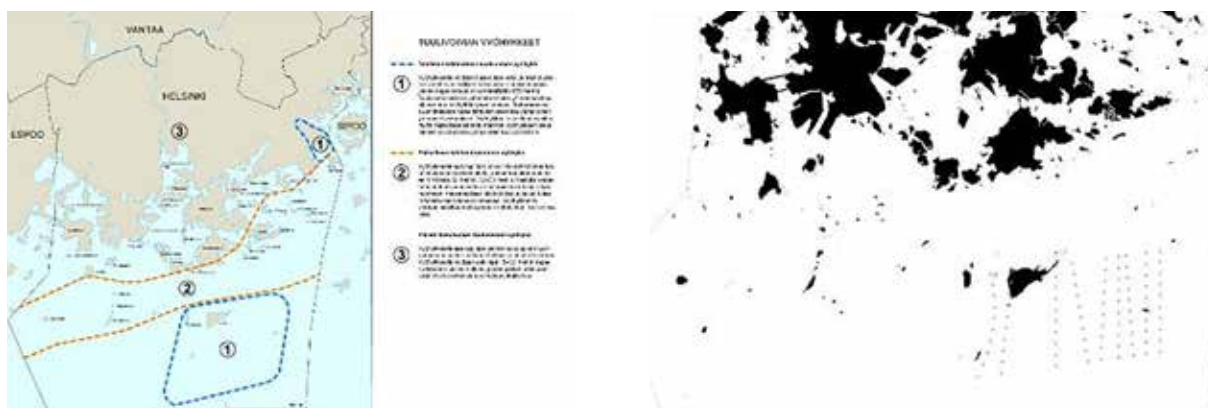
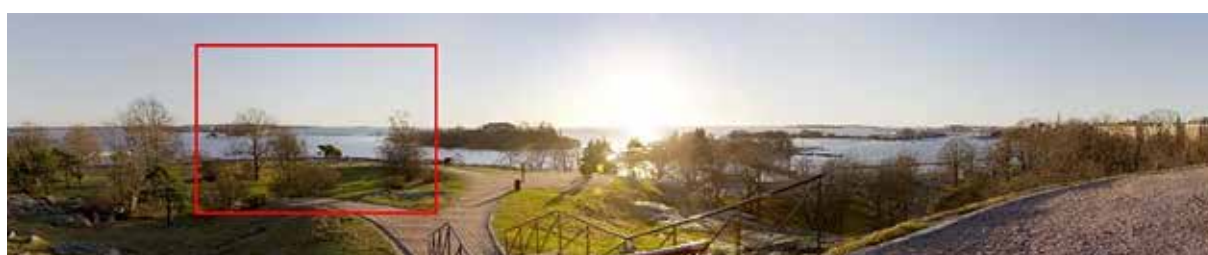
2.1) Ullanlinna, Helsinki. Studies for the possibility wind energy in front of Helsinki.

So many things need to change. There's quite a big demand for ways to produce energy which is not based on burning some stuff. There we don't have endless possibilities. We have been studying the possibility for wind energy here inside the city of Helsinki since we have quite a big sea area and an archipelago. It has been studied in several phases. The challenges so far are great that it hasn't gone further, main obstacle being the military defence of Finland. It's been studied that wind turbines affect the radars and hinder the defence. The interesting thing is that now we are in the NATO and on the other side of the Gulf of Finland, on coast of Estonia, there are wind turbines. Estonia has been a NATO-member for a while. I'm not sure if this might change the Finnish defence premises.

The potential location of these wind turbines would be behind the islands of Suomenlinna, somewhere around five kilometres from here to offshore. As marketing argument, it is said that wind turbines won't be visible from Suomenlinna because they would be located behind coastal islands, even though if there would be quite a substantial amount of wind turbines. It's studied that somewhere around 70 or even bigger amount of peak power would be comparable that with nuclear power plants that has been built in Finland recently.

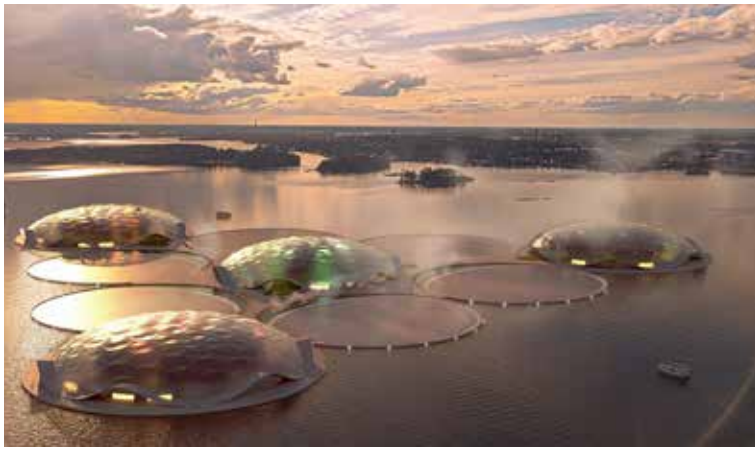
2.2-3) Hot Heart, a series of islands with the dual function of storing thermal energy storage and serving as a hub for recreational activities. It has won the Helsinki Energy Challenge, which aims to decarbonize the heating system of the Finnish capital by 2030.

In regarding the Helsinki archipelago there is an initiative called Helsinki Energy Challenge, which was presented a couple of years ago. It was an international competition in which the task was to design an energy system that won't be based on any sort of burning. In pictures 2.2-3) are example from the outcome to give you an idea. It's not science fiction. Or maybe it is a bit. These underwater silos are heat containers and futuristic islands. The landscape in Helsinki archipelago could be in the change in coming years. I like to underline to ponder if it is necessarily a change in the worse.

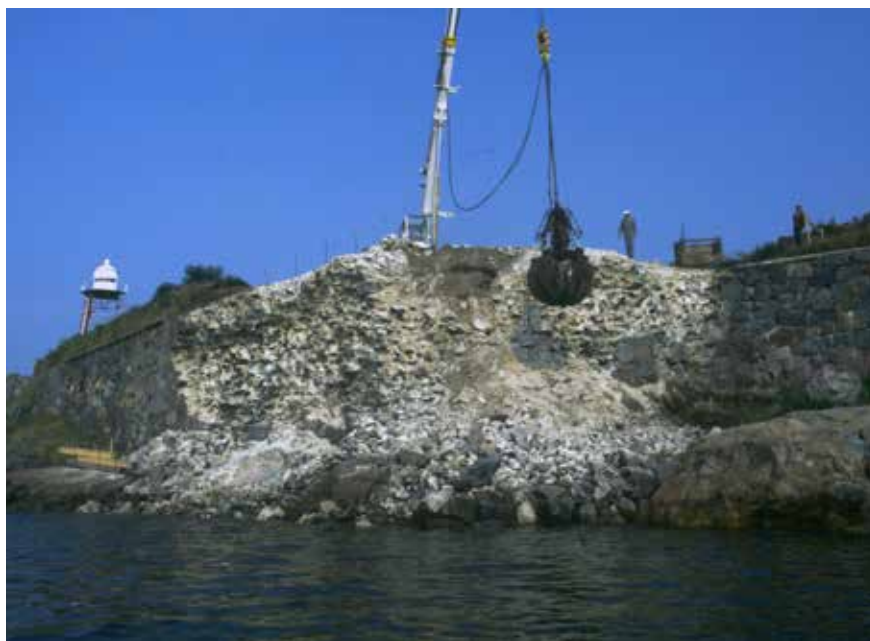
4.2-3) In 1980s the restoration methods were often maximum interventions. In 1990s, in the case of A13 shore work, only the parts in bad structural condition were repaired.

The first restoration project at Suomenlinna, where the principle of minimum intervention was implemented, was the A13 shore work (1992–1997). Built in 1750, the A13 shore work is situated at the southern part of the fortress to protect one of the two straits giving access to the anchorage bay at the back of the islands. From its casemates the guns would fire on the ship's sides and from its terreplein the masts. As artillery firepower developed in the 19th century, the enemy fleet did no longer have to approach the target in order to cause damage. During the Crimean War in 1855, the British-French fleet bombarded Suomenlinna-Sveaborg from a three-kilometre distance. As an answer to the new treat, the A13 shore work was gradually strengthened during the 19th century and partly covered by earthworks, which formed the modern line of coastal defence in front of Suomenlinna and Helsinki.

In the restoration project of the A13 shore work it was decided to preserve all historical layers. Adaptation of this principle meant that restoration was equal to repair of the existing architectural state. Other principles adapted were the use of traditional materials as much as possible, the search for solutions that are easy to repair in the near or far future, and the respect of existing soil. Since the traditional building materials were not available anymore, and many old techniques had been lost, this specific restoration project became a major learning process for all project participants, a learning-by-mistakes school.

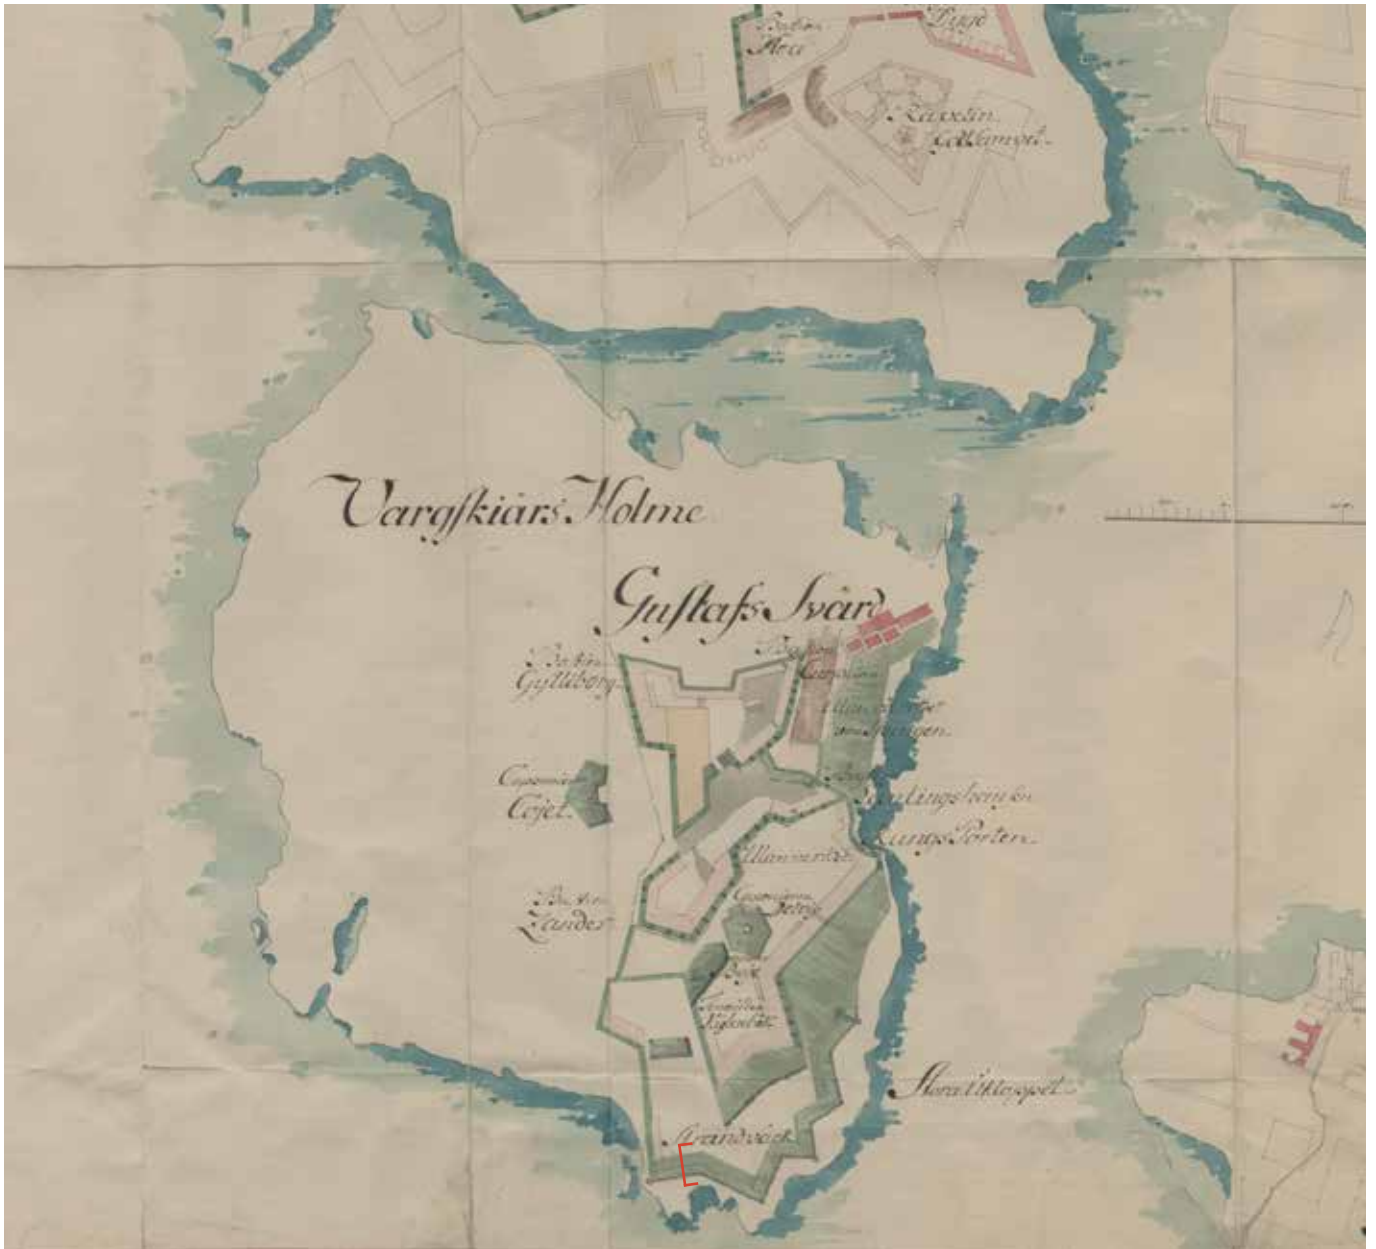
4.5) Kustanmiekkä-Gustafsvärd and A13 shore work-Strandvärk in year 1756 and the location of a 1989 test trench.

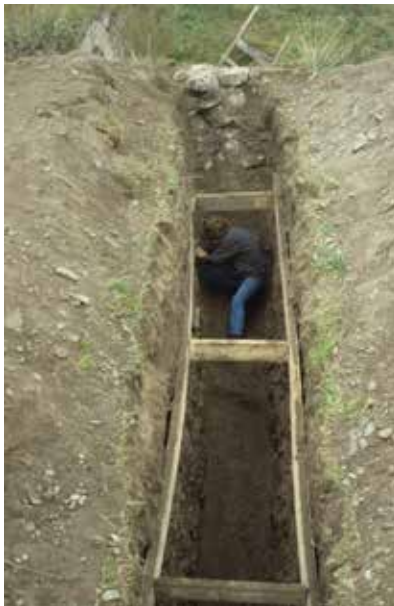
4.6) Test trench 1989.

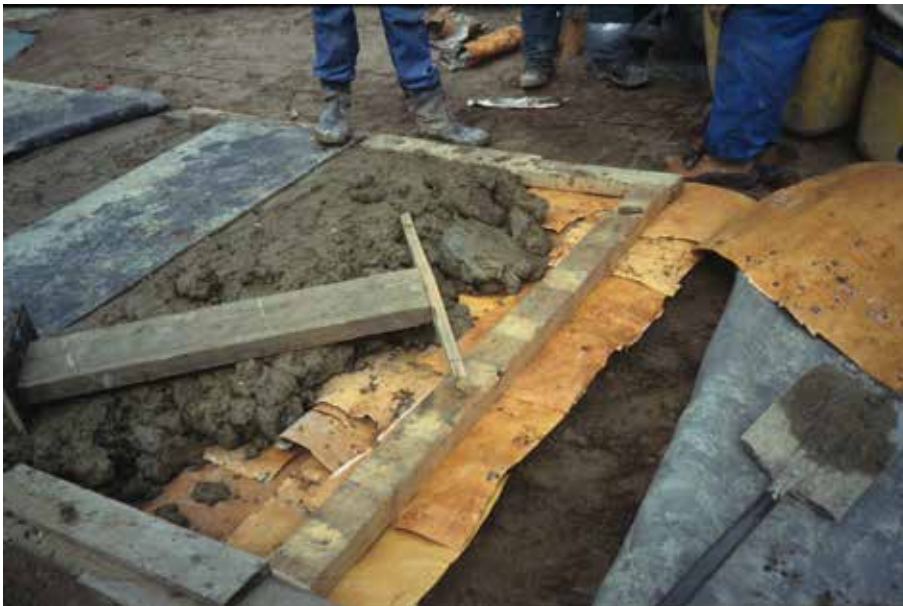
4.8) Coming from a Pelso prison in the Oulu region, the birch bark was harvested from trees that were going to be cut at the end of June or beginning of July. The clay was found near Helsinki from an old brick factory's land.

In Finland, birch bark and clay are traditional materials, which were still used for waterproofing in the beginning of the 20th century. These materials were re-adopted in A13 shore work restoration project. Due to lack of knowledge, it took several years to learn how to handle these materials. For example, birch bark must be stored so that the extracted pieces are under pressure but in a dry and ventilated environment. To maintain its waterproofing qualities clay must stay elastic. It must neither be too wet nor too dry. The maximum thickness of clay is 5 cm, otherwise it cracks too much during the dry season and is not waterproof when it rains. This kind of waterproofing needs at least 30 cm of soil above it, preferably even more.

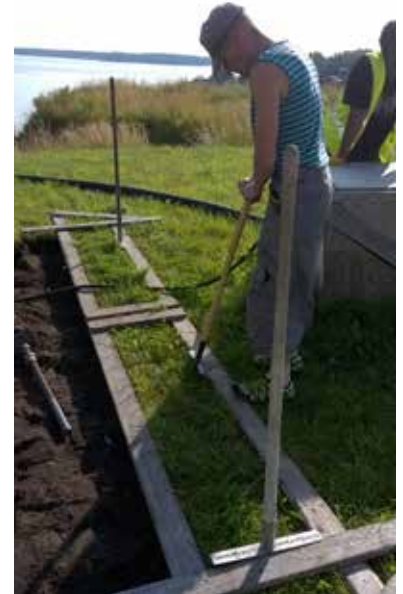
4.9) Extracting 300 x 300 x 80 "grass tiles" from Suomenlinna meadow.

The square "grass tiles" extracted from meadows have always been used for shaping the parapets and shooting sectors. This tradition was revived at Suomenlinna in the 1980s and has been developed ever since with many practical lessons learned. Grass tiles can be stored only for few days, and it is good to sink them into water before use. It was also noticed that building a grass surface to a parapet requires the same precision as the work of a bricklayer. The grass elements should all be of same size and thickness for a good result. One mistake was to build too steep profiles for the parapets. In time the earth pressure makes them even steeper, and it is difficult to get vegetation to grow on almost vertical surfaces. A 45° angle is ideal.

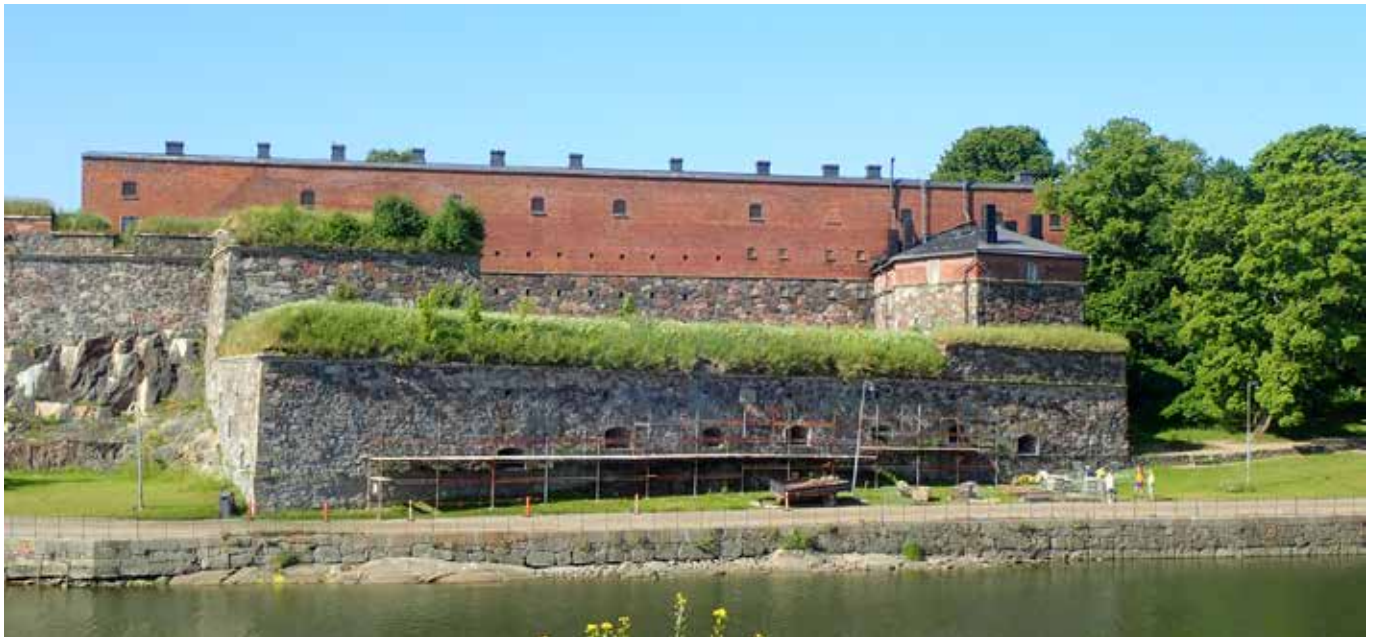
4.11) Construction site of Bastion Wrede in summer 2020.

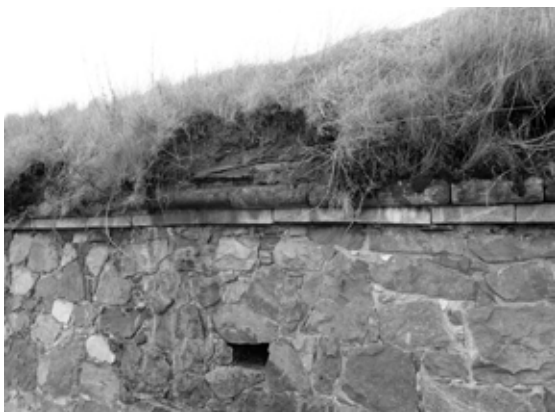
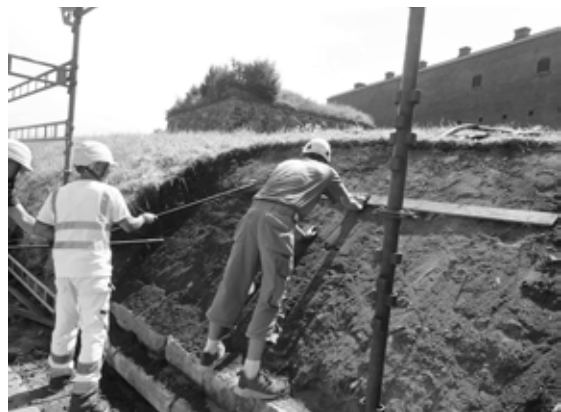
4.13-14) Rebuilding partly collapsing parapets in Bastion Wrede summer 2020.

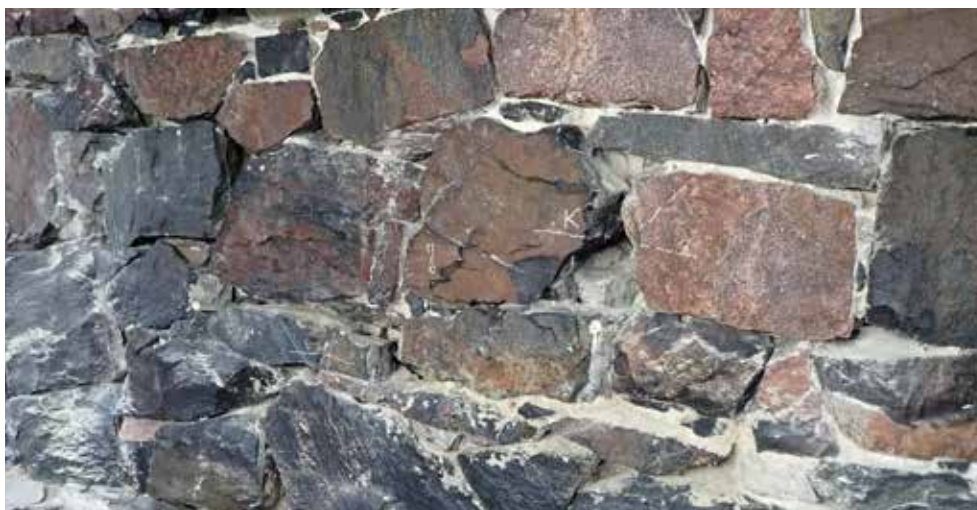
4.15) The first stage of wall repair is loosening pinning stones and extracting eroded mortar.

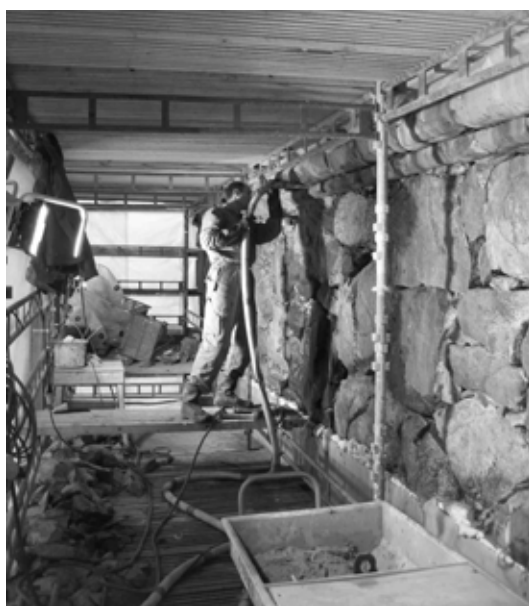
4.16) Grouting is a common method used in Suomenlinna wall repair.

The uncoursed stone walls of Suomenlinna with the width of one to three metres are built as shell walls, with a core filled with large stones and mortar. This kind of wall is structurally strong if it contains no gaps. In the repair works – after having removed only the loose material like growth, deteriorated mortar and pinning stones – grouting is a good and a conservative way to repair only what is needed. The aim is to have a wall 100 % filled with mortar and stones, leaving no space for rainwater to enter and make damage during winter.

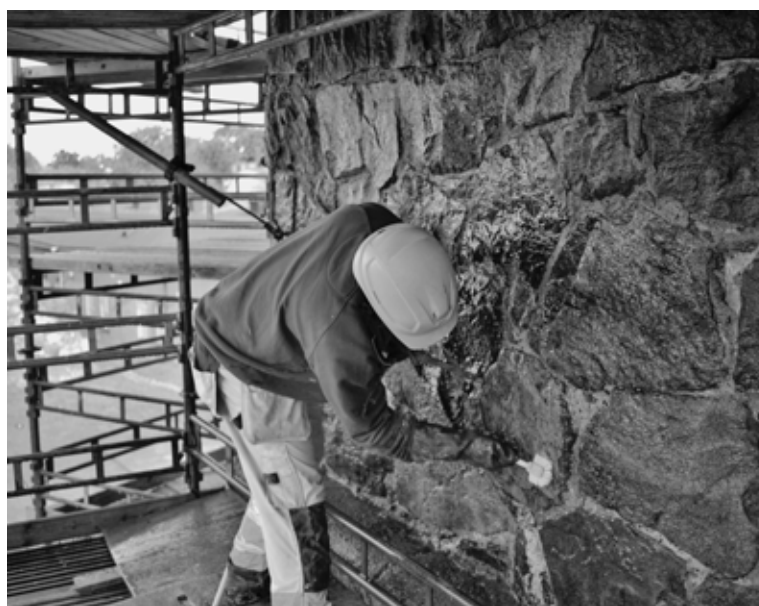
4.17) After grouting the mortar settles some hours before the wall is washed.

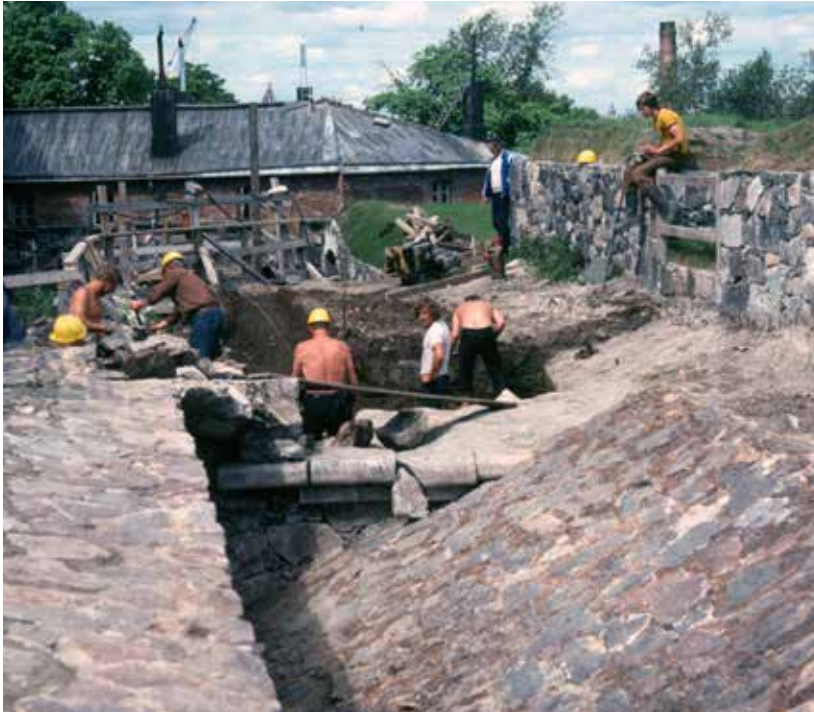
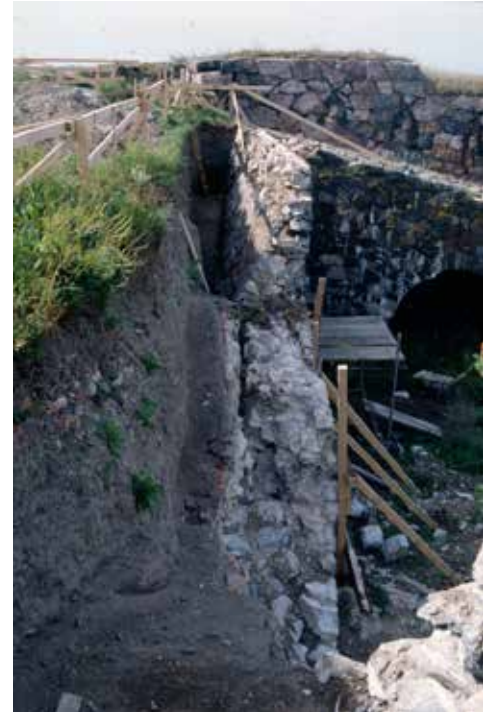
4.18-19) Earlier all earth was removed before restoration work. In A13 shore work restoration project only the soil hindering repair works was removed.

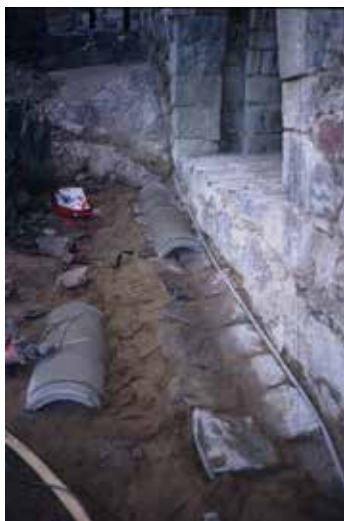
4.20-26) In the A13 shore work restoration project the principal objective besides wall repair was to prevent water getting into the structures, and if it did get in, to provide an exit for it. During the restoration project, the 18th-century drains and gutters were remade or repaired. Instead of using plastic drains with a short lifespan, the drains were built with stones and concrete pipes cut into two. Instead of using geotextile, the drains were covered gradually with cobble stones, uncrushed gravel, and sand. The gradually diminishing gravel is replacing the geotextile. This kind of infrastructure can easily be repaired in the future.

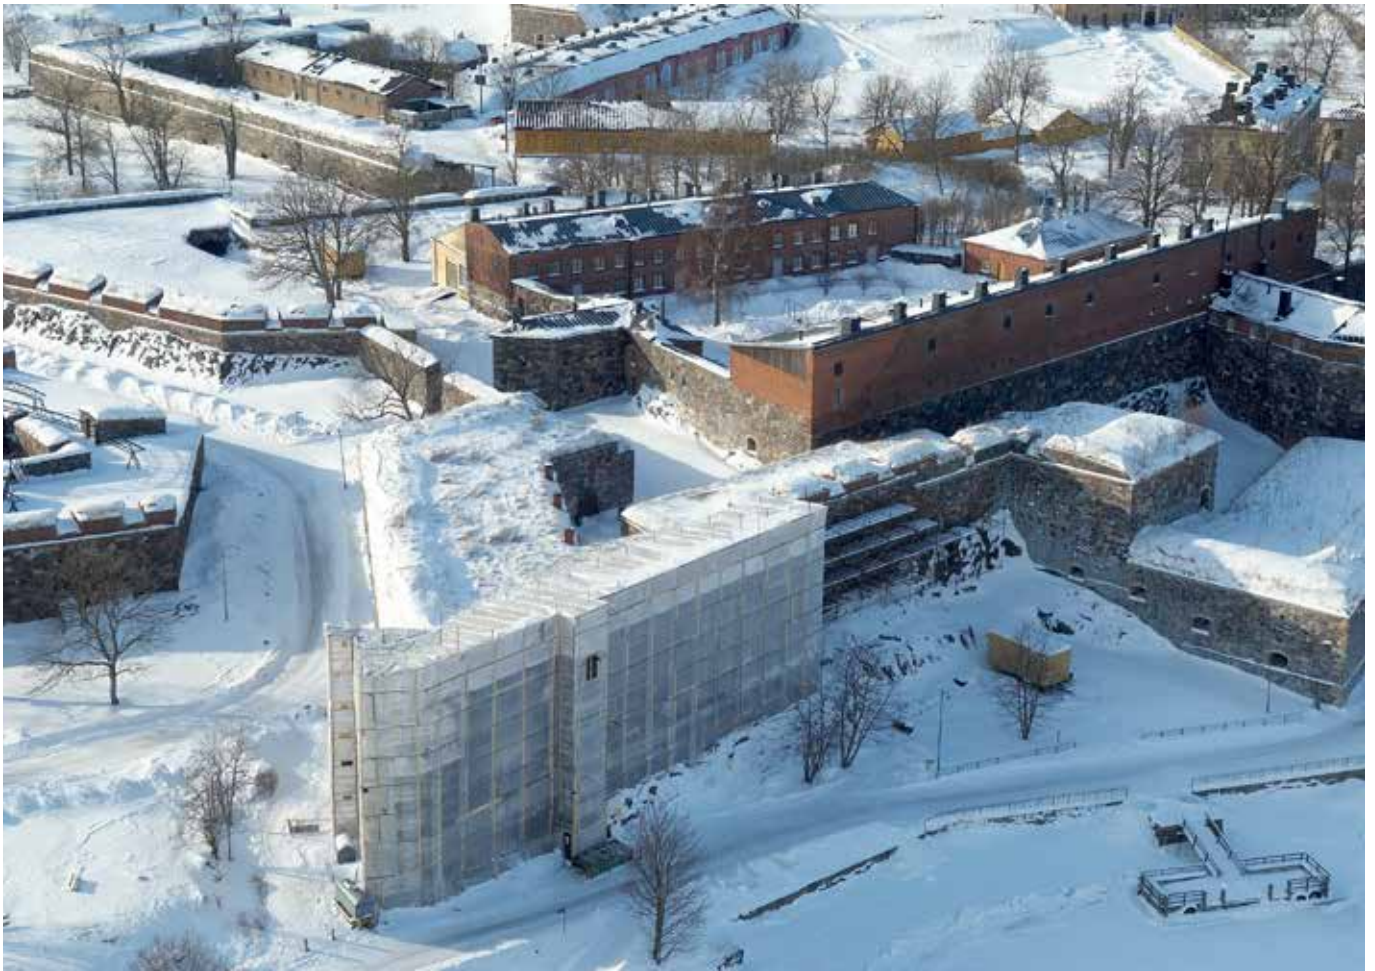
4.27) B48 Bastion Virtue (Hyve) under restoration 2010.

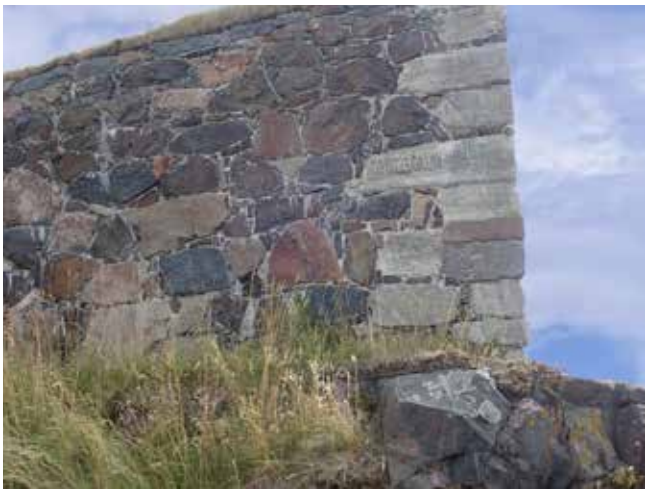
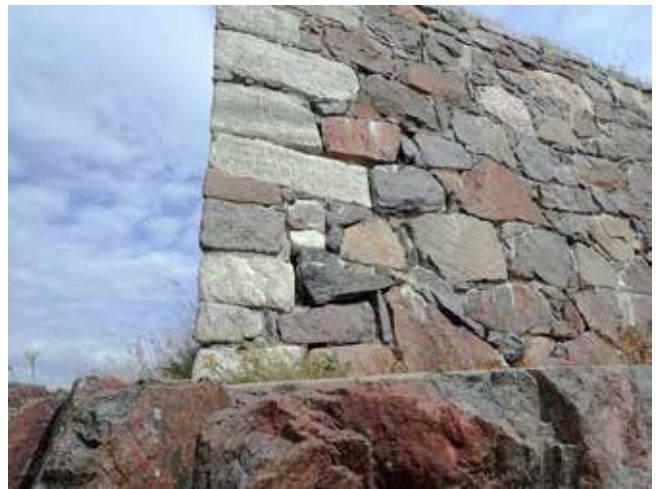
4.28-29) The two faces of the salient of A5 bastion Gyllenborg were restored in 2005 and 2006 with hydraulic lime mortar. In the photos taken in 2021 it is clearly visible that the left face of the bastion already needs repair. It is orientated to southwest (open sea) receiving wind, rain and sun. The increasing number of freeze-thaw cycles shortens the restoration life cycle of Suomenlinna fortifications.

During this survey was also noticed that the expected lifespan of the Suomenlinna fortification restorations is not half a century as expected earlier, but sometimes only a quarter, especially on the walls facing south-west, south and south-east. There is some 10 to 15% more rainfall in the Helsinki region today than in the 1990s. When everything is extremely wet, the water pressure makes water move upwards also. In these situations, the traditional materials are not waterproof anymore. In some cases, the birch bark and clay have been replaced by modern rubber membrane even though it is not in line with earlier restoration principles.

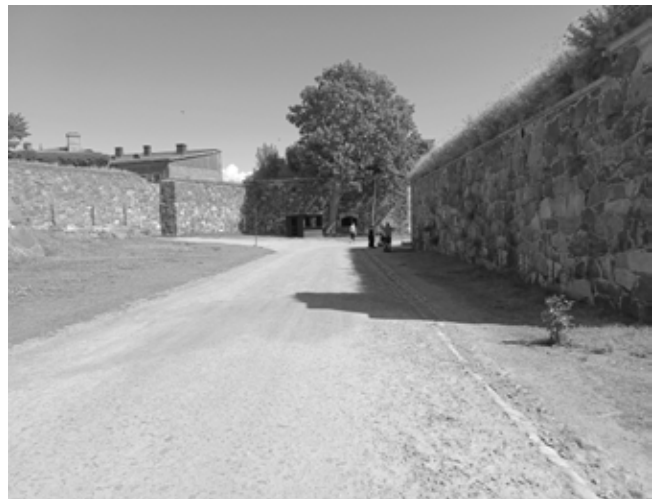
5.3) The driveways are getting wider because people are walking beside them. Sometimes it is easier to walk on the grass than on the stone pavement or more pleasant on the shadow rather than under the sunshine. This changes radically the appearance of the historical landscape.

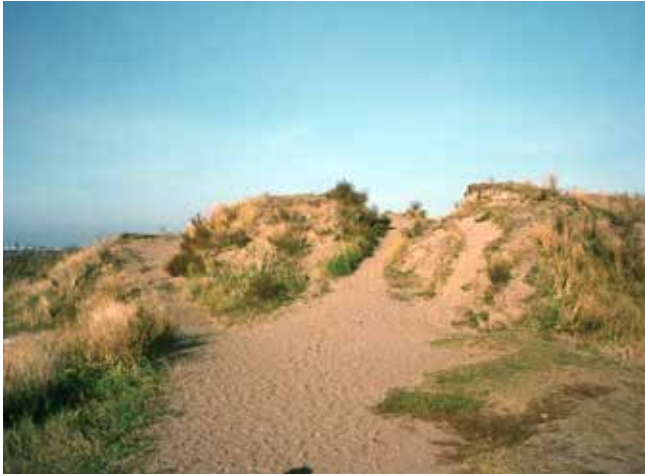
5.4) Picture has been taken in the 1970's when the ramparts were badly eroded. In some places we are going towards the same situation when the green surface of the ramparts is vanishing and the structure of sea sand layer is revealed.

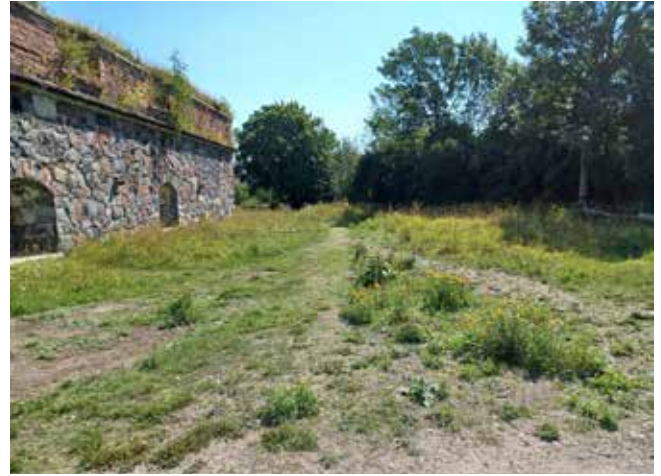
5.5) This is a moat where there has been a driveway for building site. Meadow of the moat has been repaired three years ago and still the vegetation has not been recovered.

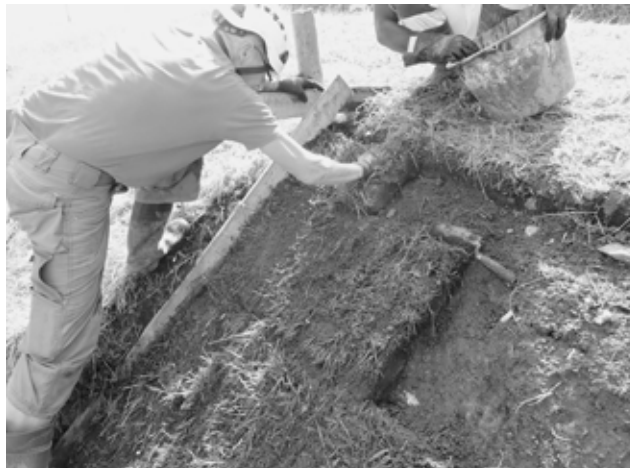
5.6) To have vegetation on the deep slopes it is easier with the grass tiles, Suomenlinna own transfer grass. Nowadays it is more difficult to find places where to get them because the places are recovering so slowly.

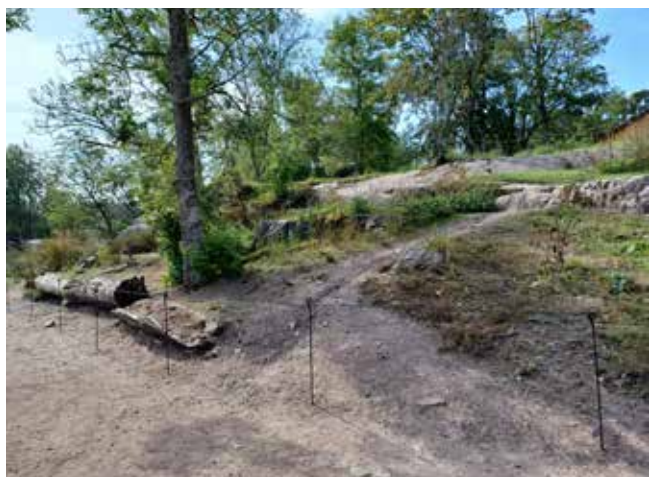
5.7) With light fences we try to prevent the visitors from walking on the slope which is badly eroded.

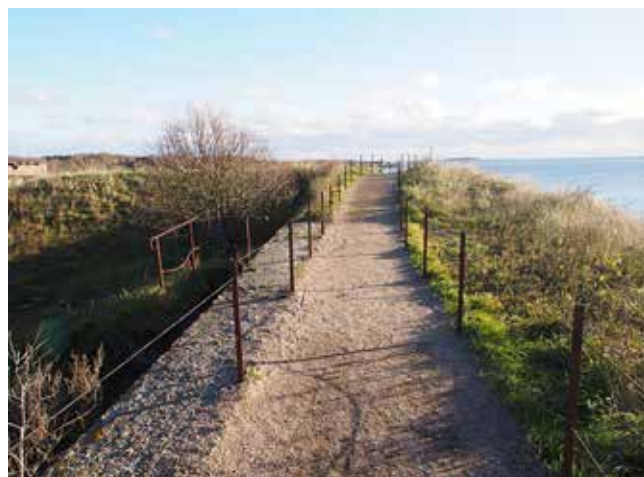
5.8) On the ramparts of Kustaanmiekka there has been build new path with modern structure and fences to avoid erosion.

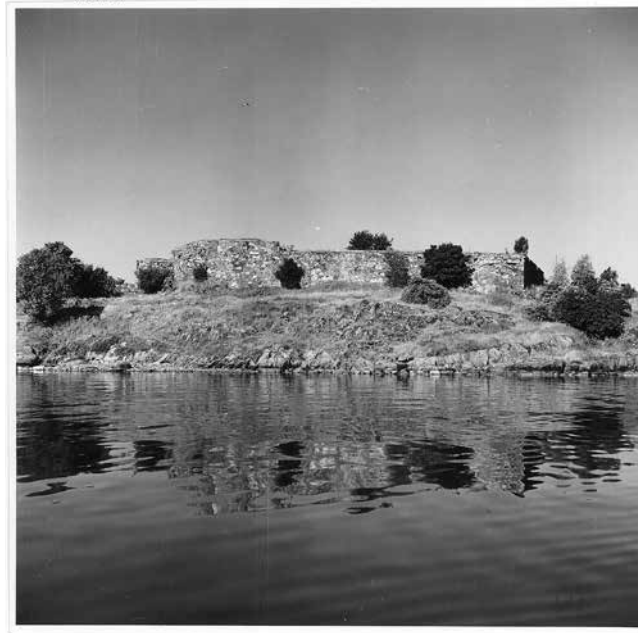
5.9) This picture from the eastern shore of the island Iso Mustasaari has no exact timing. The rock and the shore between the sea and the stone walls is quite open.

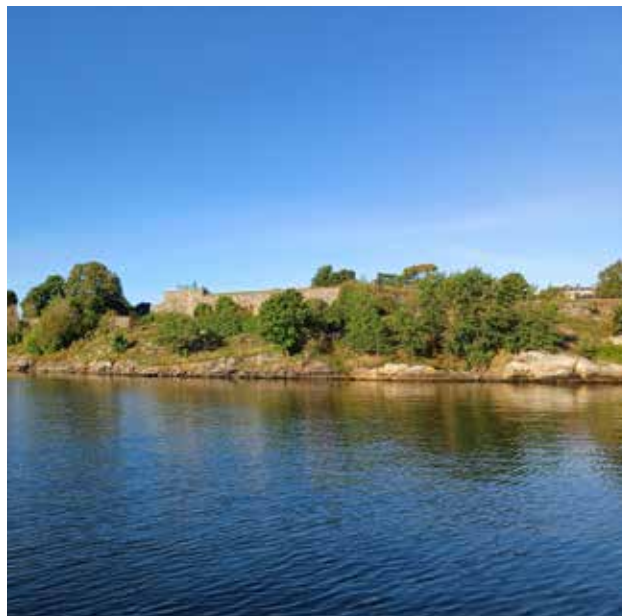
5.10) Picture is taken in summer of 2024 from the eastern shore of the island Iso Mustasaari. In front of the stone walls there are a lot of trees and bushes. From the sea you cannot see the fortress and if you want to see to the sea which has been the purpose in times of war, it is almost impossible.

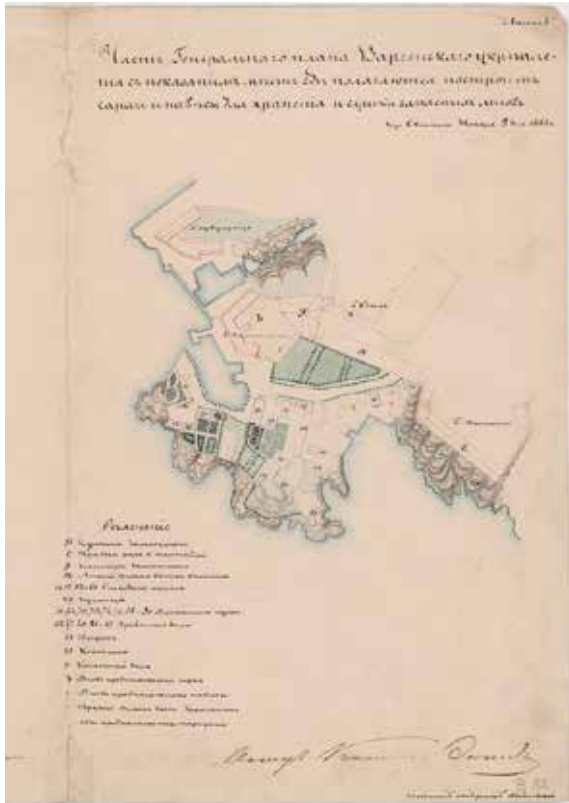
5.11) Old plan from year 1844. On the western shore there is an old harbour and from there begins the tree alley of Kultaranta heading to east. North side of the alley is marked by two rows of trees.

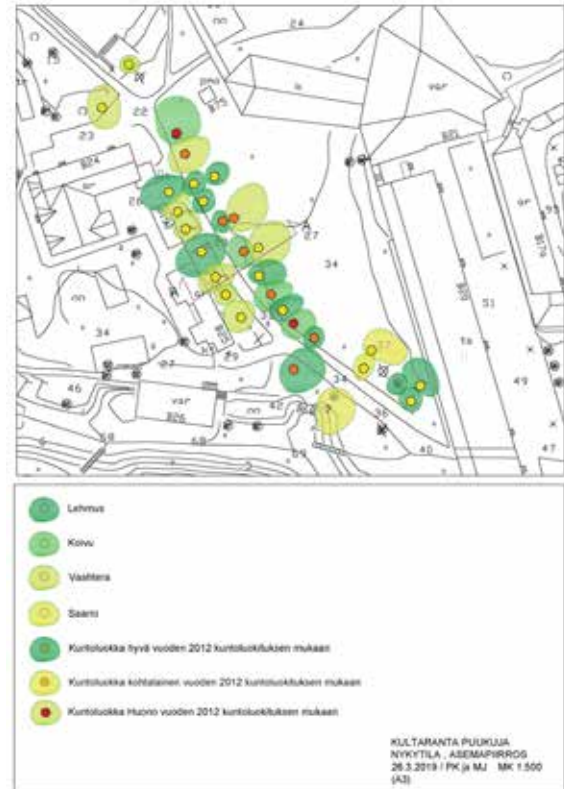
5.12) The tree alley 2019. Red, orange and yellow are marking the condition of the tree and the different kinds of trees and the species of the trees.

This tree alley has two special characteristics: one is that on the other side there has been trees in two rows. The other is that the trees are not all same species. We don't know if this was the case originally. In 2019, some of the trees were in poor condition and some had to be felled by the Governing Body of Suomenlinna.

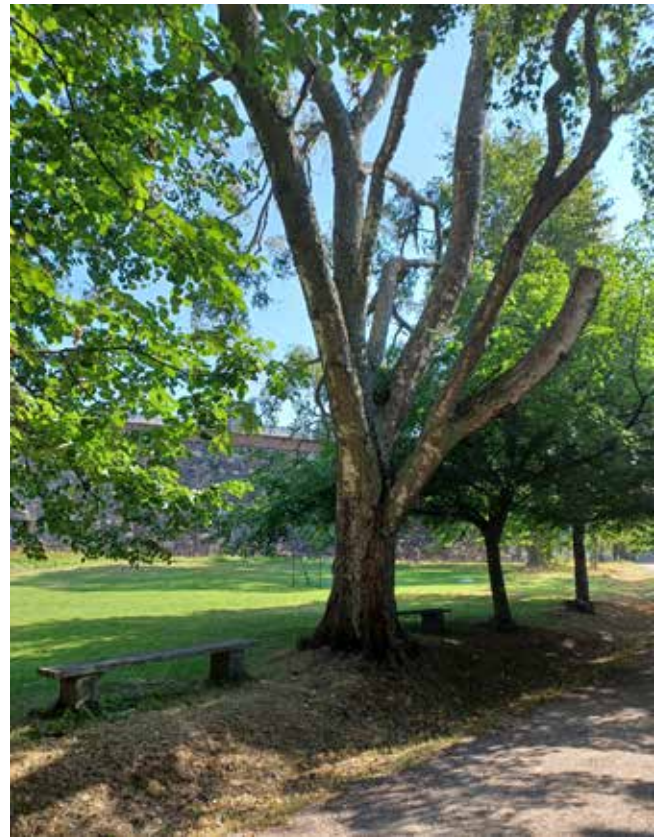
5.14) The tree alley in the summer 2024. The small trees where planted long time ago between the old trees and they have no chance to develop into big trees.

When one or two trees fall from an alley, it is not possible to plant a new tree between two old ones, because there is not enough space and light for the new tree to grow healthily. An unfortunate restoration has been made in Kultaranta: new trees have been planted between the old ones, and they have apparently had no chance of surviving in such a cramped space. In some historical areas, decisions have previously been made to cut down all the trees in the alley and plant an entire new tree alley. This is not the case anymore, today we now know very well the value of old trees.

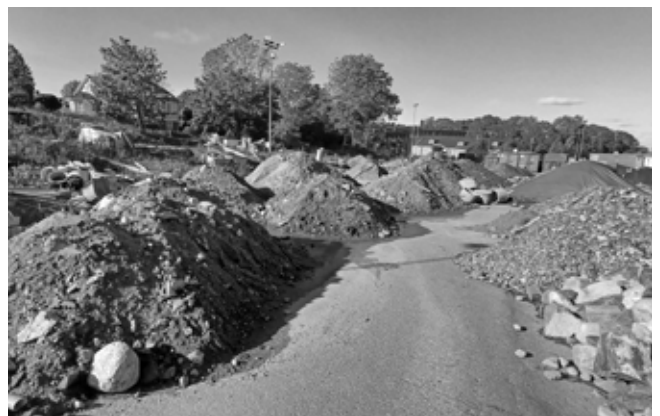
6.2) Beneficial re-use of soil is mainly limited by the small size of the long-term storage area and also by the geotechnical suitability of typical Suomenlinna soil containing a lot of construction waste, such as pieces of bricks. Too often it is noticed that the quality of Suomenlinna soil is not suitable for present requirements.
