EUROPEAN PROJECT ON FORTIFIED LANDSCAPE FACING NEW THREATS

# RESILIENT FORTRESS

SUOMENLINNA SUMMER SCHOOL REPORT

ERASMUS+ project

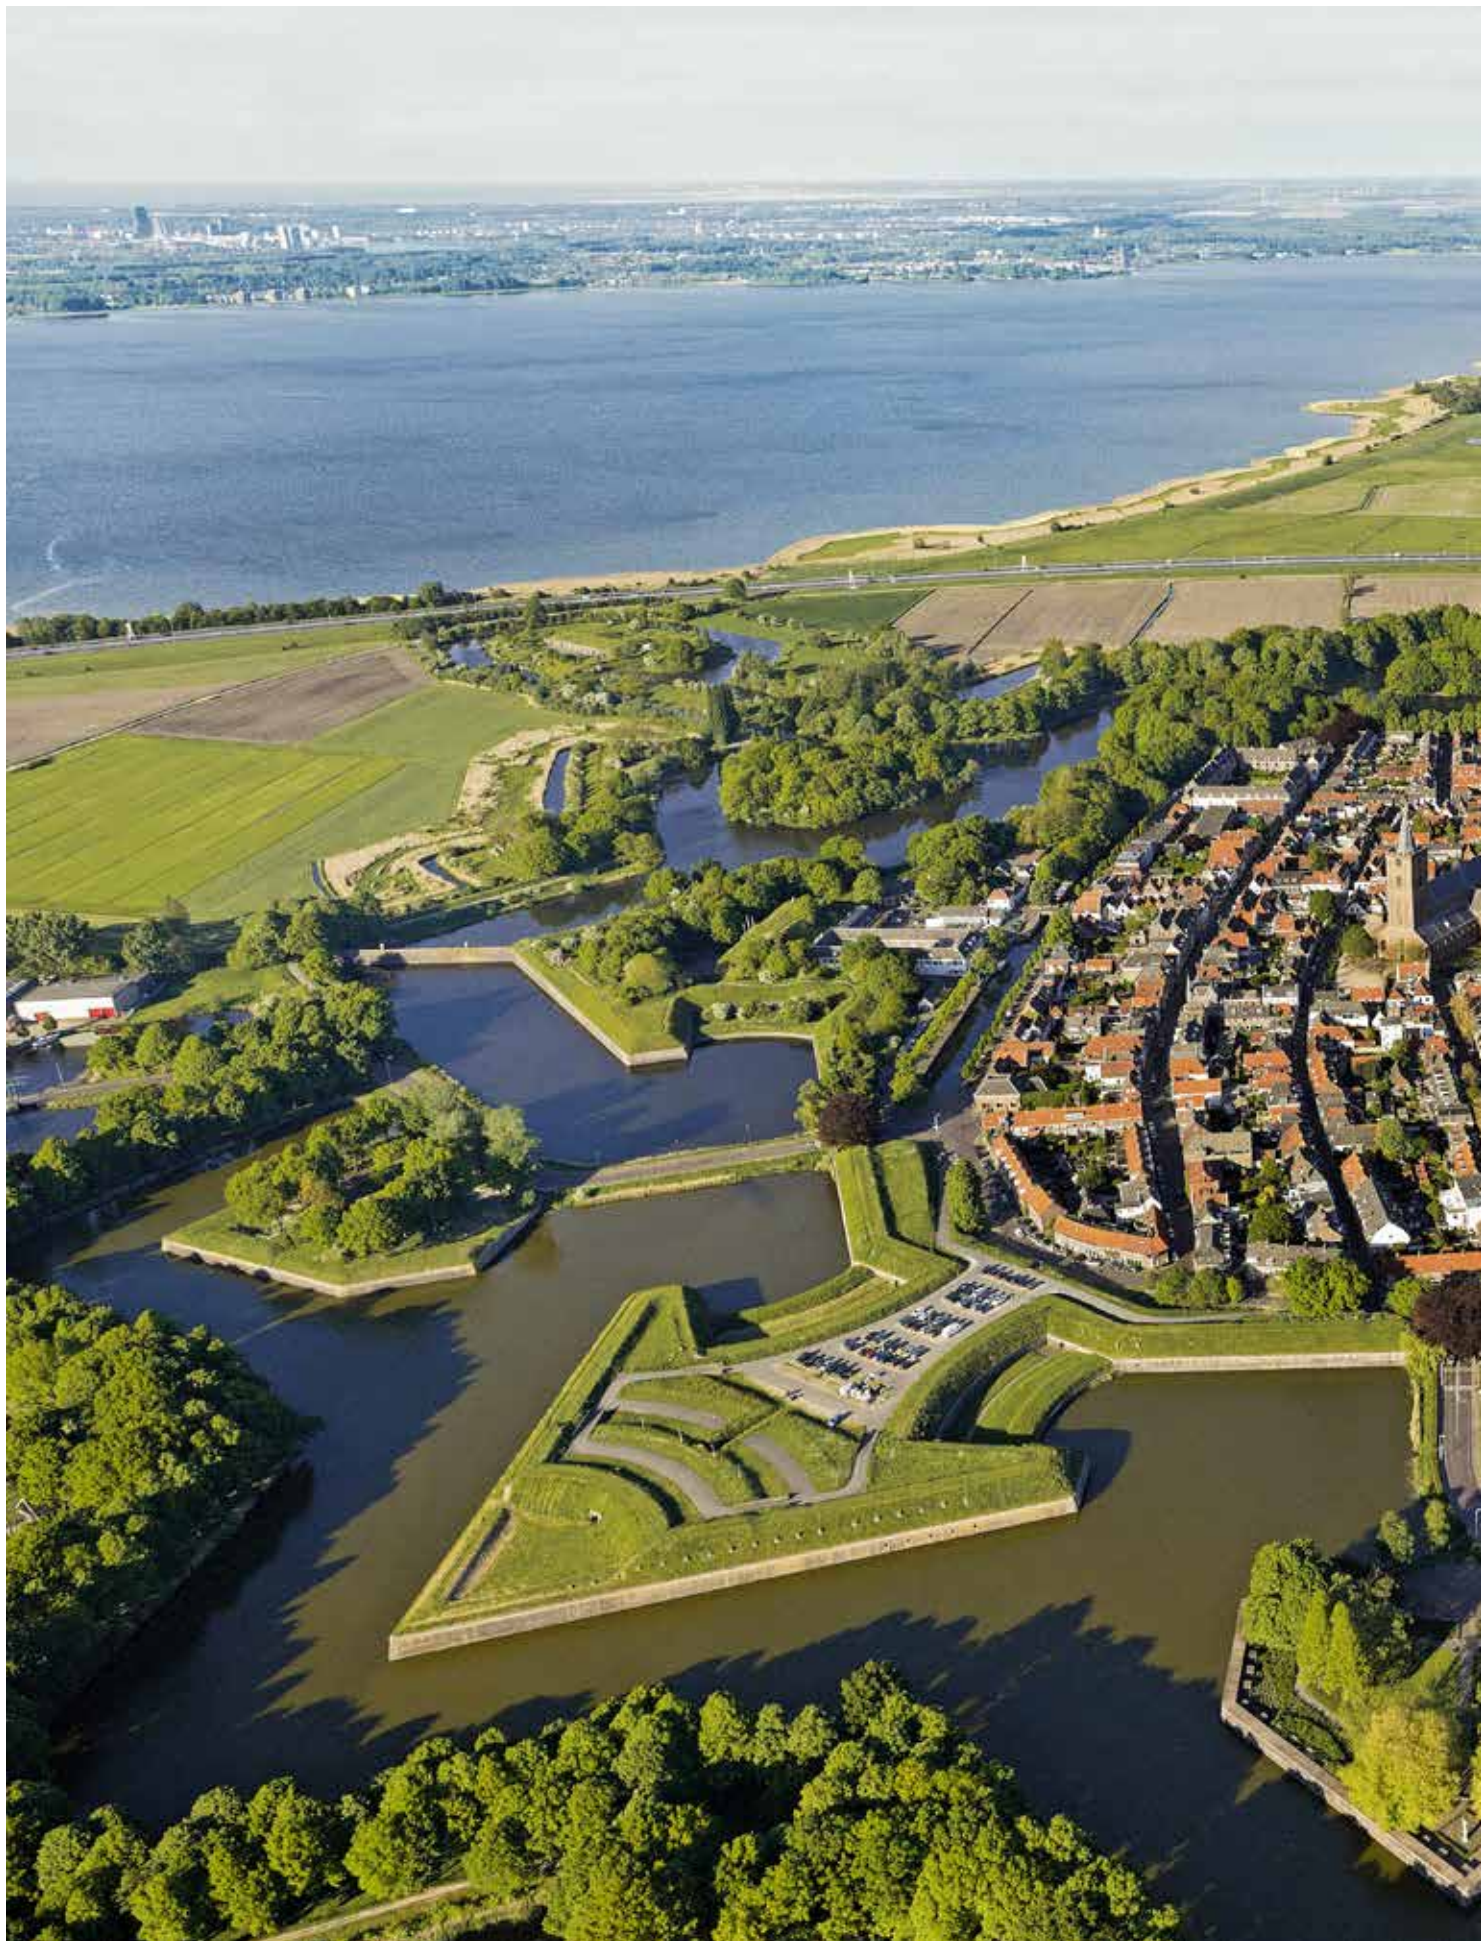
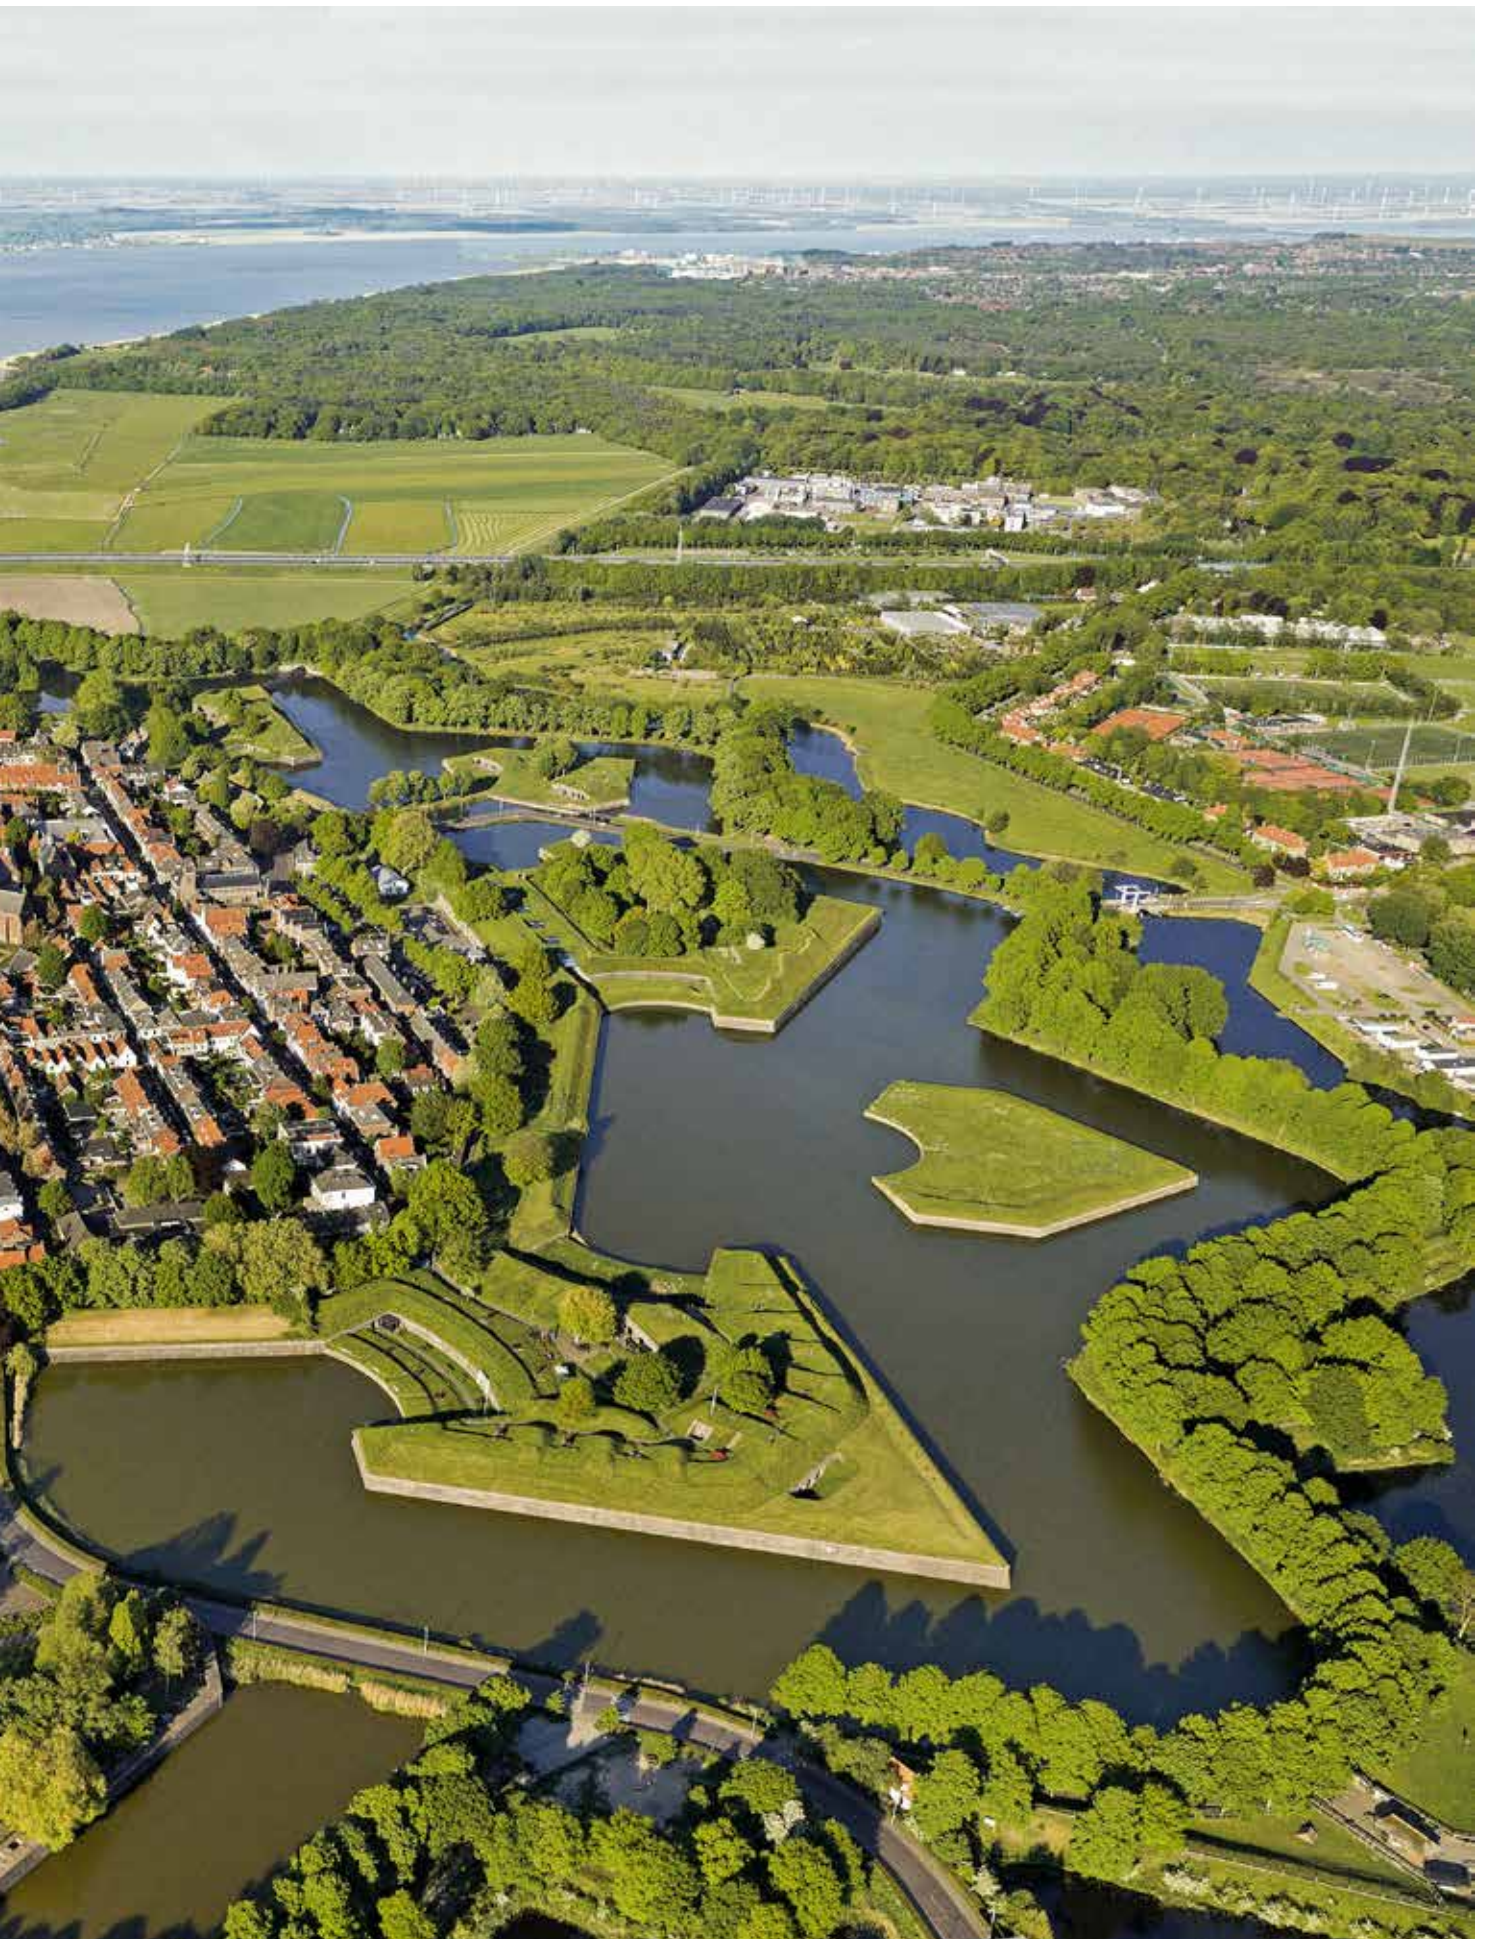
7.3) Aerial view of the fortifications of Naarden.

Looking at the fortifications themselves, one can distinguish three different construction phases. The bastioned trace, consisting of a wall with six large bastions, a wide inner ditch with six ravelins and a covered way that envelopes the whole fortress. This complex was built between 1673 and 1685. It coincides with the start of the construction of the Dutch Waterline. This bastioned trace exists virtually unchanged today. The casemates in the walls and the bastions deserve a special mention. They are unique. Of the fortifications predating this bastioned trace nothing remains, except for several parts of the medieval walls preserved in the underground.

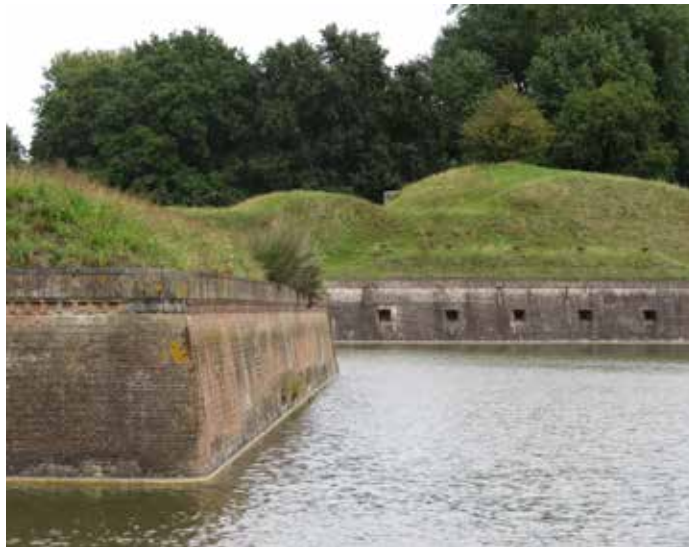
7.5) Picture of the 17th century fortifications, showing the embrasures of the five casemates in one of bastions. From here the ditch around the ravelins (on the foreground) could be defended.

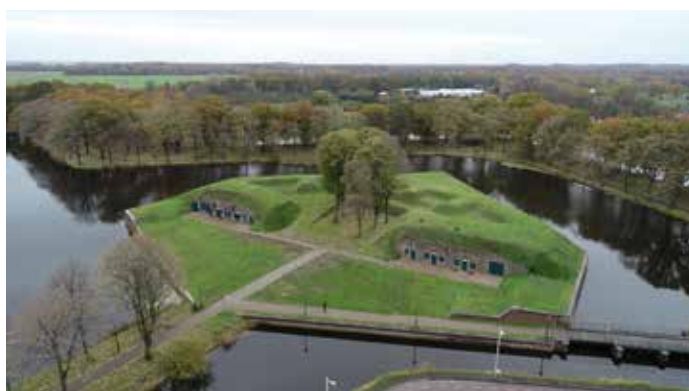
7.7) Aerial view of one of the ravelins in Naarden. The masonry of the ravelin dates from the 17th century. The earthworks of the ravelin were completely remodelled in the 19th century. At that same time (1875) the two bombproof guardhouses were constructed. They consist of a thick masonry construction, covered in an even thicker layer of earth.

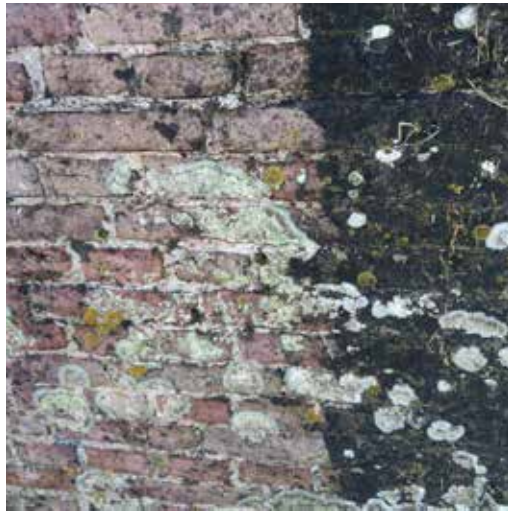
7.8) One of the things stated in the vision on the masonry was the preservation of lichen. On the right side, the wall with black algae and lichen. Damages and other irregularities are not visible without cleaning. On the left the wall after cautiously cleaning it with water at low pressure. The algae are removed, and the lichen stay.

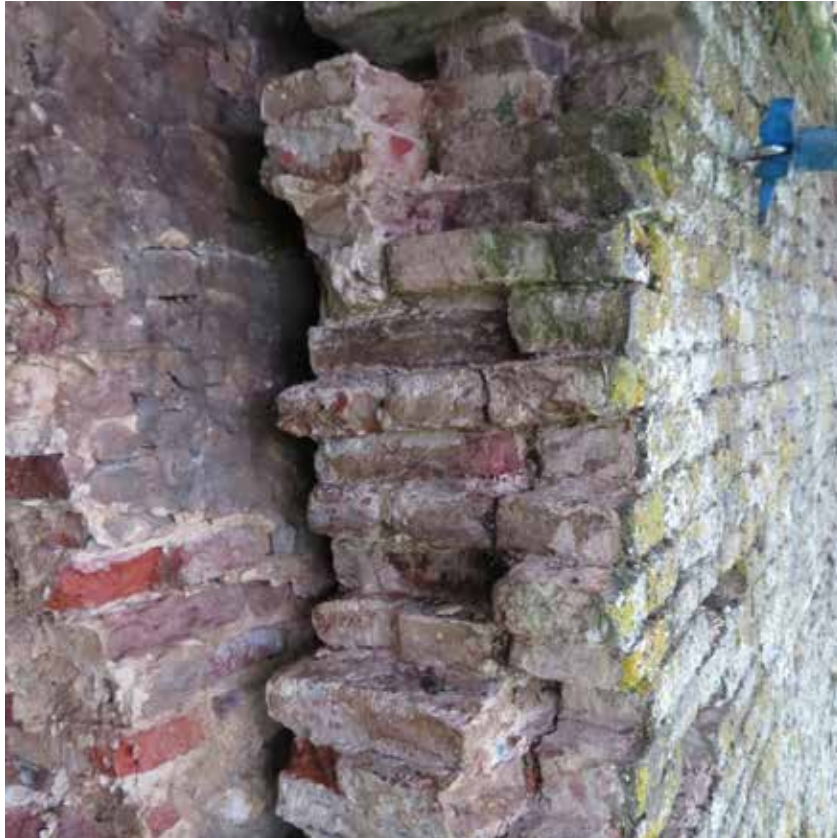
7.10) The cavity in the wall. On the left the core of the wall, dating from the 17th century. On the right the shell that was placed in front of it as a reparation in the 19th century. Between them the cavity of about 8 centimetres.

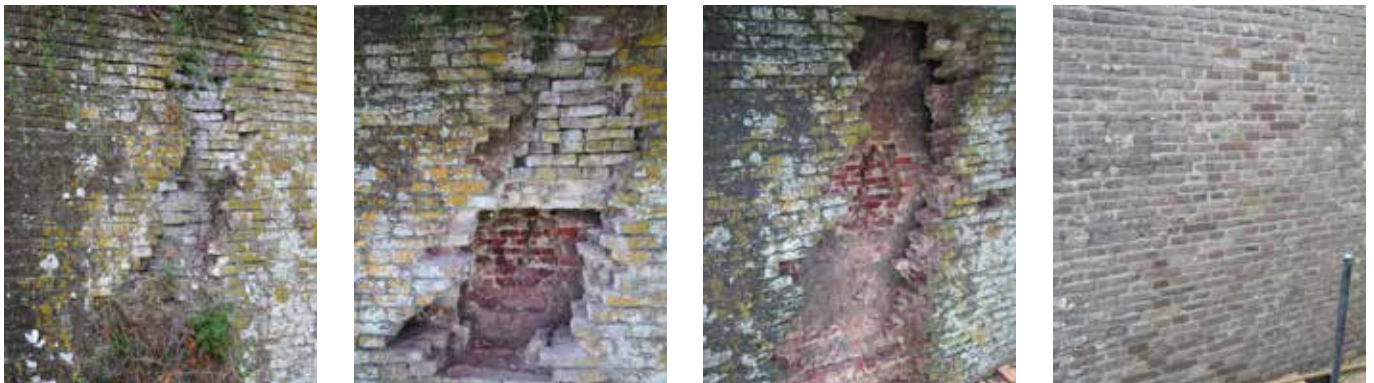
7.12) The restoration of a damaged part of the wall. From left to right:

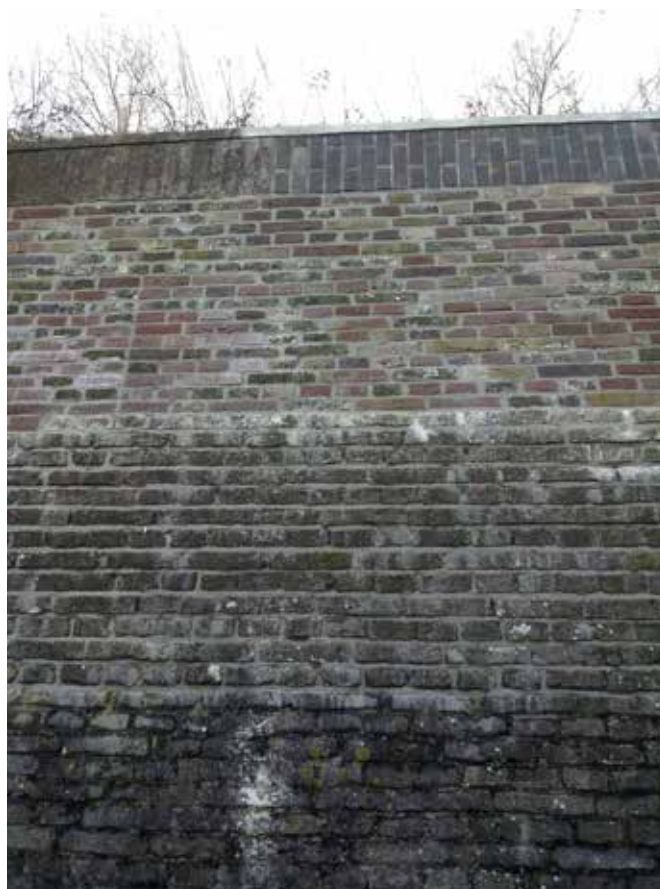
7.13) The efflorescence of lime that was visible on the wall in February 2019.

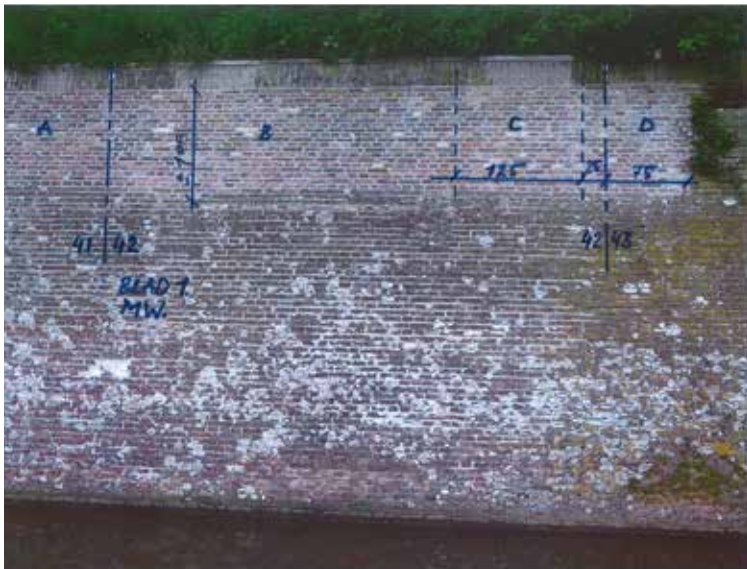
BLAD 1: met sel mortar.

7.14)

From a technical point of view all mortars gave good results. They had hardened well, there was no lime or salt efflorescence detected, and the cohesion between stone and mortar was strong. However, one thing immediately stood out when inspecting the test samples in-situ: the two surfaces with the trass-lime mortar stood out very much. They looked much lighter than the surrounding masonry, which was not desirable from an aesthetic point of view. The other two samples blended very nicely into their surroundings.

In addition to the aesthetic side, the fact that these two samples remained so much lighter, also raised the question whether they disturbed the overall water management of the masonry. The later sample analysis showed that the masonry at greater depths in these two samples was wetter than in the test samples without trass. In other words, the water transport is indeed disturbed. Could this have negative consequences for the longer term? The analysis of the samples provided no evidence for this. However, a trass-lime mortar was also used on the nearby Katten bastion during the restoration of 2009.

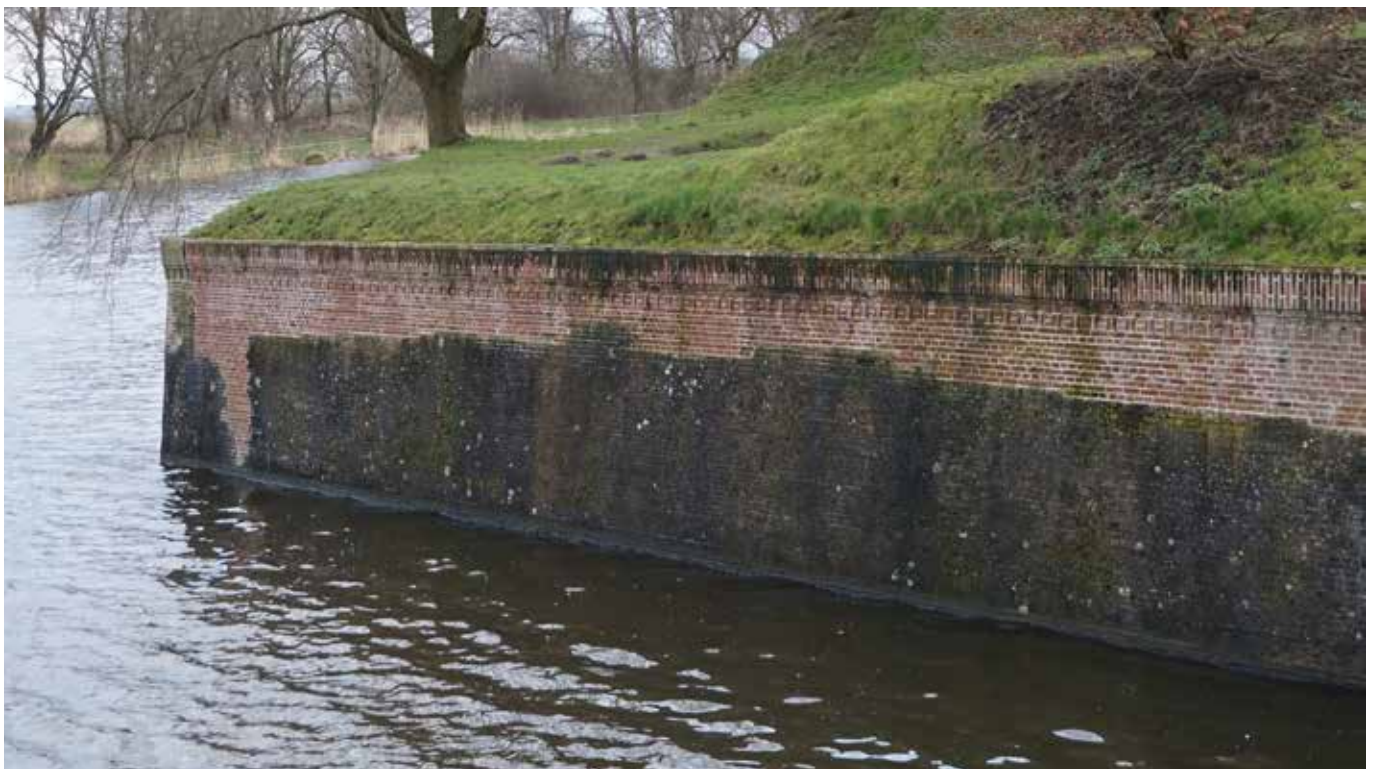
7.15) The masonry of the adjacent bastion (Katten), that was restored in 2009, still stands out very much in comparison to the older masonry. Besides that, this older masonry shows much more growth of moss and algae.

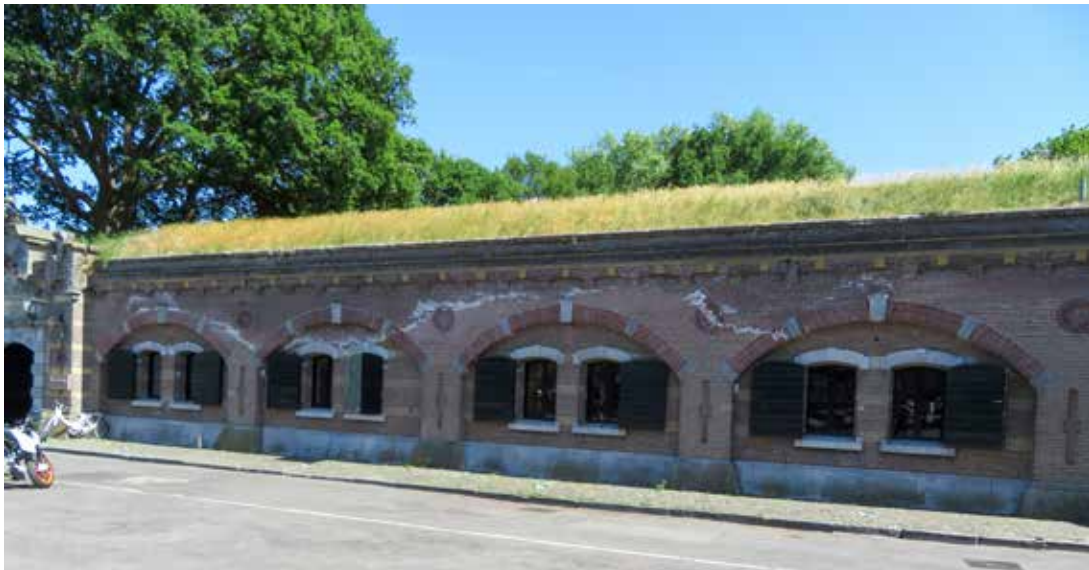
7.16) The façade of the Promers barracks, showing the salt efflorescence in 2019.

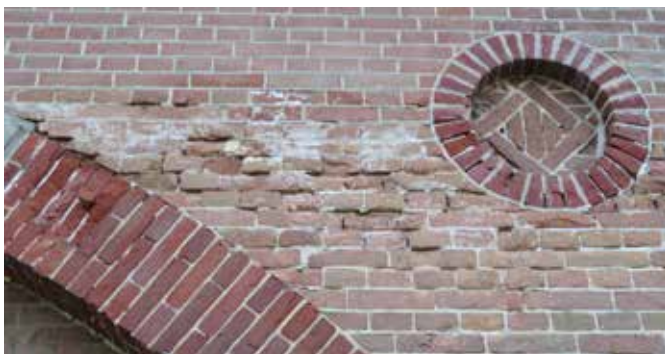
7.17) The damage caused by the salt in 2019.

It looks like reparations and restorations of the past have worsened the problem: the use of cement, the use of bricks that were too hard, and the fact that big reparations were done without bonding the new masonry with the existing masonry. These factors disturb the movement of humidity through the facade. It led to the decision to remove all the cement joints, all the way up to the healthy lime mortar. They will be replaced by a lime-mortar of a recipe based on the original mortar in the façade. All the reparations of twenty years ago will be taken out and replaced by new reparations that are well-bonded with the surrounding work, using stones of a similar

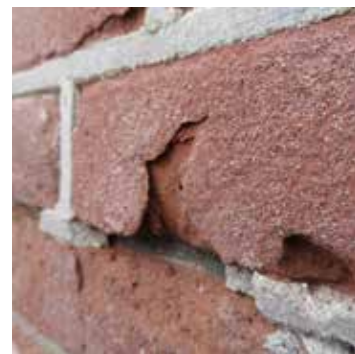
7.18) Detail of a splinter of brick about to come off in 2019. This is due to the salt crystallization in the masonry.

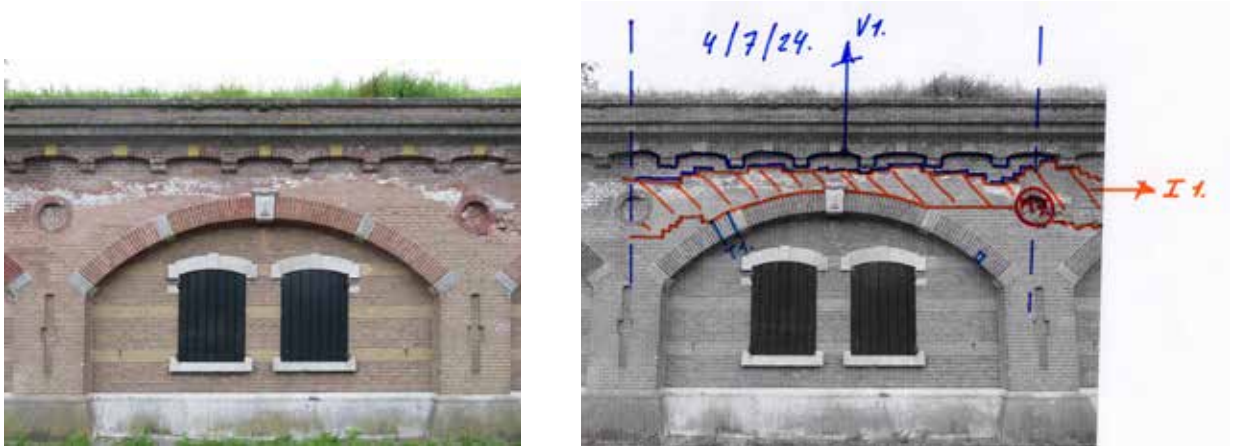
7.19) Picture showing the efflorescence in 2024. Next to it the same part of the wall with the proposed intervention marked on it. In blue the part where the cement joints need to be removed. In orange the part where the reparations of the previous restoration (in 2000) need to be taken out and replaced. As a test, part of this reparation will be taken out in October 2024 and replaced with new masonry. It will be tested in August 2025.

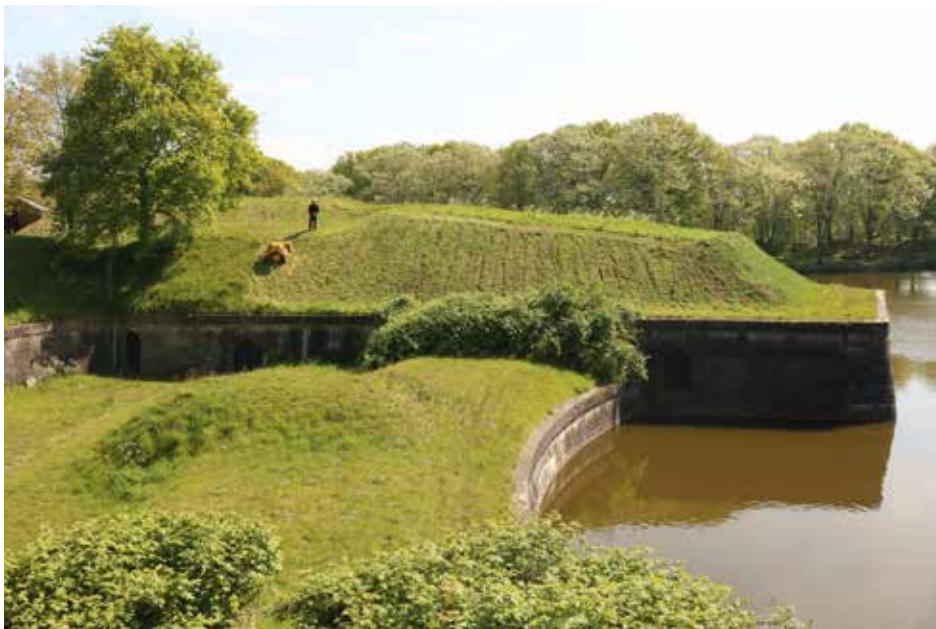
8.1) Naarden's fortifications, the mechanical maintenance of grass cover at bastion Oranje.

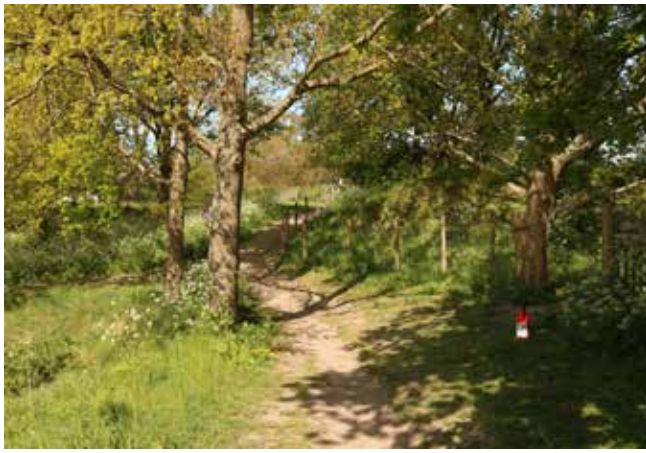
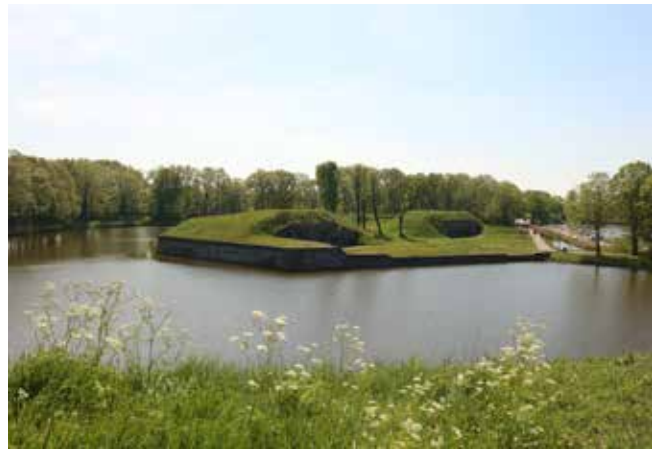
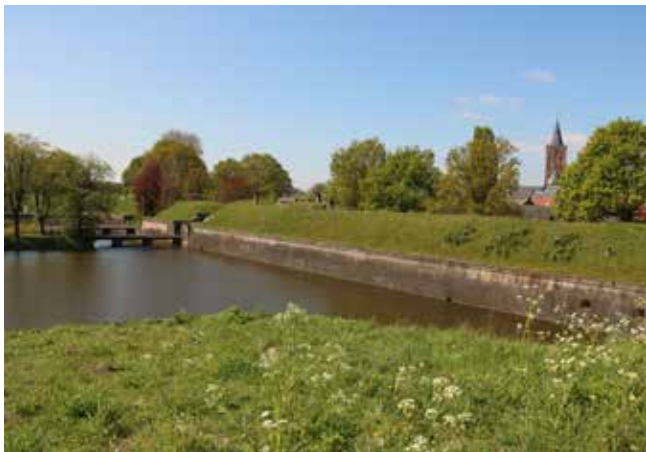
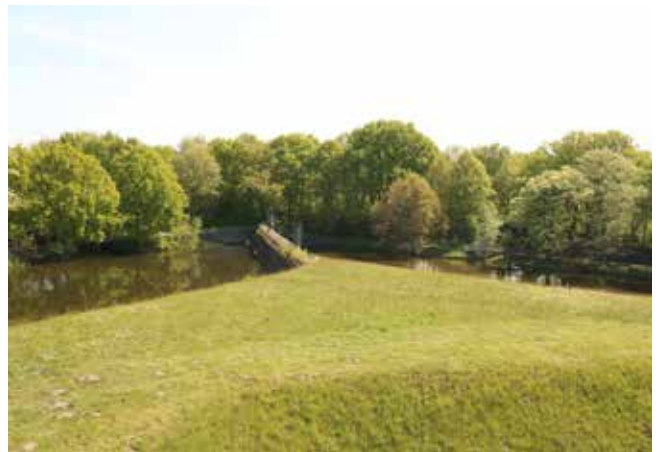
8.2-5) The green cover of Naarden's fortification before the summer drought.

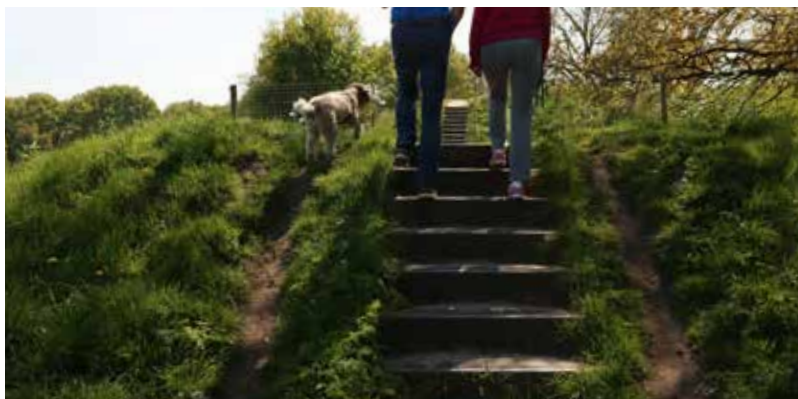
8.7) Stairs along the main path are highly vulnerable to vegetation erosion, leading to damage over time.

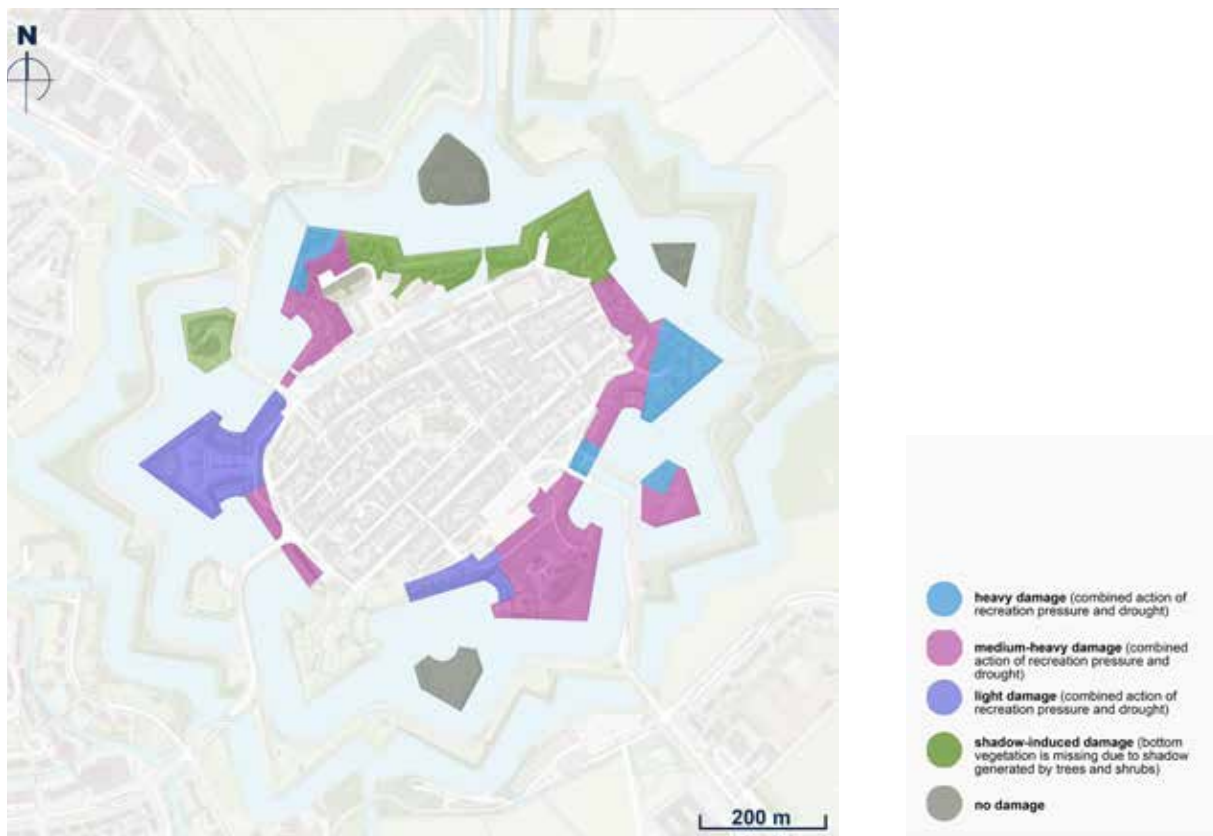
8.8) This map visualizes damage levels recorded throughout 2022-23, ranging from light to severe. It serves as a key tool for assessing impact and guiding the redesign of circulation paths within the fortifications.

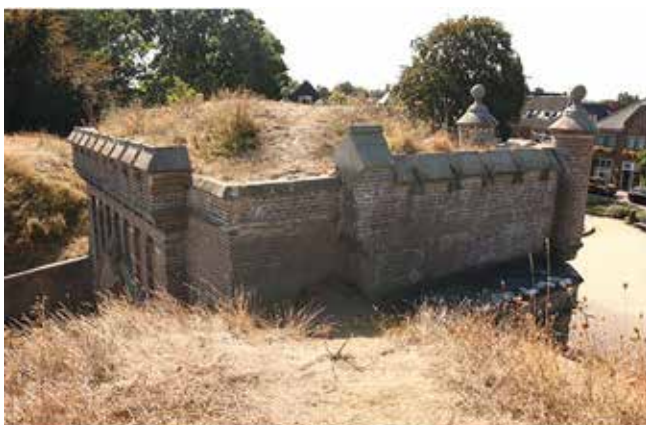
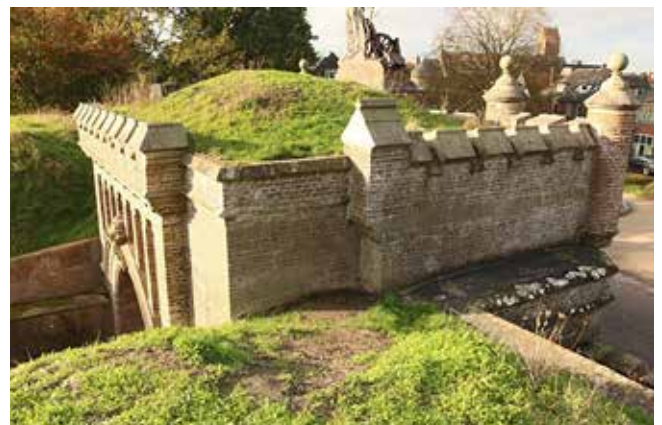
8.9) The Utrecht's gate before and after recovery from the summer drought .

One area of concern includes the Utrecht Gate and Bastion Oranje, where damages exacerbated by recreational pressure were further intensified by drought during summer months. Provisional measures, such as fencing off the area, facilitated natural recovery of the vegetal cover in the fall. Although the grass cover at the shoulder of Bastion Oranje was restored in 2021, intense frequentation of this highly panoramic spot quickly undermined this intervention. While some natural recovery was observed during fall, the quality of new vegetation raised concerns regarding its sustainability over time.

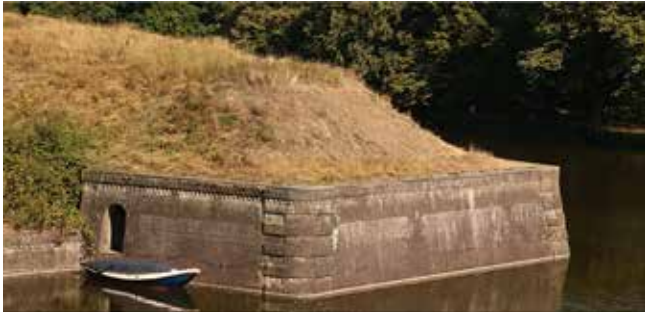
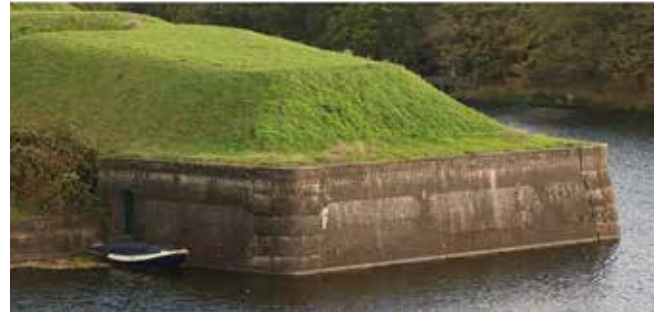
8.10) The shoulder of bastion Oranje before and after recovery from the summer drought.

To address these issues at Bastion Oranje, two complementary measures are proposed: closing the outer path along the water side to alleviate recreational pressure, and planting bushes along traverses to clearly delineate the main visitor route along the inner path. This latter intervention not only increases vegetal cover but also requires careful design to minimize visual disruption from both within the fortifications and the covered way.

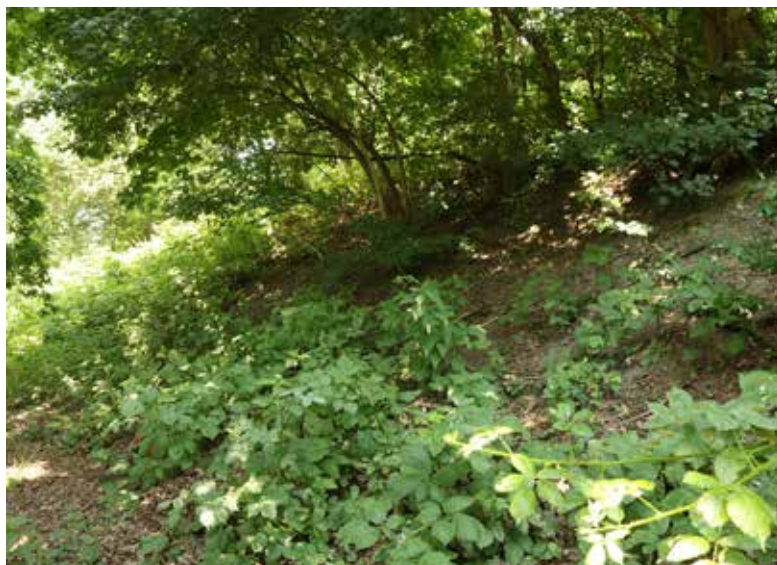
8.11) The dense tree cover at bastion Katten helps against drought but limits lower vegetation growth.

To achieve a better ecological balance at Bastion Katten, the new green plan includes measures aimed at fostering the growth of lower vegetation while maintaining the forest-like character of the area. This involves careful selection and pruning of tree branches to promote lower-level growth. Furthermore, removed branches can be repurposed to block off secondary paths, aiding in the preservation of the site.

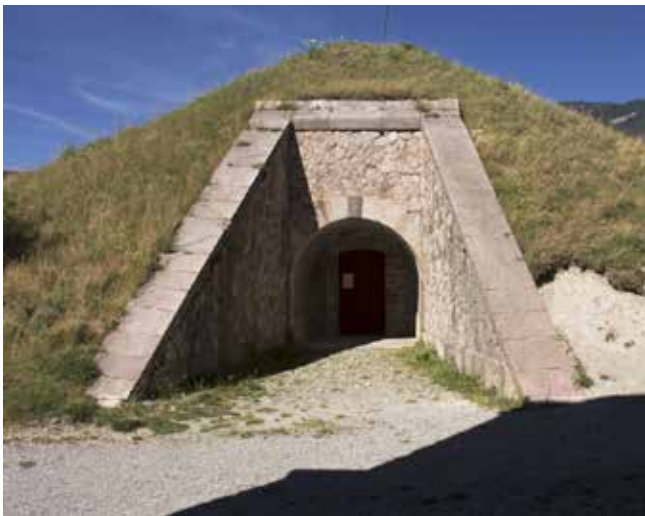
9.4) The powder magazine.

Within this family of buildings, the powder magazine is of particular interest because of the alterations it has undergone, which have led to the appearance of certain pathologies in recent years. The interior of this powder magazine is highly representative of the many buildings of this type constructed between 1667 and 1815. It appears to be the only authentic Vauban storehouse to have been brought up to the standards required for protection against rifled artillery after 1874. The powder magazine for the stronghold of Mont-Dauphin was included in Vauban's initial design of 1692 and was one of the first buildings to be constructed. Completed in 1694, it is a rectangular rubble masonry building with a bomb-proof vault, supported on each side by four thick buttresses cushioned on an inclined plane. The powder magazine is divided into two levels by a floor. The upper level houses the powder room, protected by walls over 3 m thick and featuring a broken barrel vault made of cut tufa rubble. The cross-beamed floor rests on oak beams supported by a central row of wooden posts set on ashlar blocks. The upper level is the entrance from the courtyard. It is accessed via a covered walkway launched from a perron. Two diverging flights of stairs leading down from this perron provide access to the lower level.

In 1882, to protect the powder magazine from rifled artillery, the building was brought up to standard, in accordance with the ministerial instruction of 22 August 1874. On each side, a ramped-arch vessel was built, which also served as a drainage gallery and storage area in wartime. The whole structure was covered by a protective mass of earth, with an entrance to the south-east, set into the slope and supported laterally by two walls. Today, the powder magazine is open to the public for tours, exhibitions and events.

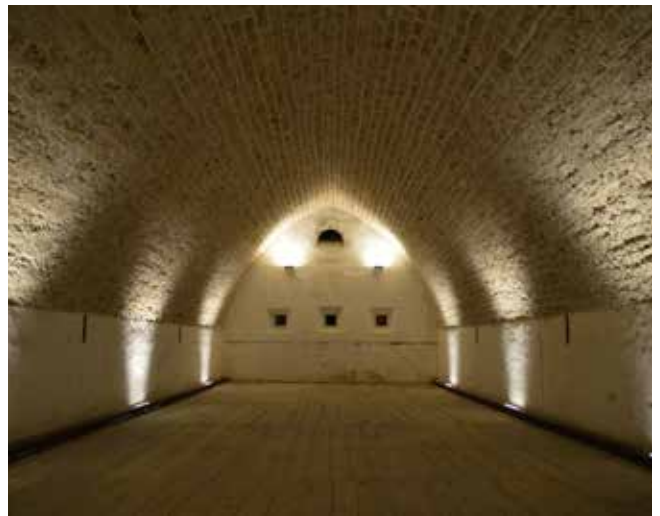
9.5) High room of the magazine.

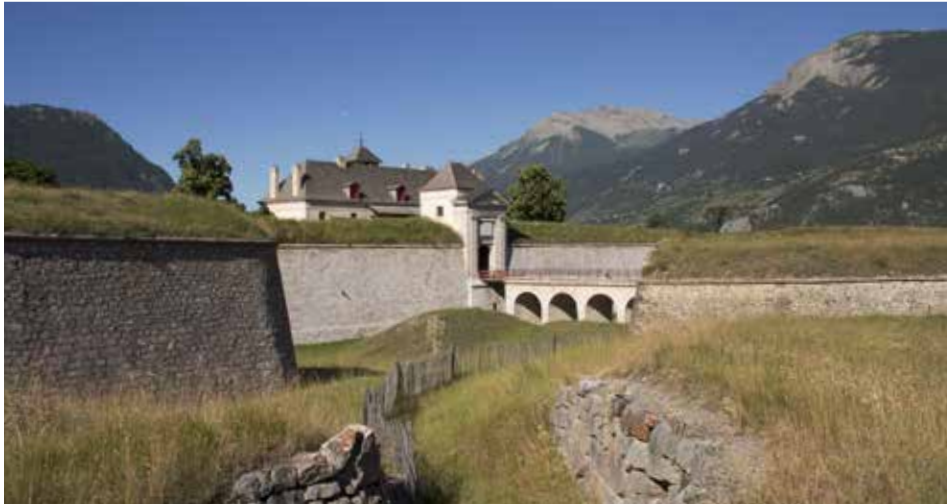
9.6) The Briançon gate.

The first is representative of the royal works of the classical period, whose role was to display the prestige of royal works in the architecture of the royal absolutism of the reign of Louis XIV. The lunette d'Arçon built later (between 1728 and 1731) on the glacis of the square, this ravelin is one of three commissioned thirty years earlier by Vauban to watch over a blind spot on the Eyglies front. The other two, which were to frame it, were never built. In 1791, General d'Arçon ordered its conversion into a lunette with reduced security and casemates with inverted fire, quickly nicknamed the "Lunette d'Arçon".

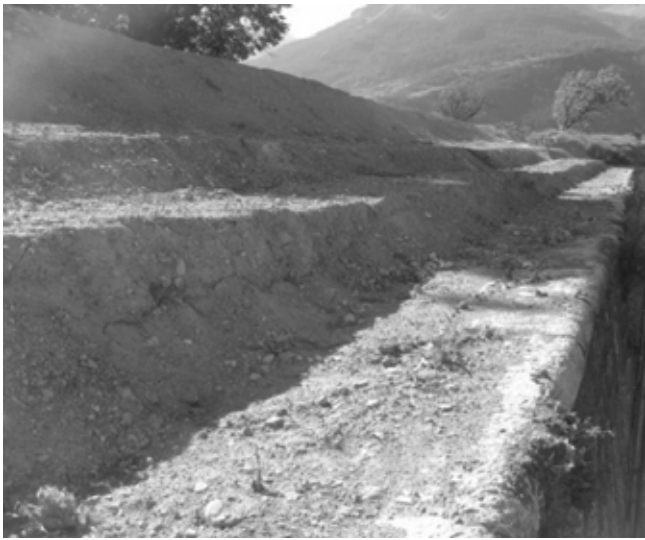
9.8) Embankment of the Briançon gate.

The first example concerns the escarpment on either side of the Porte de Briançon on the northern front. The 2005 condition report noted several defects affecting the facing of this structure:

- Detachment of the facing from the inner blocking as a result of the mortar being washed away by run-off and seepage.
- Misalignment of courses due to vegetation.
- Locally deformed facing.
- Poor condition of the string course and the first three upper courses, due to particularly intense rainwater run-off at the top of the curtain wall.

Looking at the location of these defects, it can be seen that the parts with washed-out joints are located at the top of the structure, suggesting a break in the waterproofing of the curtain wall. Similarly, the deformed parts are accompanied by the presence of parasitic vegetation and faded joints, suggesting localised infiltration of the masonry rendering.

- Reconstruction of the waterproofing of the upper sections.
- Allowing water to drain away.  
This part of the project will be implemented through the following works.
- Dismantling/reassembling deformed stone facings, including pinning.
- Creating decompression wells.
- Replacing ashlar in search of new stone (particularly in cords, first courses and base courses).
- Recasting and repointing.
- Lime grout injection.
- Installation of a reinforced tarpaulin at the top of the embankment, reprofiling and planting of vegetation.

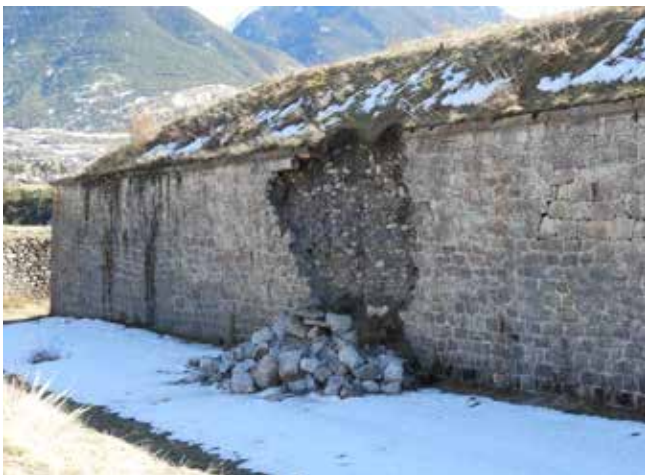
9.10) In winter 2018-2019, part of the wall of bastion 63 collapsed.

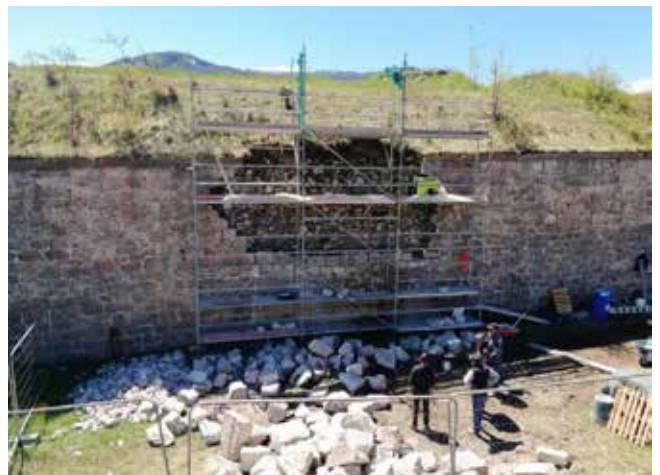
9.11) The crowning was reconstructed.

Two observations can be made to explain these two disorders. The first concerns the nature of the soil throughout the stronghold of Mont-Dauphin. Vauban was struck by the appearance of the rock of the plateau on which the stronghold was built (poudingue/pudding\* in geological terms). He thought that this conglomerate was so solid that the walls of the ditches to be built could do without a masonry facing, which would be a great source of savings. Unfortunately, this was not the case.

A site report from 1693 informed him of the following: "you have been informed that no rock has been found in the excavations, as had been thought, but only stones and pebbles covered in sand and earth, which obliges you to multiply the masonry well beyond what had been planned". Rolled pebbles from glacial and torrential alluvial deposits were used for the core of the masonry and were not bonded to the binder. Entire sections of certain escarpments were detached. Although Vauban had been informed of this as early as 1693, he had ordered from a distance that the pebbles be broken to ensure better bonding, which was not carried out until 1697. To sum up, the faces of the bastion are flanked by simple masonry facings, rather than masonry of the "weight wall" type.

In addition, the soil behind the bastion is heterogeneous and the measures planned by Vauban to make it more resistant were not taken. A quick examination of the collapsed structures also reveals late repairs to the facings where cement was used for the joints. This cement mortar jointing created an obstacle to moisture exchange. The addition of the original wall configuration to the cement mortar joint first explains the appearance of the belly, then the collapse.

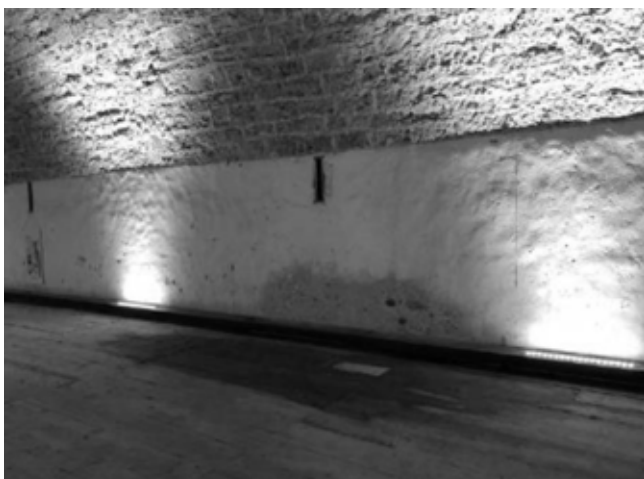
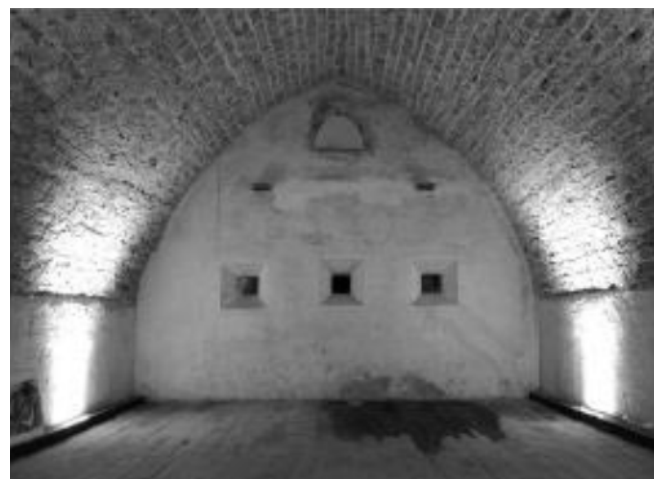
9.12-13) Infiltrations in the powder magazine.
