EUROPEAN PROJECT ON FORTIFIED LANDSCAPE FACING NEW THREATS

# RESILIENT FORTRESS

SUOMENLINNA SUMMER SCHOOL REPORT

ERASMUS+ project

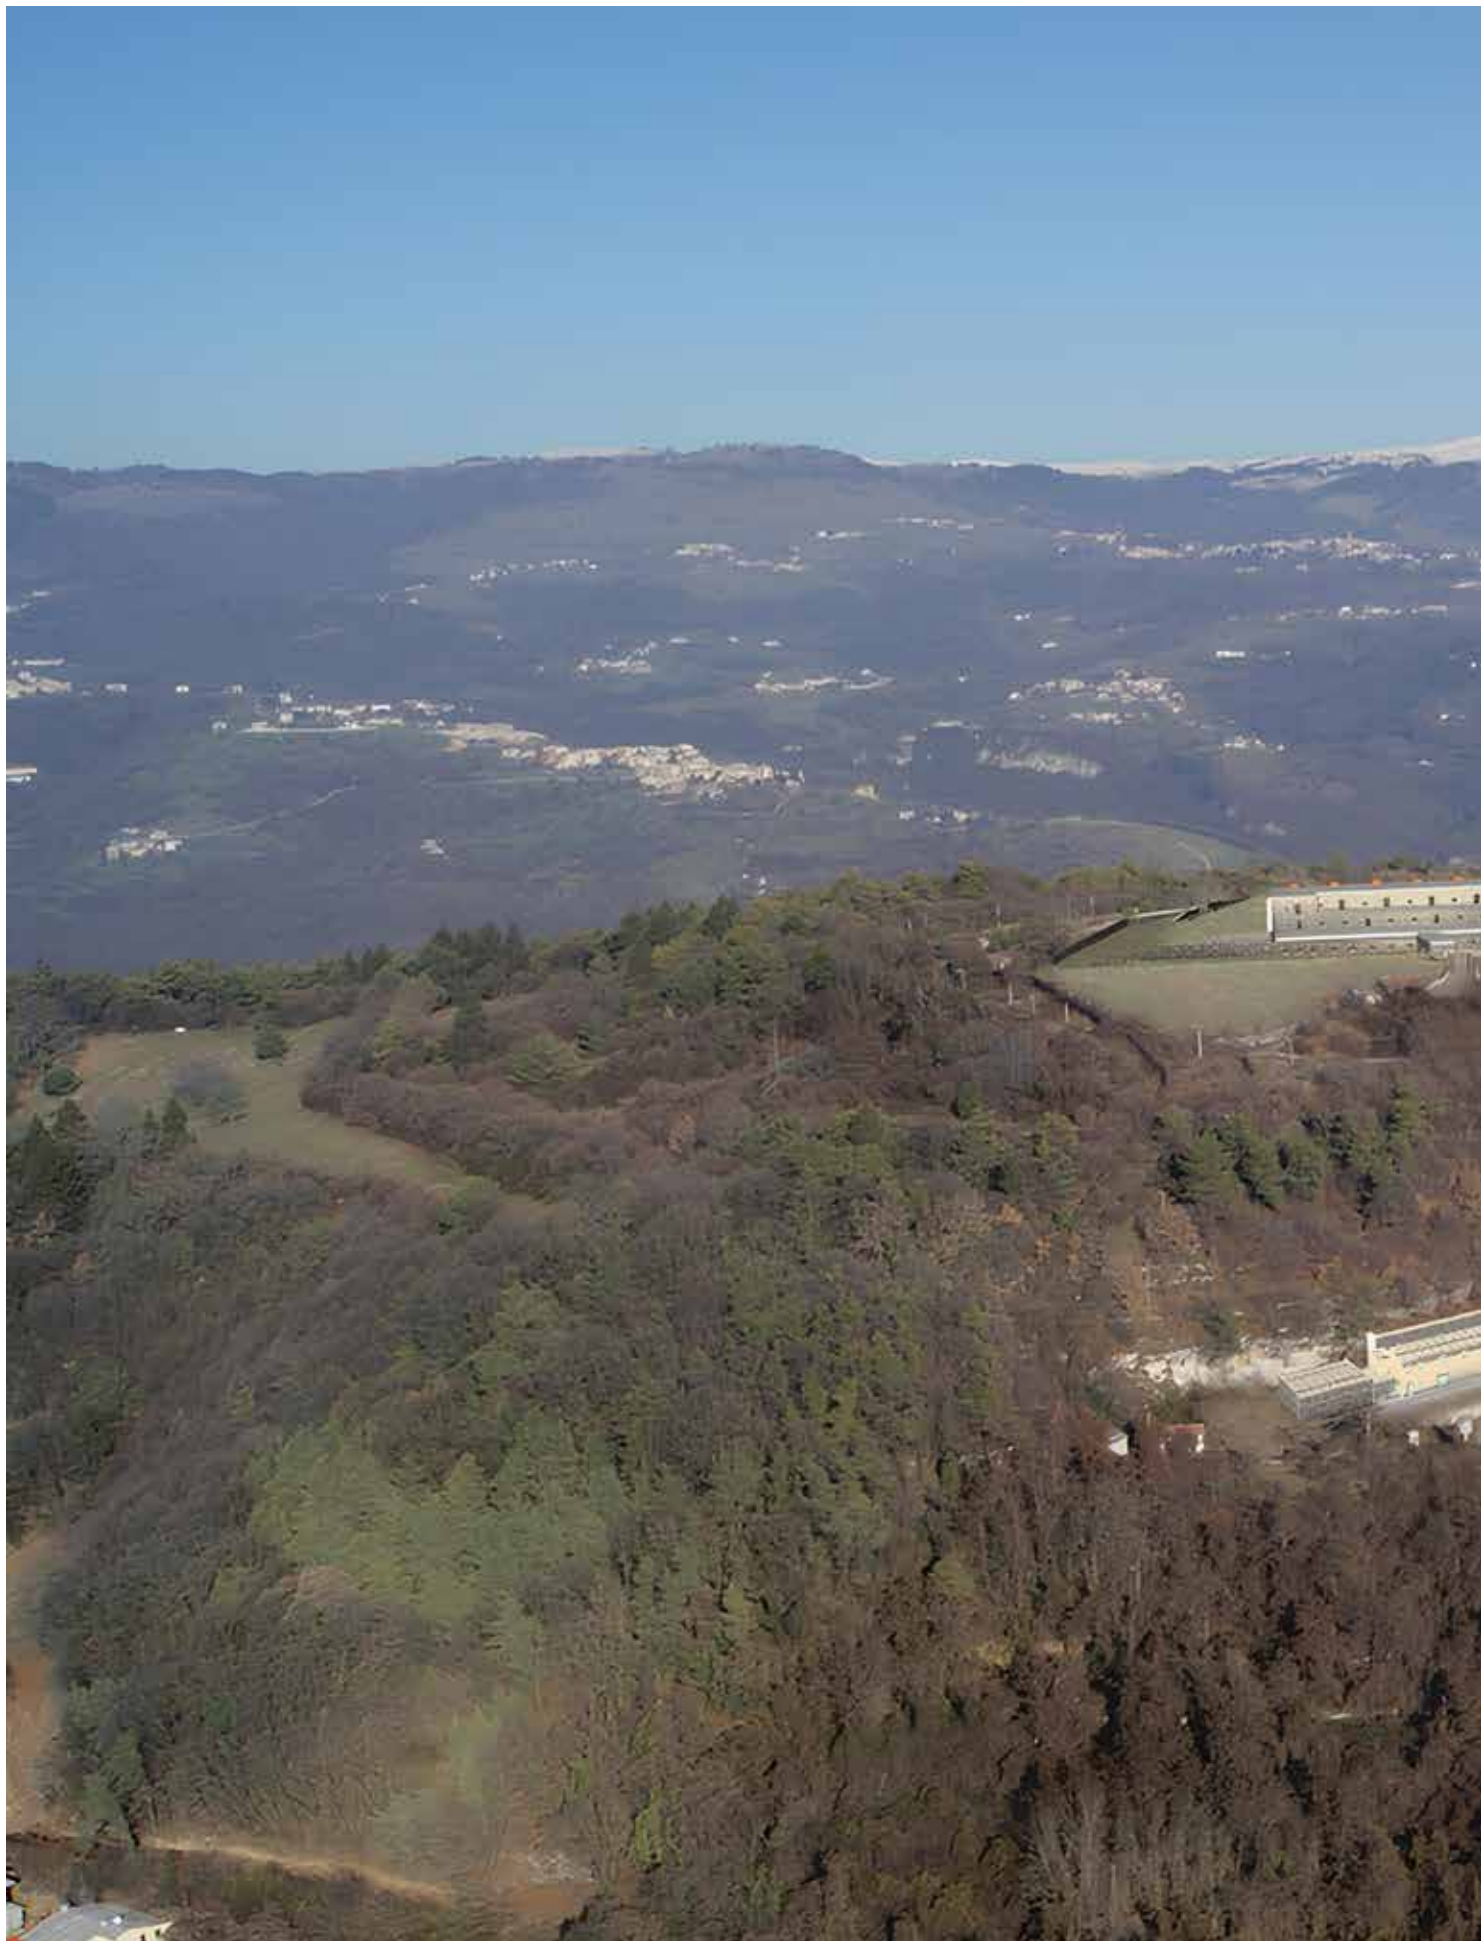
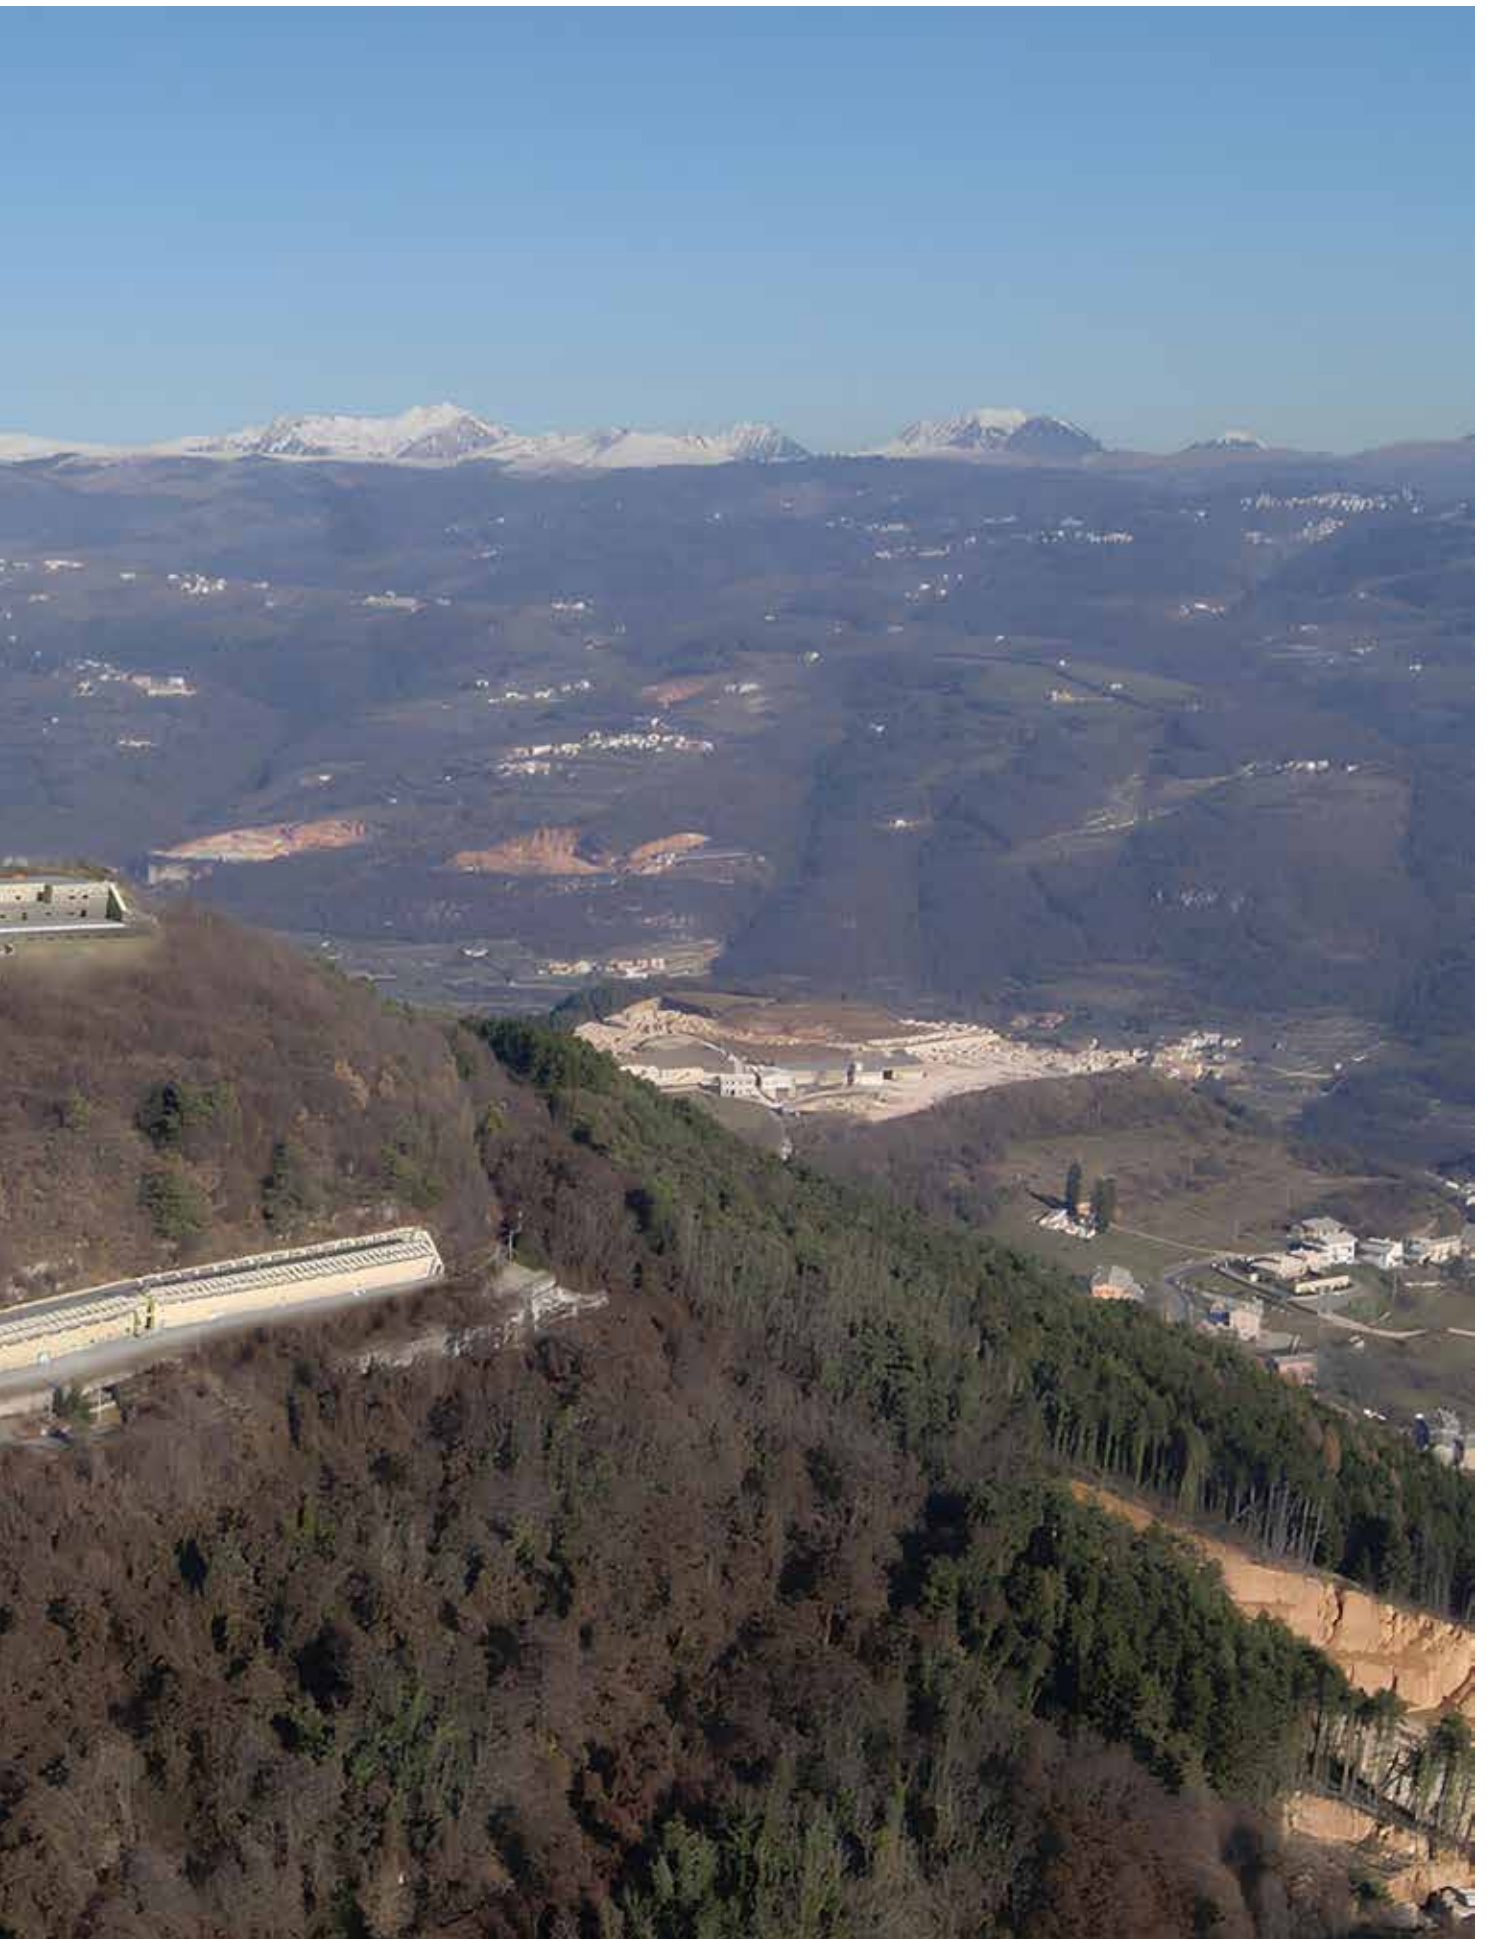
10.1) Aerial view of the Forte Tesoro and barracks after the restoration project.

The renovation phases ran from 2012 to 2022, including restoration of the original architecture and structural consolidation. Traditional materials such as stone were used alongside modern elements such as concrete and Corten steel, creating a contrast that enhances the fort's history. Particular attention was paid to accessibility, with paths connecting the fort with the surrounding landscape. The roof was restored, allowing visitors to enjoy a panoramic view of the Alps and Lake Garda. The new Corten steel domes, designed to harmonise their surroundings, offer observation points.

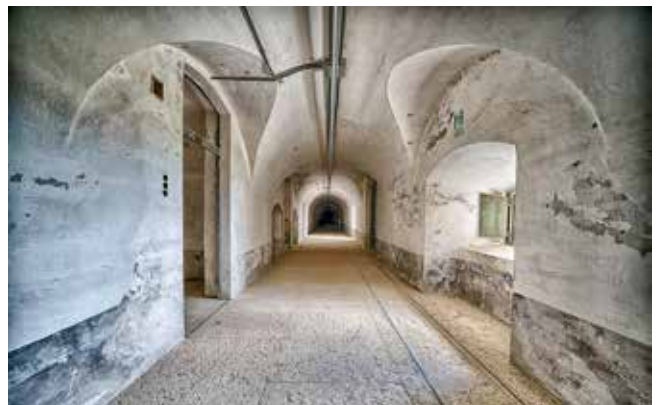
10.5) Interior view at the level of the armoured batteries.

On the ground floor there is a forced ventilation system with metal ducting that interprets the technological solutions historically found in Italian armoured forts. For the electrical distribution, open conduits were adopted not to affect the wall and to allow flexibility for future implementation of the network.

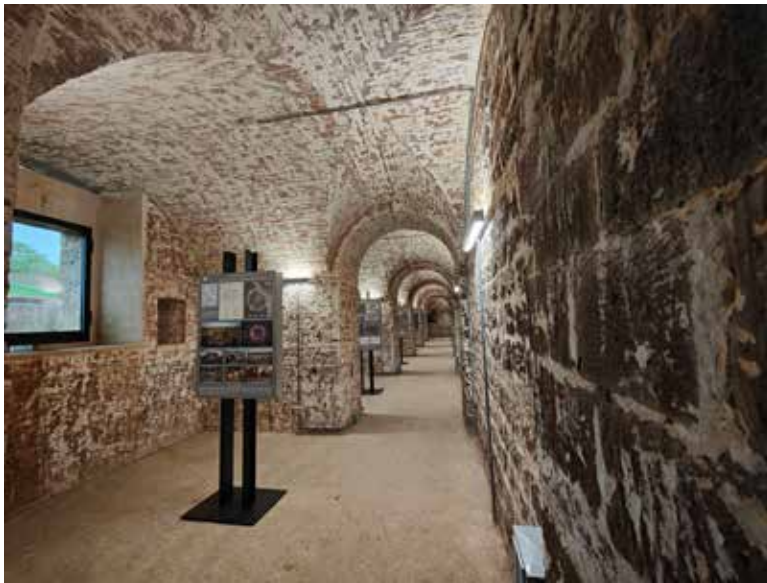
The intervention was diversified according to the state of the sites, with excavations of varying depths for waterproofing with bentonite sheets, covered either with turf or with draining paving. The artillery emplacements were restored to house 1:1 scale models of the cannons made of metal based on historical drawings.

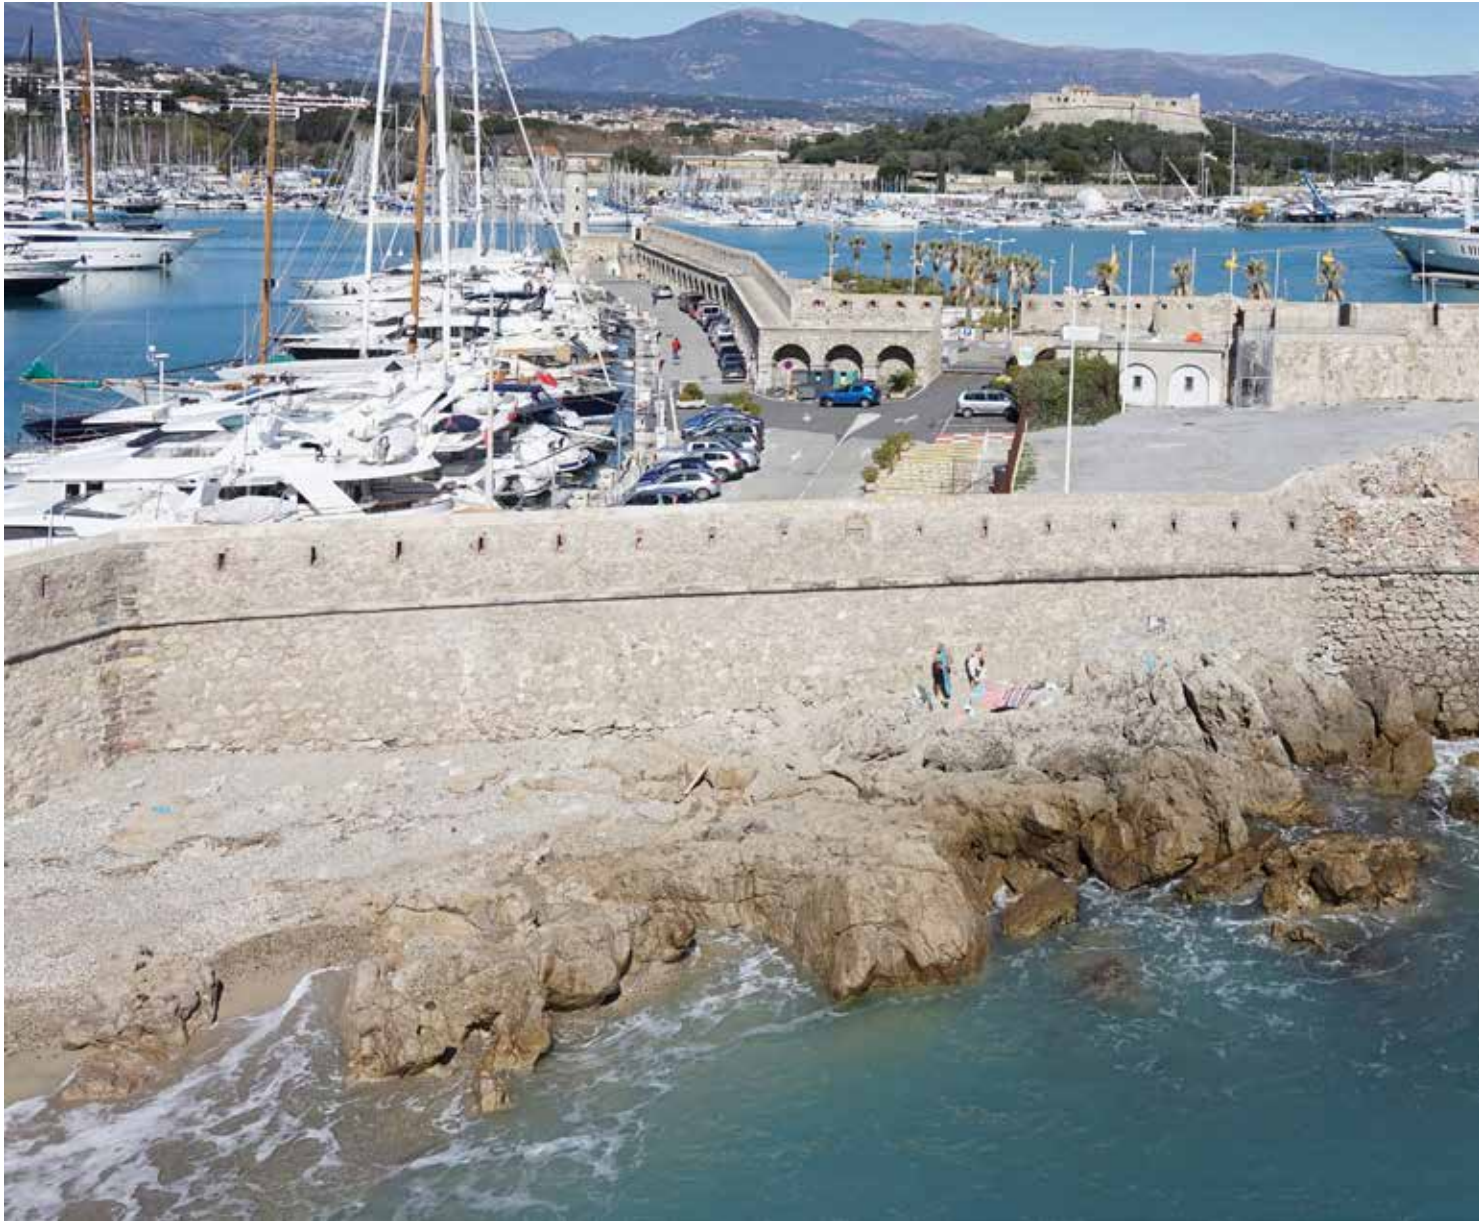
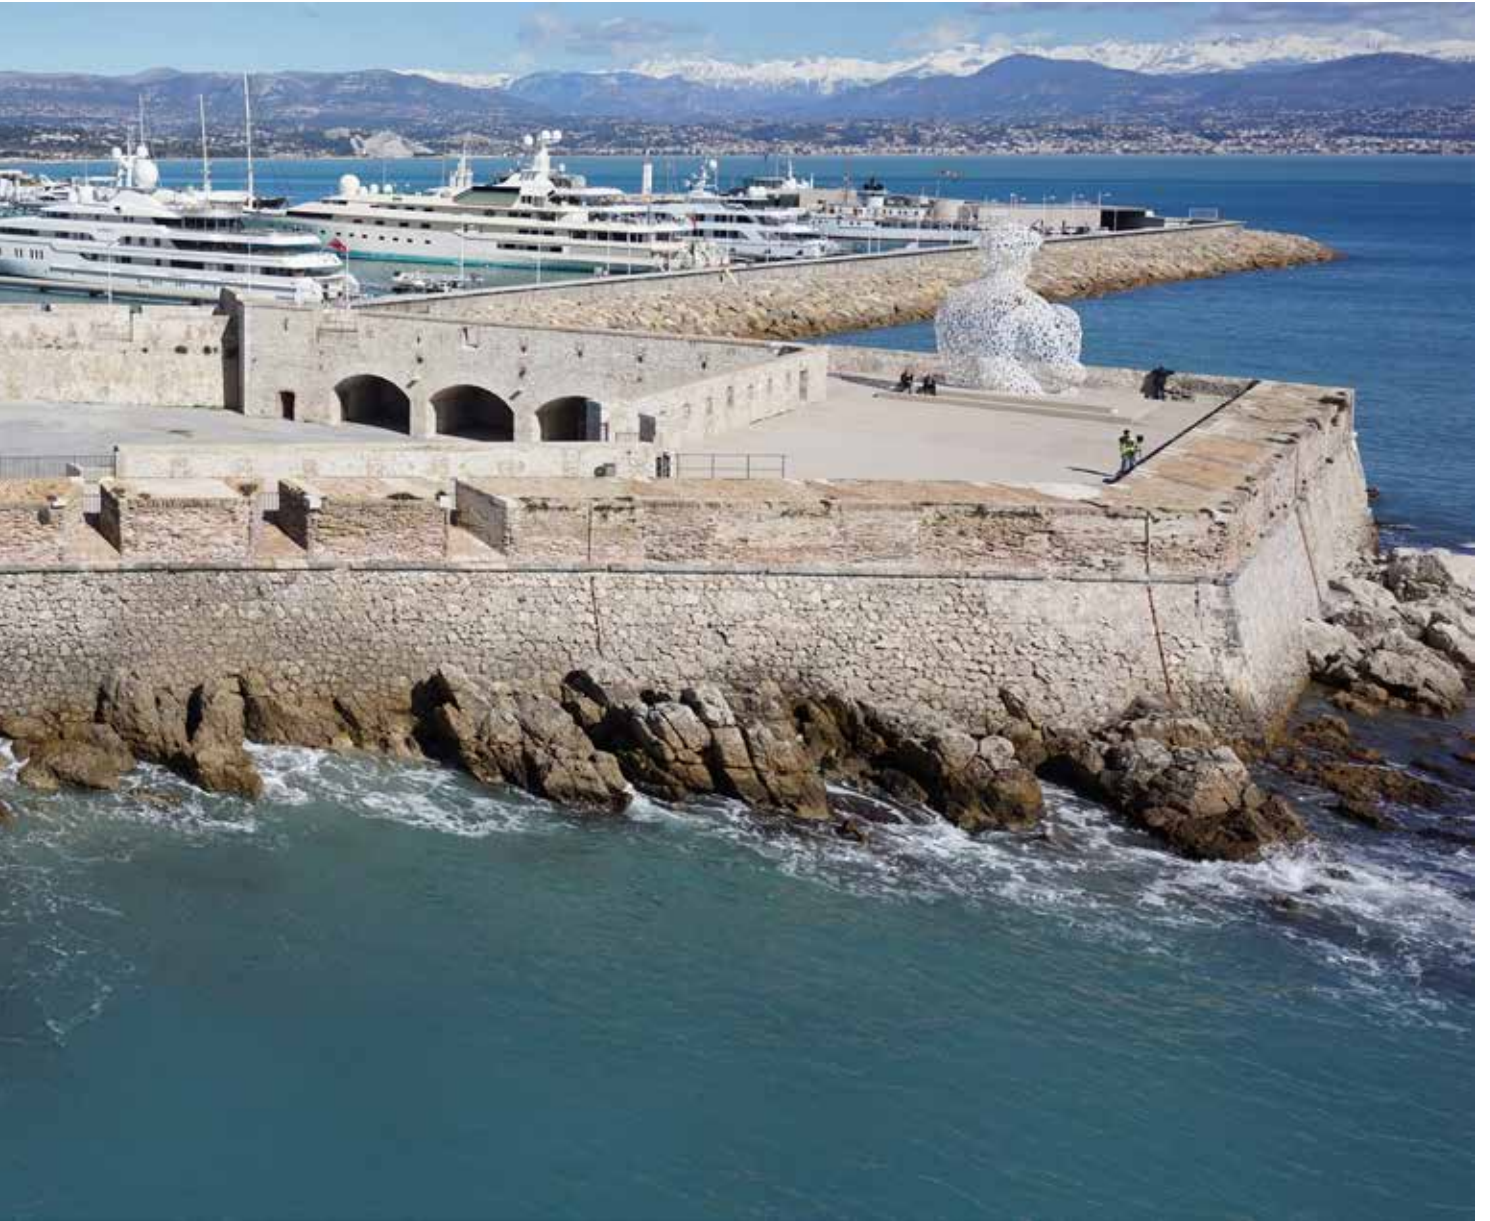
11.1) Aerial view of the Bastion St Jaume in Antibes.

The rampart's brick parapet was in bad condition. Some faces were heavily eroded. The top of the brickwork was dismantled by vegetations' roots. The rubble scarp needed repointing and the tip of the bastion had lacking stones in its quoin.

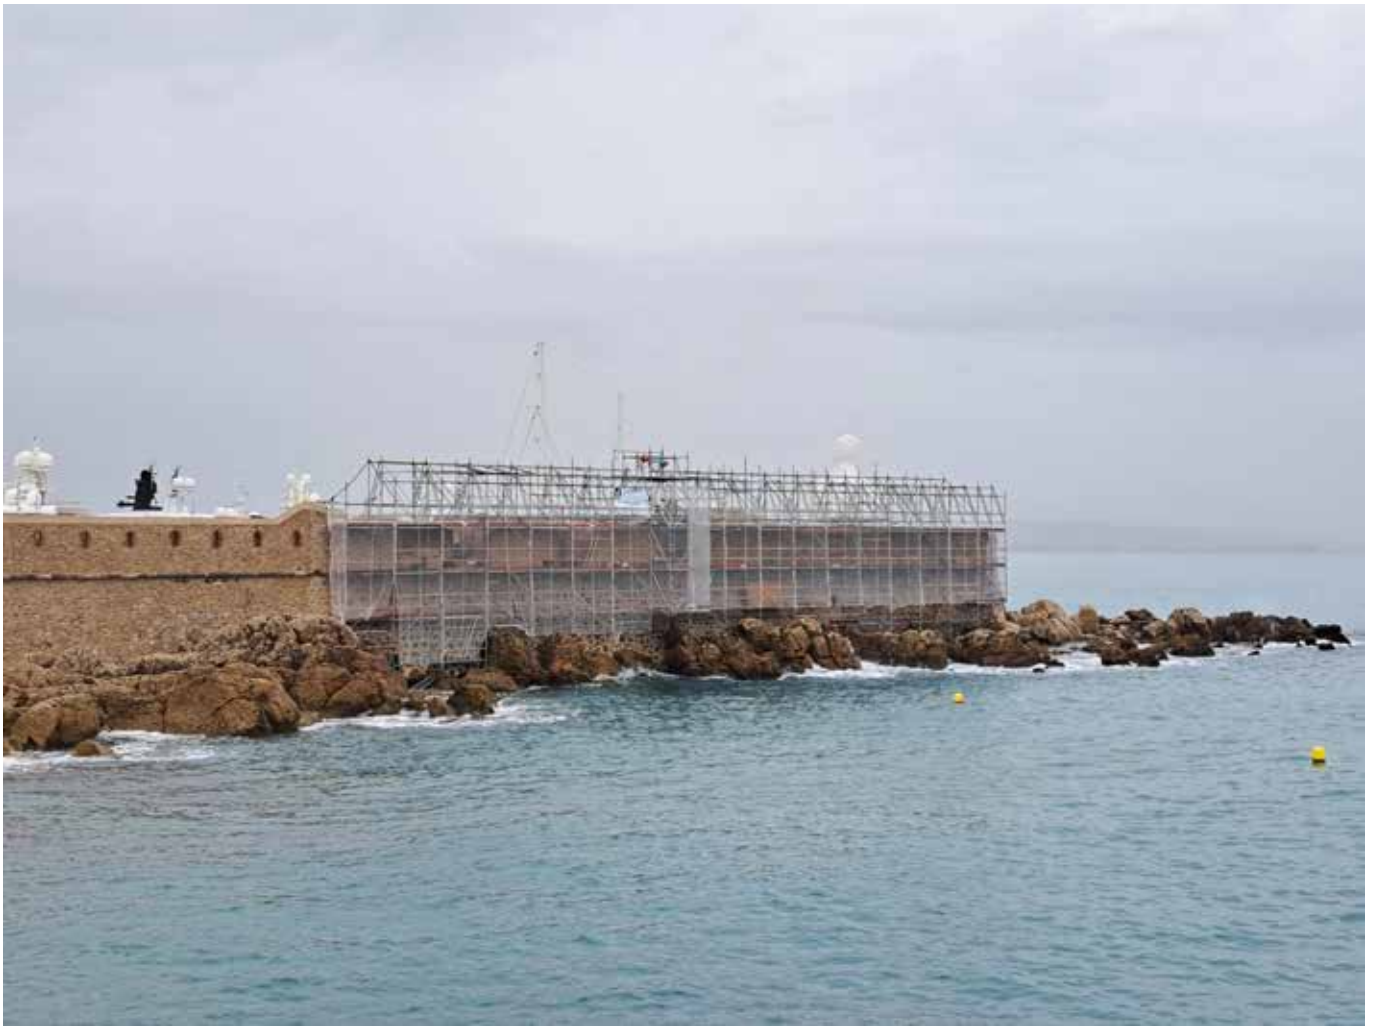
11.4) Scaffoldings for the first phase of works.

As the restoration started and the scaffoldings were erected, a herpetologist started inspecting the cracks of the masonry with an endoscope, in search of geckos. The presence of excrements was a first indicator of their presence. A nest with eggs was eventually found and several reptiles were encountered on site.

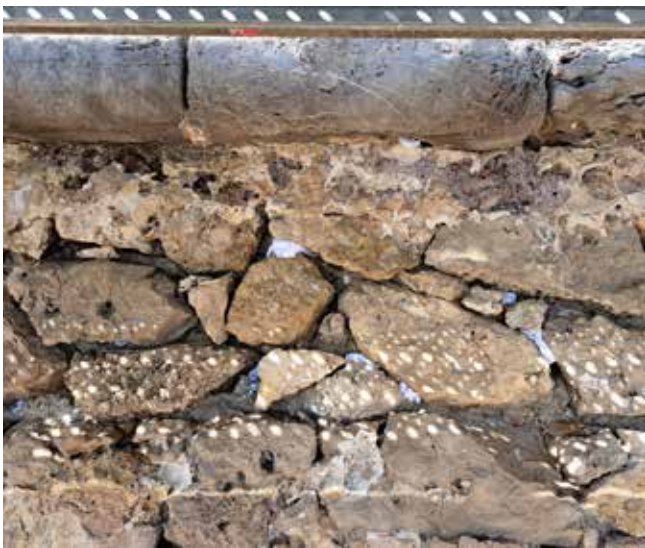
11.5) Marking suitable anfractuosités with handkerchiefs.

During his inspections, the herpetologist used handkerchiefs to mark the anfractuosités that were already hosting geckos or that ought to remain open so as to become a habitat for geckos. Once the amount of anfractuosités and their position was known, the restoration process was confirmed during an onsite meeting at which all the stakeholders were present : the ecologist, the architect, the client, the construction firm and the "Architecte des Bâtiments de France" (State architect). As the workers would progress with their work, it was decided that they would take away the handkerchiefs and insert a Provençal cane to prevent filling in the wall with mortar.

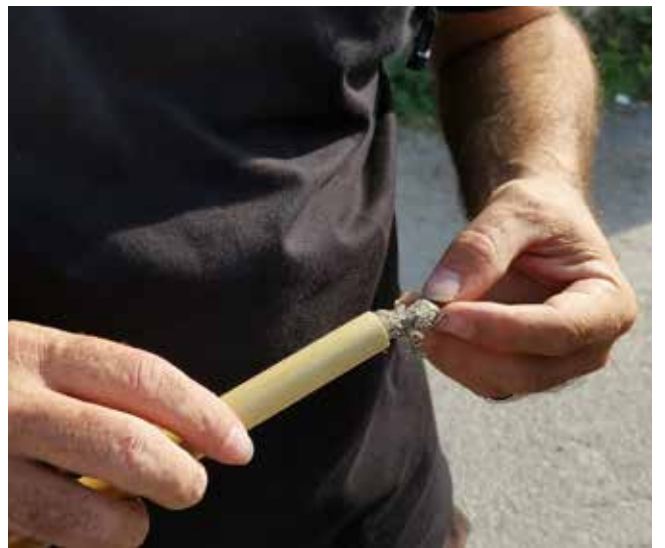
11.6) Finding the right size of provencal cane.

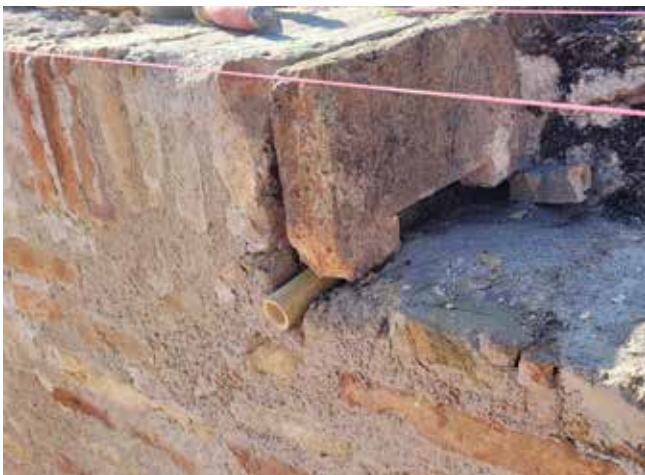
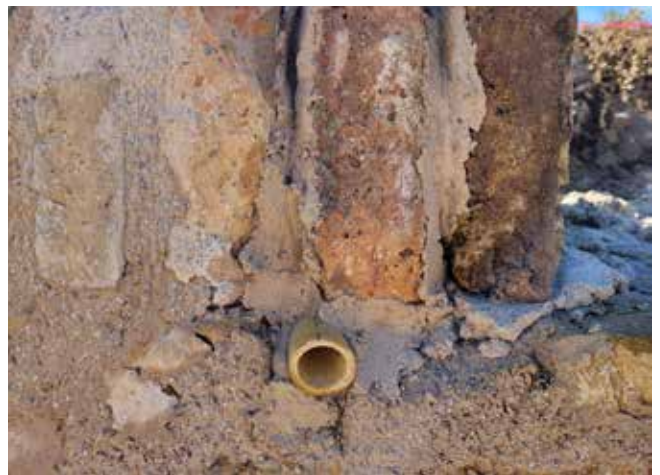
11.7-8) Creating habitats for the geckos.

This first experience in Antibes of a new way of restoring was for us a sort of "prototype". A similar process was implemented at the Citadelle of St Tropez, where also protected geckos were found. This time, it is at the architect's suggestion that the client added an ecologist to the team. This is how the first phase of restoration of the scarp included the creation of gecko habitats in the cracks of the masonry.

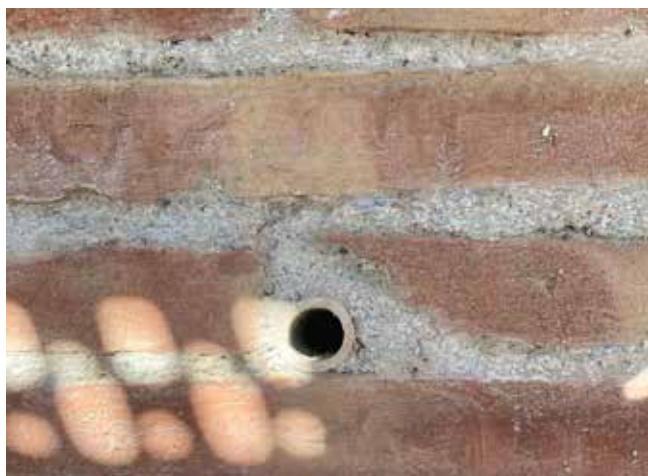
11.9) The restored brickwork in Antibes' rampart.

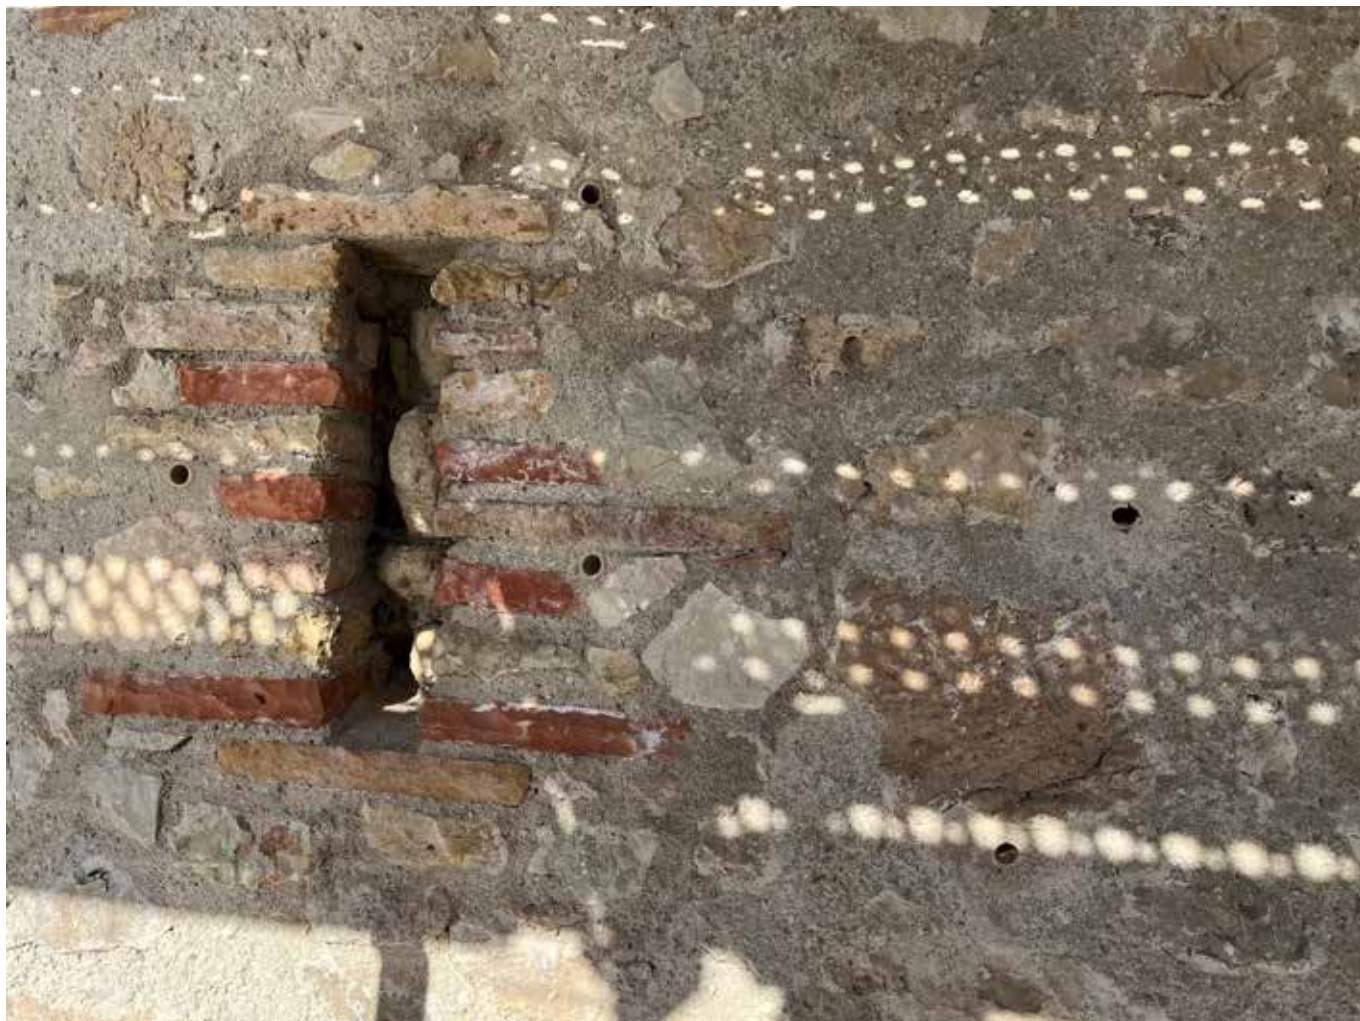
11.11) The restored brickwall of Port Vauban in Antibes.
